BIG SUR RIVER STEELHEAD ENHANCEMENT PLAN

Prepared for:
Department of Parks and Recreation
Monterey District
2211 Garden Road
Monterey, CA 93940

Prepared by:
Denise Duffy & Associates, Inc.
947 Cass Street
Monterey, CA 93940
Contact: Josh Harwayne

March 2003

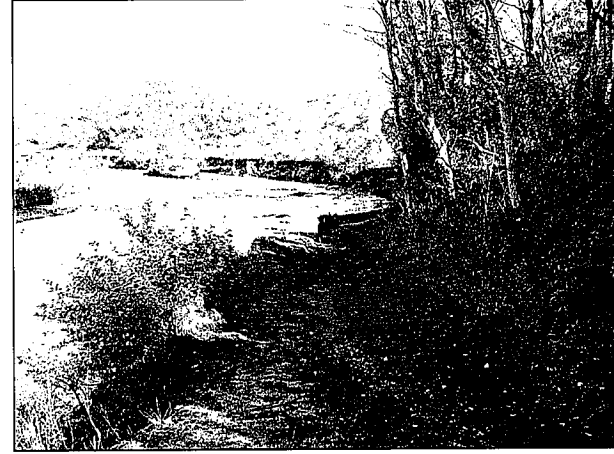
Left bank trail-related erosion at RM 0.18 Capital
improvement site CP-1.

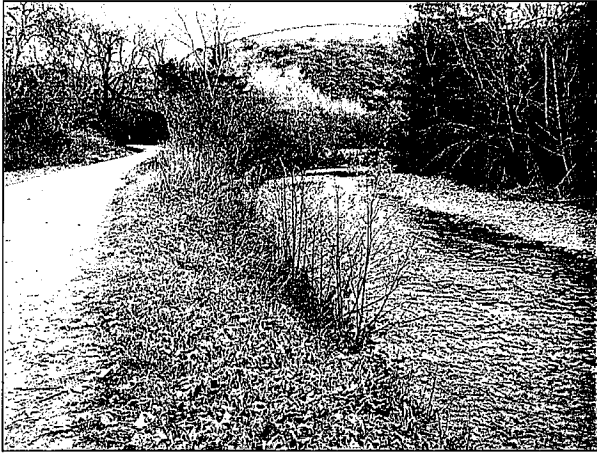
1997-98 Right bank failure at ranch road. (RM 1.29-1.32). Note alder and willow recruitment at toe. Road realignment and bio-engineered slope treatment proposed.

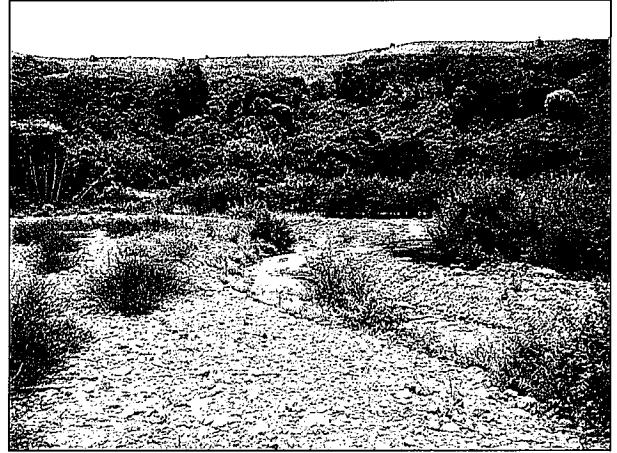
Braided channel in area of severe channel widening (RM 1.38)

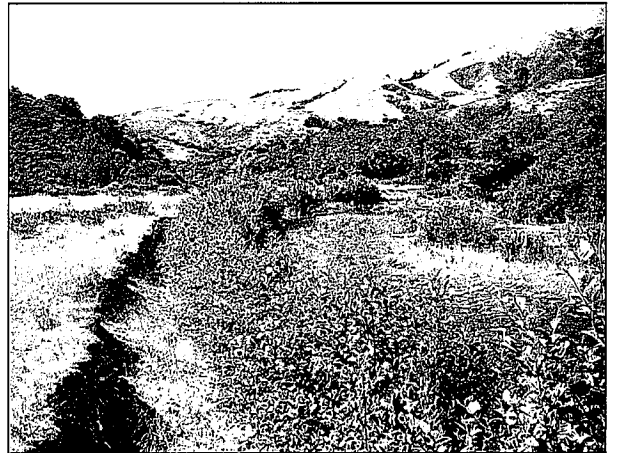
1997-98 left bank failure at (RM 1.48). Note alder and willow recruitment at toe.

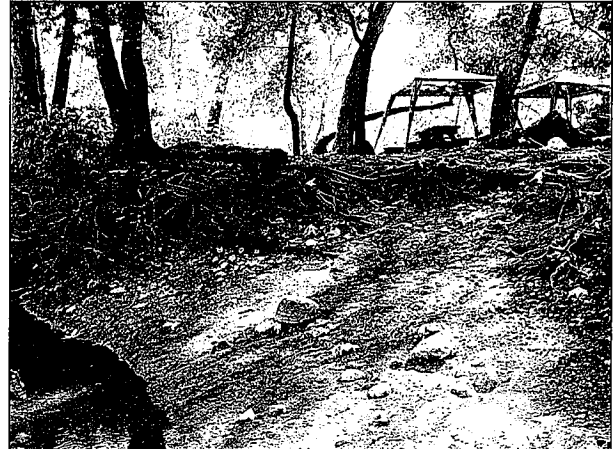
Denuded riparian habitat and severe bank erosion at river site # 151. (PBSRM 1.72)

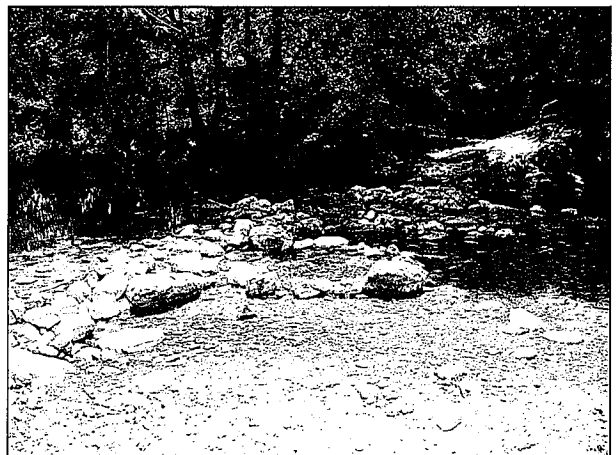
Rock dam passage obstruction at Post Creek confluence. (PBSRM 1.77)

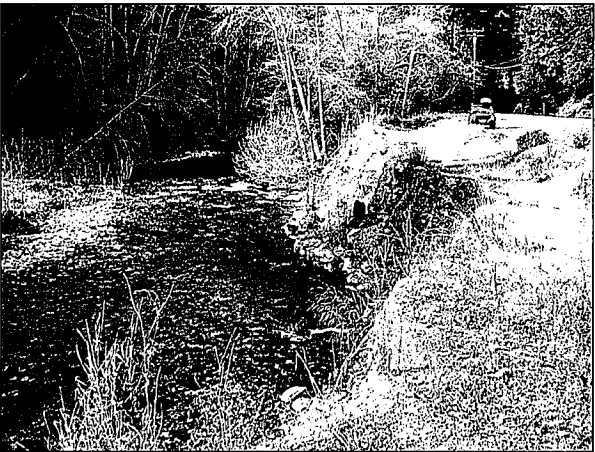
Highway 1 bank failure near PBS gate. (PBSRM 0.35) Site proposed for bio-engineered log wall to provide habitat, limit erosion and maintain road fill. Looking downstream.

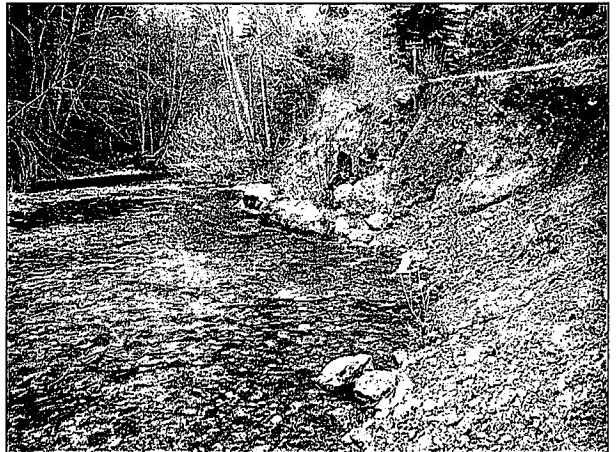
Highway 1 bank failure near PBS gate.

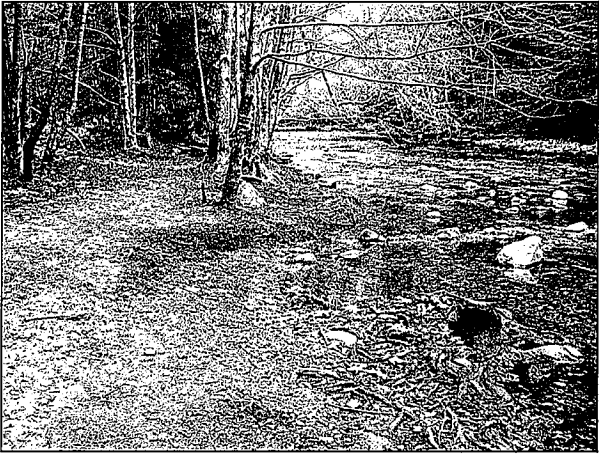
Riparian habitat at day use picnic area, denuded by recreational use. February 2002 conditions. (PBSRM 0.99)

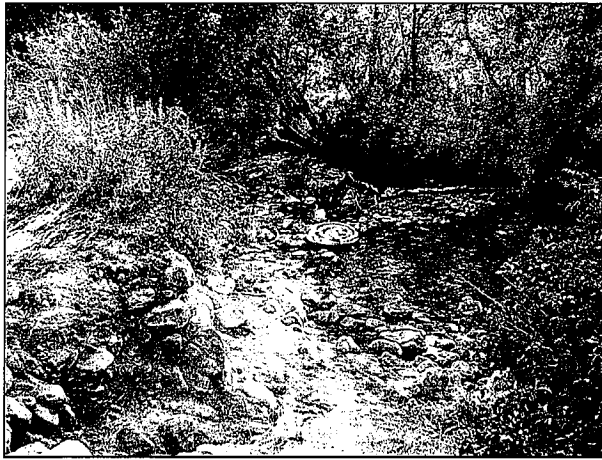
Severe bank erosion and heavy recreational use below Post Creek confluence. (PBSRM 1.81)

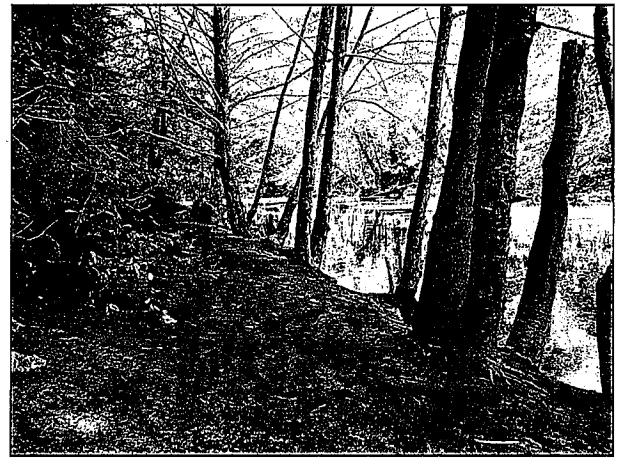
Severe bank trampling and heavy recreational use below USGS Big Sur Gage. Persistent modification of downstream control riffle by construction rockdams in the vicinity of PBSRM1.98, limits accuracy of realtime-remote gaged low-flow measurements. As a result, summer baseflows are most often estimated by USGS staff and are considered poor records. (PBSRM 2.02)

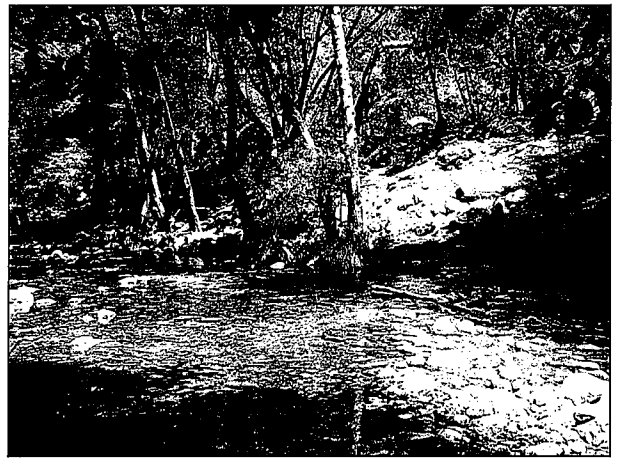
Camp site and recreational use impacts to riparian corridor, below river sites 199 and 200. (PBSRM 2.05)

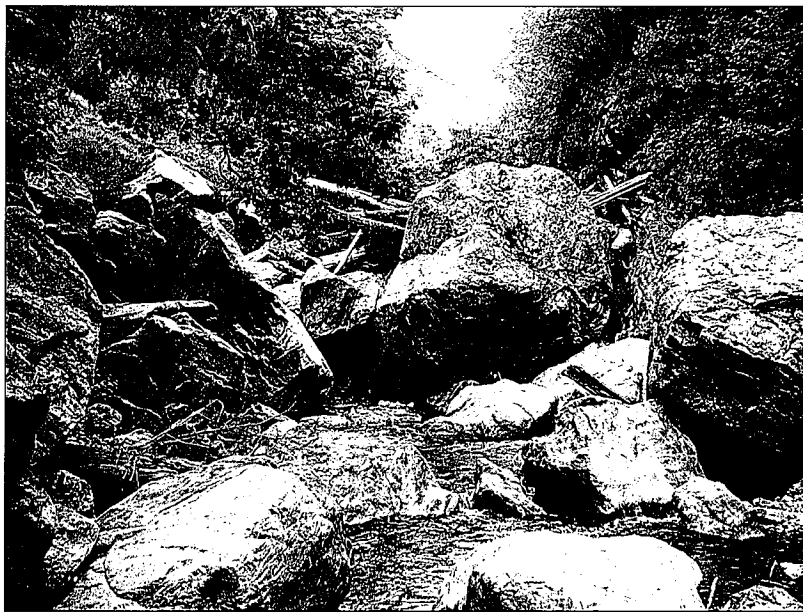
25-35' tall boulder and log jam barrier at upper end of Gorge. (PBSRM 2.51)

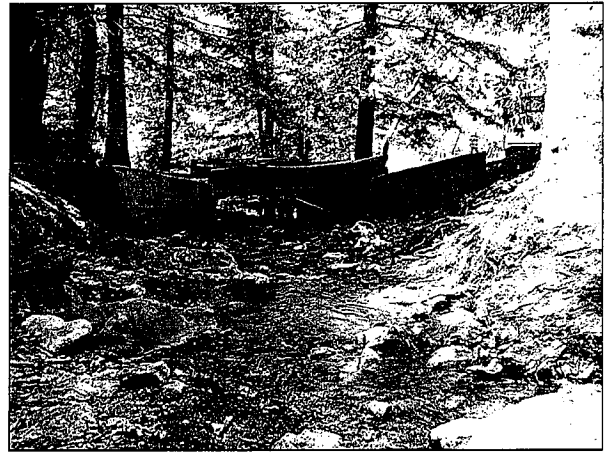
Low clearance at upstream camp road crossing results in debris backups and local flooding. (PCRM 0.081)

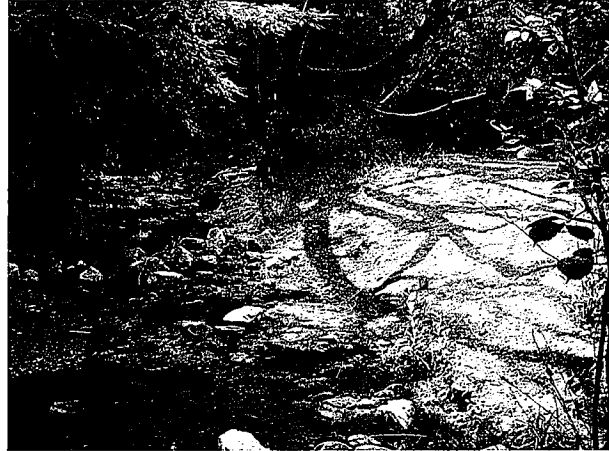
Post Creek degraded riparian zone between camp roads. (PCRM 0.025-0.05)

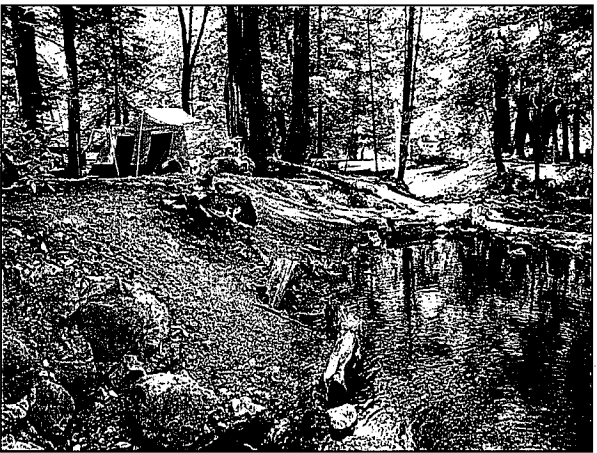
Post Creek degraded riparian zone between camp sites #104 and #106 proposed for removal. (PCRM 0.0865-0.11)
Revegetate with native species and install temporary riparian exclusion fencing to limit access to informal trails.

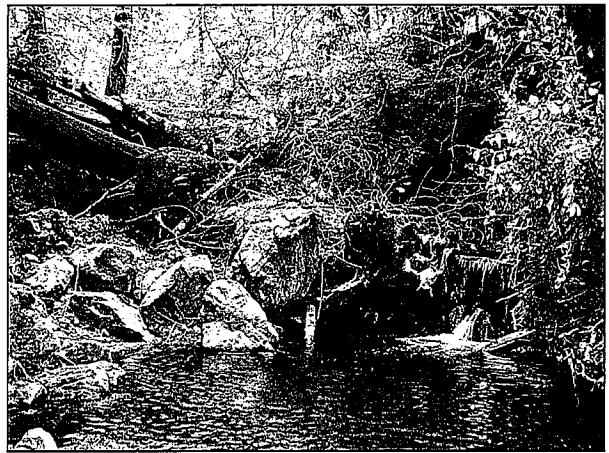
Post Creek near park boundary. Numerous logjams and passage barriers exist between PCRM 0.15 and a large landslide toe at PCRM 0.38..

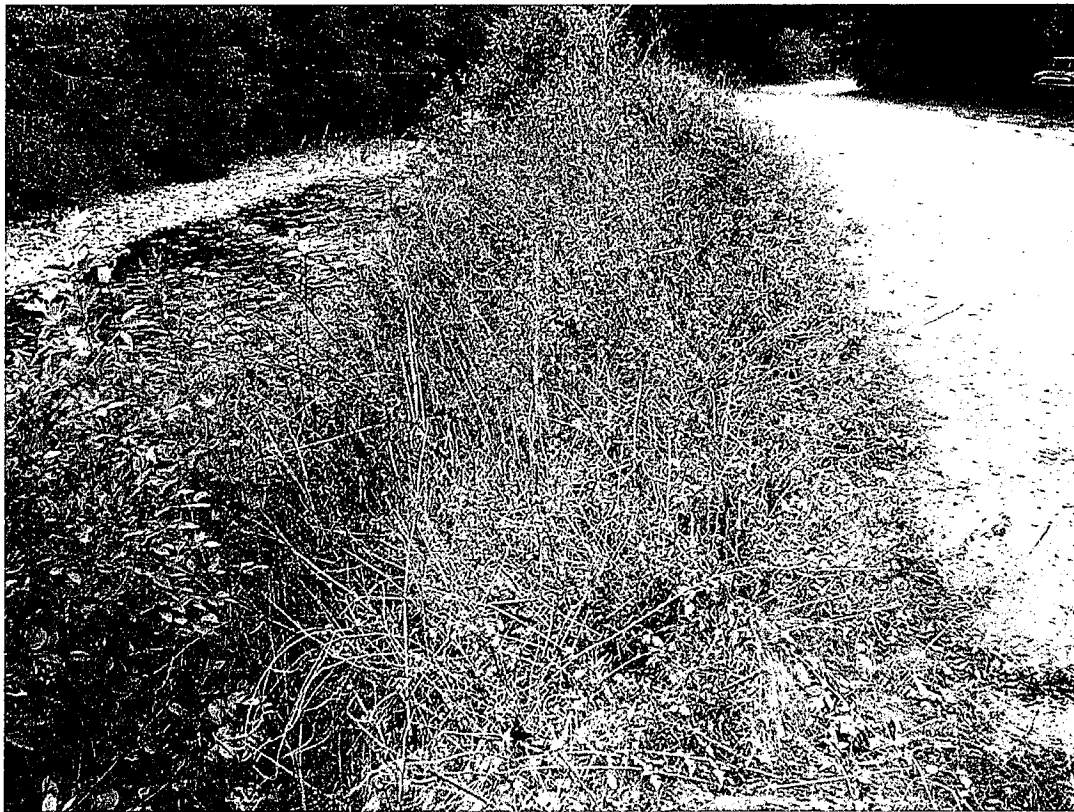
Figure 2. Andrew Molera State Park Project Site

The site is adjacent to a park access road and the position of the road has confined the river channel and upland riparian corridor to a narrow strip of land. The bank is near vertical along the reach and unstable and the amount, distribution and density of riparian vegetation on the stream bank and upland area are very sparse. Figure 2 presents a photo showing conditions looking downstream from the upstream edge of the site. Confining the channel and riparian corridor to a narrow strip of land reduces the riparian vegetation and bank stability, making the bank susceptible to erosion during high flow events. Erosion of the stream bank material has caused the angle of the bank to increase to nearly vertical. If left unchanged, it is foreseeable that future flows could cause further erosion and bank instability.

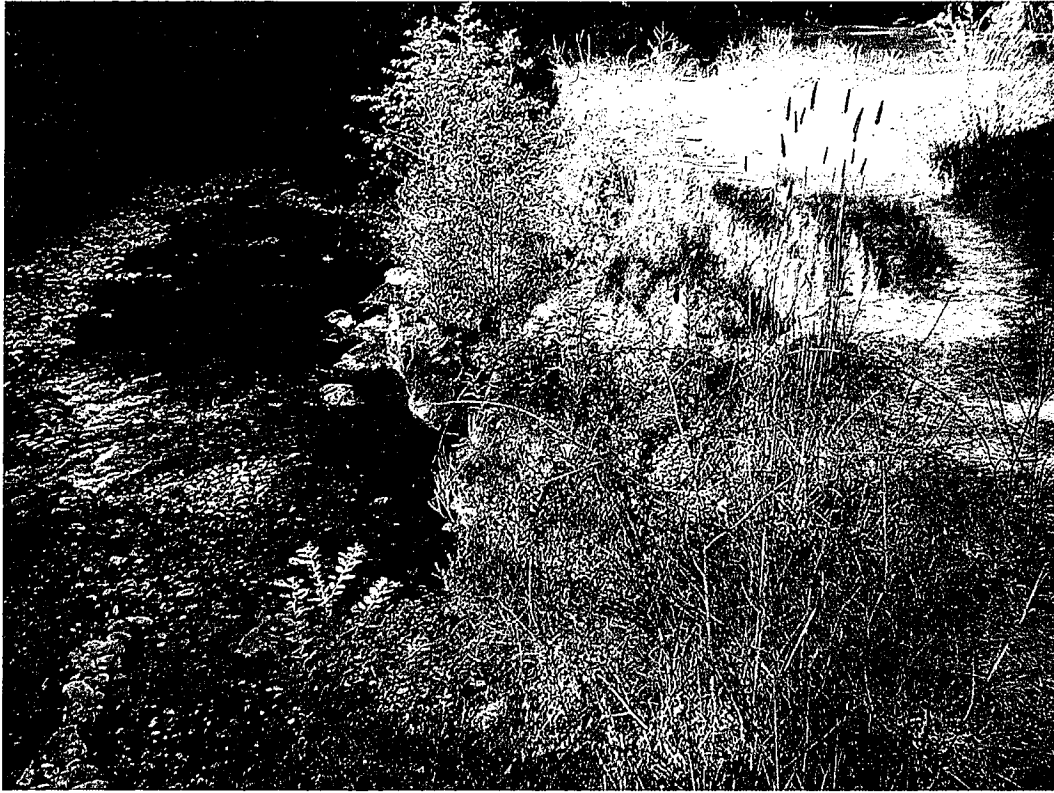
Figure 6. Pfeifer Big Sur State Park Project Site

The project site is located on an outside meander bend of the Big Sur River. The bank is under cut and experiencing bank failure, as seen in Figure 6, a photo of current bank conditions. The bank is in close proximity to State Highway One, and if left unchanged, it is foreseeable that future flows could cause extensive erosion and bank instability and impact Highway One.

To restore the bank to a more stable and natural condition, the proposed project will include constructing a 115-foot long vegetated log-revetment wall and reshaping and vegetating the top bank to a milder slope. The log-revetment wall will be constructed from a combination of a concrete reinforced footer log and redwood logs. Each cell between each course of logs will be filled with a live willow brush mattress and soil, as shown in Figure 7. The logs will be tied to the existing slope using Chance soil anchors that are driven into the slope using an hydraulic auger. As the live willow mattress grow and mature, the root structure will provide long-term bank protection and erosion control. The top of the bank will be vegetated with native, locally available plants. The placement of vegetated rip-rap is proposed set at the toe of the wall to provide additional protection against scour.
