Garrapata Creek Watershed Assessment and Restoration Plan

July 2006

Prepared by
The Garrapata Creek Watershed Council

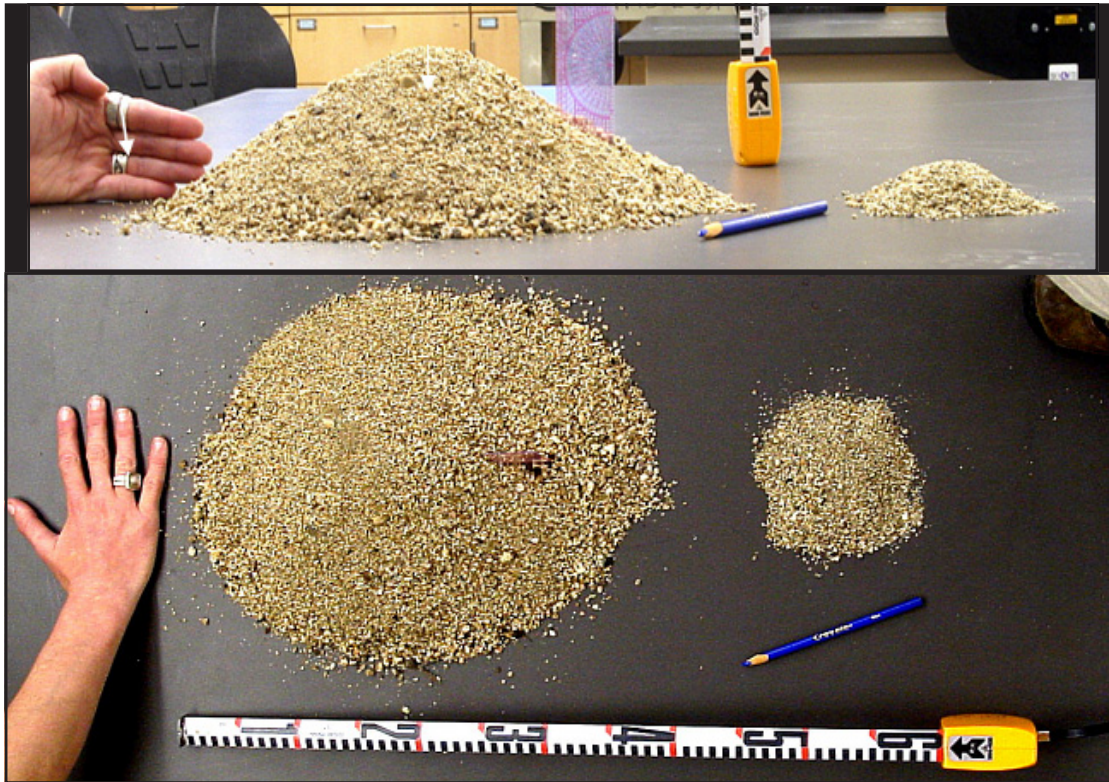
Another way to illustrate the great difference in sediment loads is to compare the amount of sediment flowing past a given point in each creek (Fig. 17). If Joshua Creek were unimpaired by sediment, its sediment pile (left pile in Fig. 17) would be much smaller than Garrapata's because Joshua Creek was flowing at a much lower rate that day.

Figure 17: Bedload material collected on February 19, 2004.
Left pile is 5260 g collected from Joshua Creek.
Right pile is 710 grams collected from Garrapata Creek.
Sampling time for both creeks was 20 minutes.

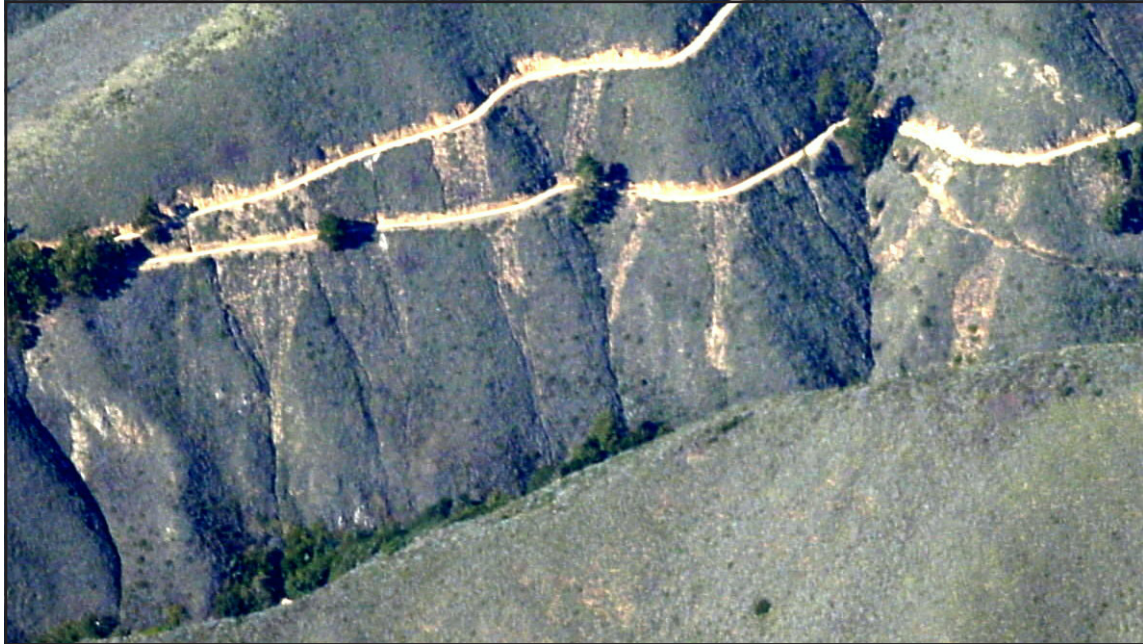
watershed revealed that the main sediment sources in the watershed are the roads cut along the southern slope of the Joshua Creek watershed where numerous landslides and sediment aprons are present (Figs. 18 and 19).

*Figure 18: Sediment aprons shed from side-casted road cut material in Joshua Creek Watershed.
Photo: D. Smith October 31, 2004.*

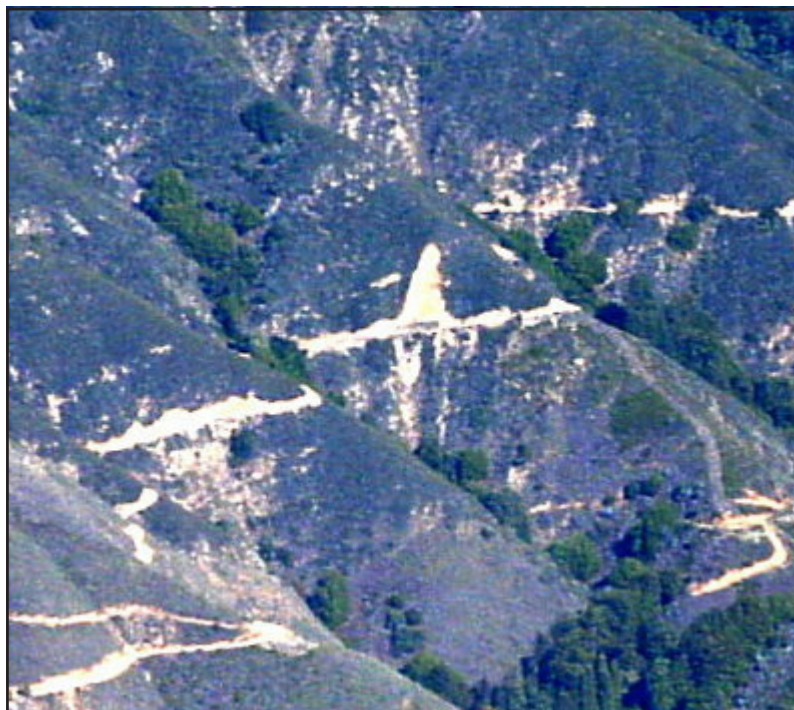
*Figure 19: Shallow soil slip and sediment aprons along the roads in Joshua Creek Watershed.
Photo: D. Smith October 31, 2004.*

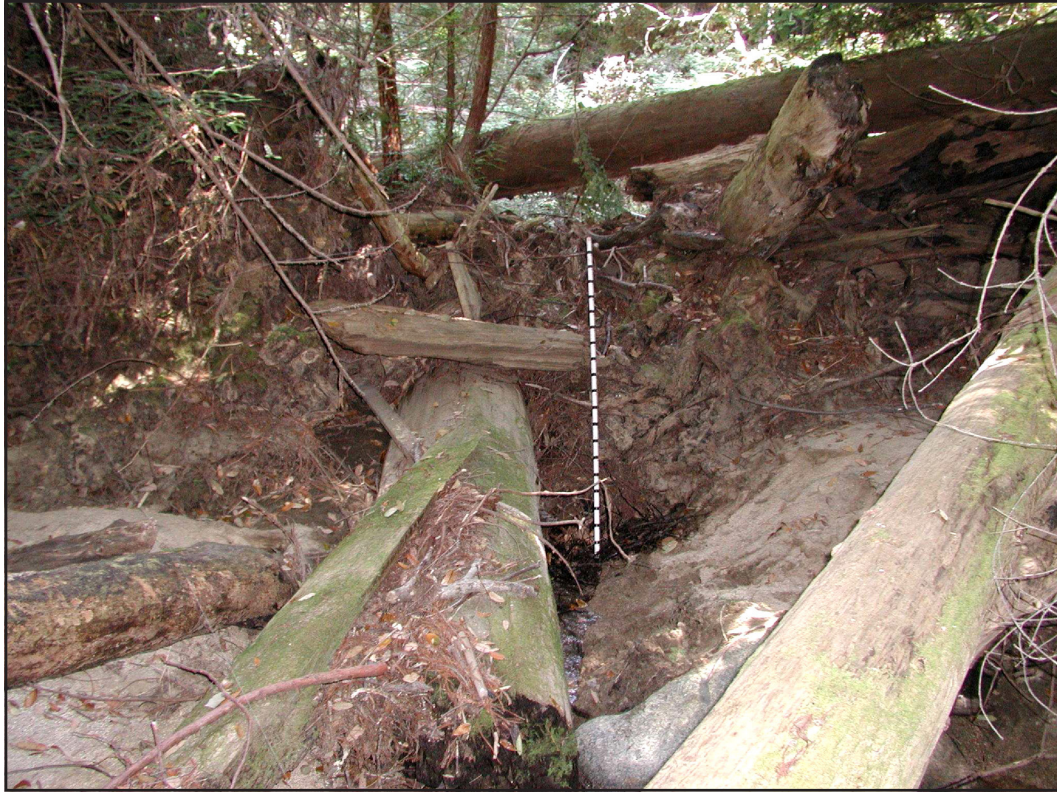
Figure 29. This debris jam (gb04) is likely the limit to anadromous fish in Garrapata Creek. This is the backside of the debris pile looking downstream. Photo: J. Casagrande 11 August 2004. See Casagrande and Smith, 2005 for naming of each logjam.

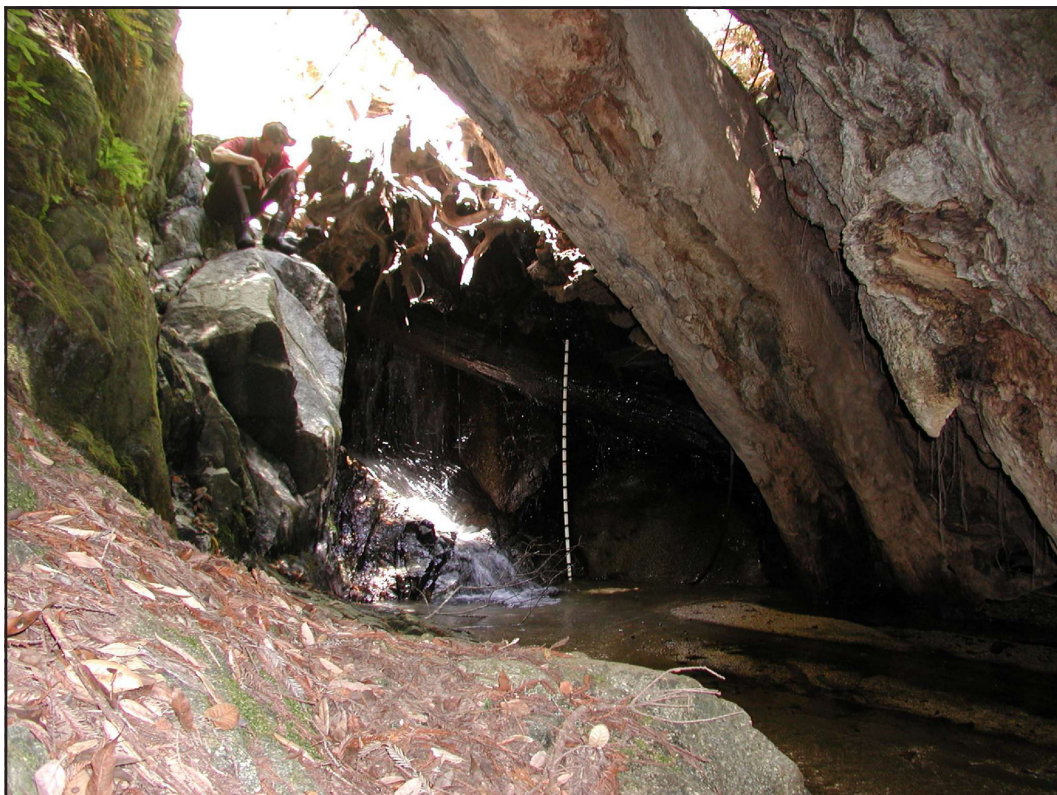
Figure 30. This logjam (gb08) at approximately 3 meters tall is a significant barrier to migration on Garrapata Creek. Photo: J. Casagrande 11 August 2004.

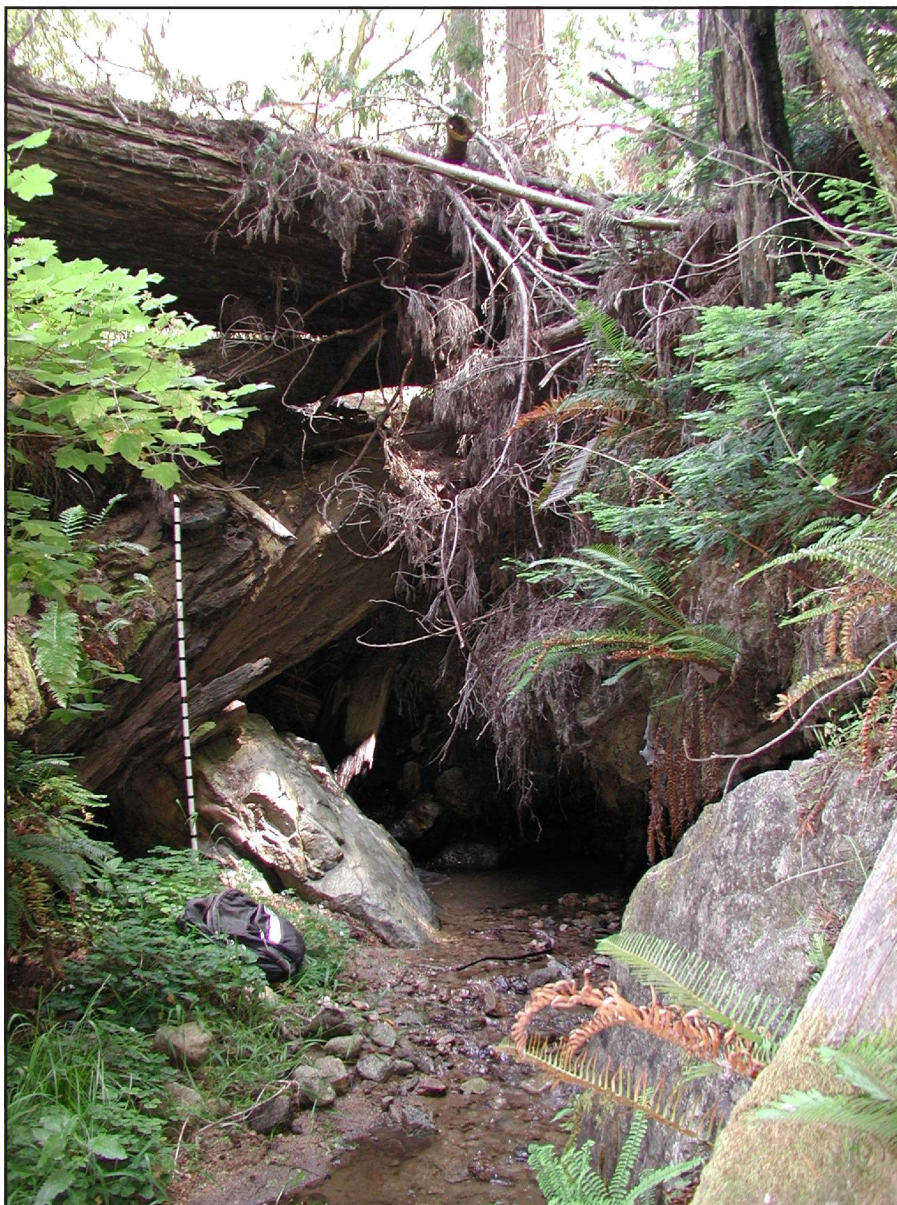
Figure 31. This is large logjam on Joshua Creek (jb08) is a complete barrier to steelhead. Photo: J. Casagrande 3 June 2004.

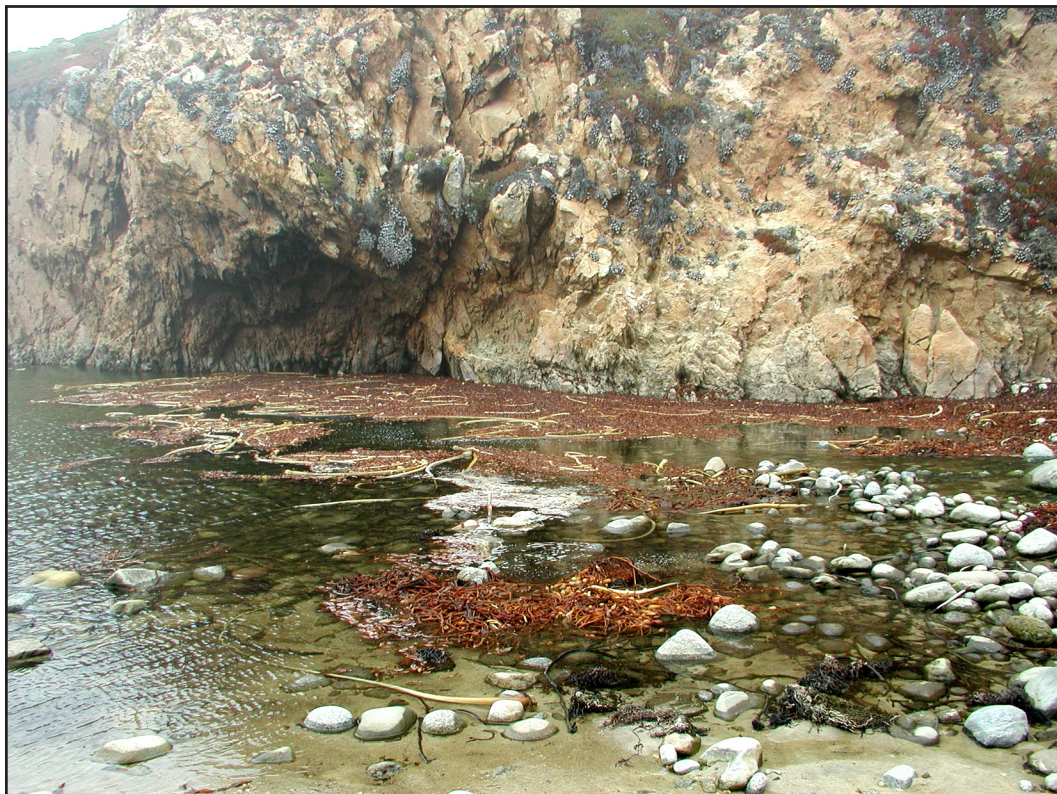
*Figure 34. Large amounts of kelp enter the lagoon during wave events where it will then decompose and take up dissolved oxygen from the water leaving anoxic waters in place.
Photo: J. Casagrande 12 Oct 2005.*

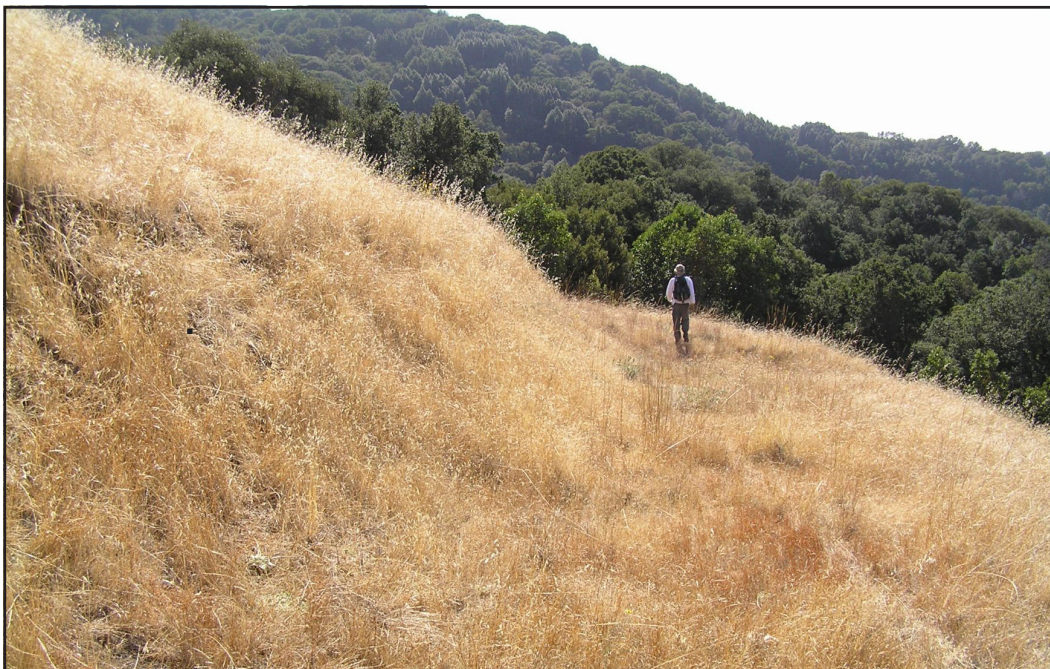
Figure 39: Decommissioned roadbed in upper Wildcat Canyon. This stretch of road does not appear to have had noticeable “treatment” related to road decommissioning, however the simple act of ripping the compacted roadbed could have led to invasion of weedy annuals, as is depicted in this photograph. Photo: N. Nedeff October 2005.
