Garrapata Creek Watershed Assessment and Restoration Plan

July 2006

Prepared for
**The Garrapata Creek Watershed Community and
the California State Department of Fish and Game**

Prepared by
The Garrapata Creek Watershed Council

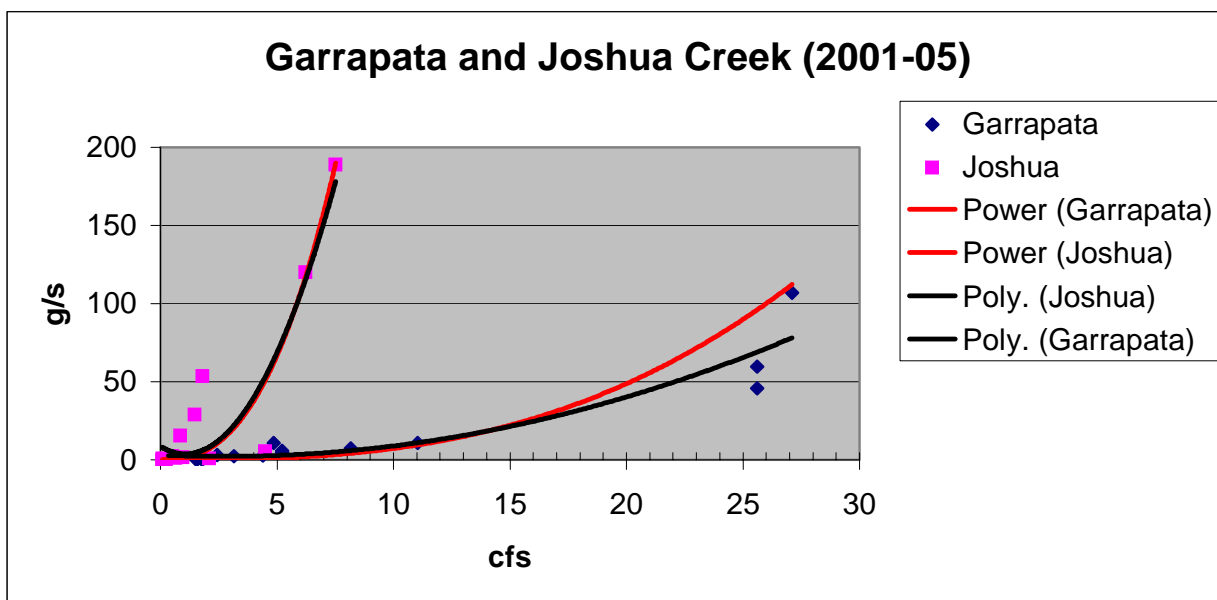
The significantly steeper line in the Joshua Creek data clearly demonstrates that Joshua Creek has an excess of sediment when compared with Garrapata Creek (Fig. 16). Given a slight increase in stream flow in Joshua Creek, the sediment transport rate increases significantly. In contrast, Garrapata's sediment transport rate increases very gradually even at much higher flow rates. Visual inspection of both creeks supports these data.

Figure 16: Sediment transport rates (grams per second) at different stream flow rates (cubic feet per second) for Garrapata and Joshua Creeks based upon samples taken between 2001 and 2005.

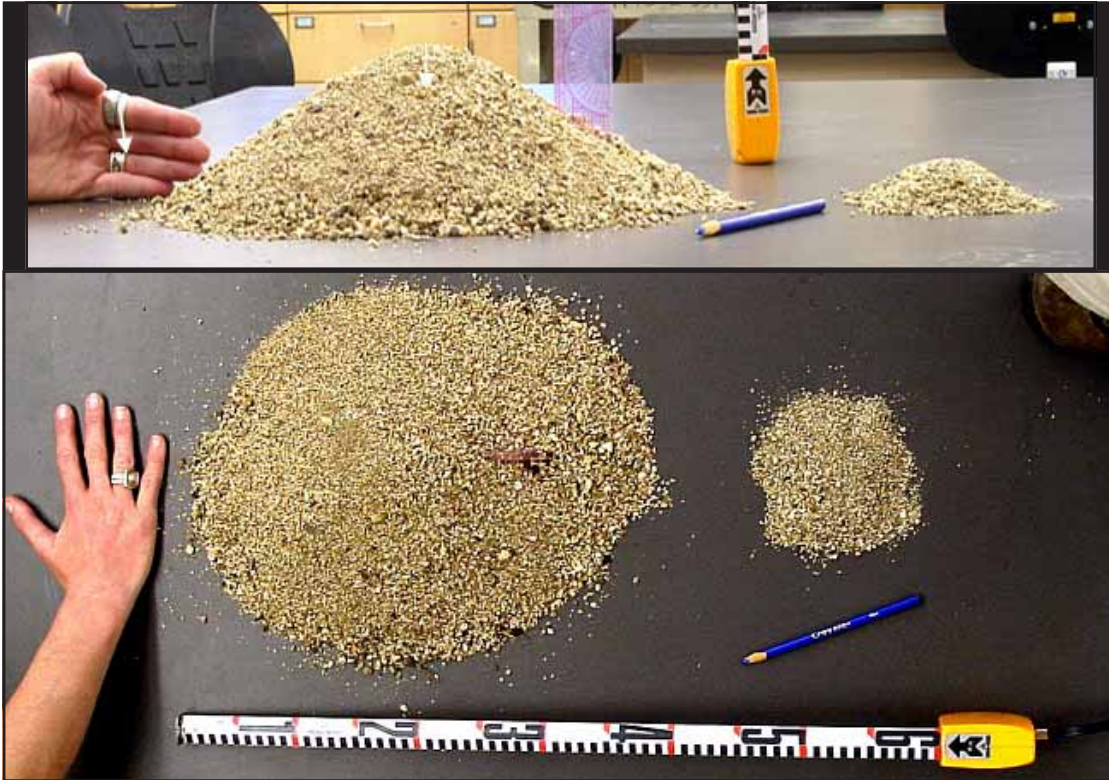
Another way to illustrate the great difference in sediment loads is to compare the amount of sediment flowing past a given point in each creek (Fig. 17). If Joshua Creek were unimpaired by sediment, its sediment pile (left pile in Fig. 17) would be much smaller than Garrapata's because Joshua Creek was flowing at a much lower rate that day.

Figure 17: Bedload material collected on February 19, 2004.
Left pile is 5260 g collected from Joshua Creek.
Right pile is 710 grams collected from Garrapata Creek.
Sampling time for both creeks was 20 minutes.

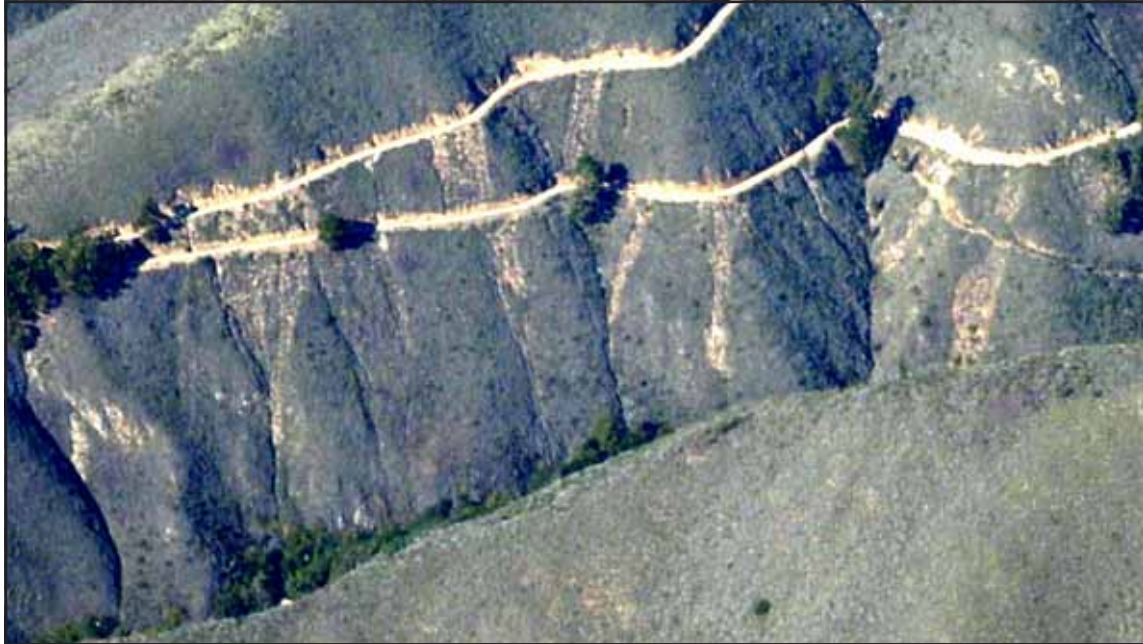
watershed revealed that the main sediment sources in the watershed are the roads cut along the southern slope of the Joshua Creek watershed where numerous landslides and sediment aprons are present (Figs. 18 and 19).

*Figure 18: Sediment aprons shed from side-casted road cut material in Joshua Creek Watershed.
Photo: D. Smith October 31, 2004.*

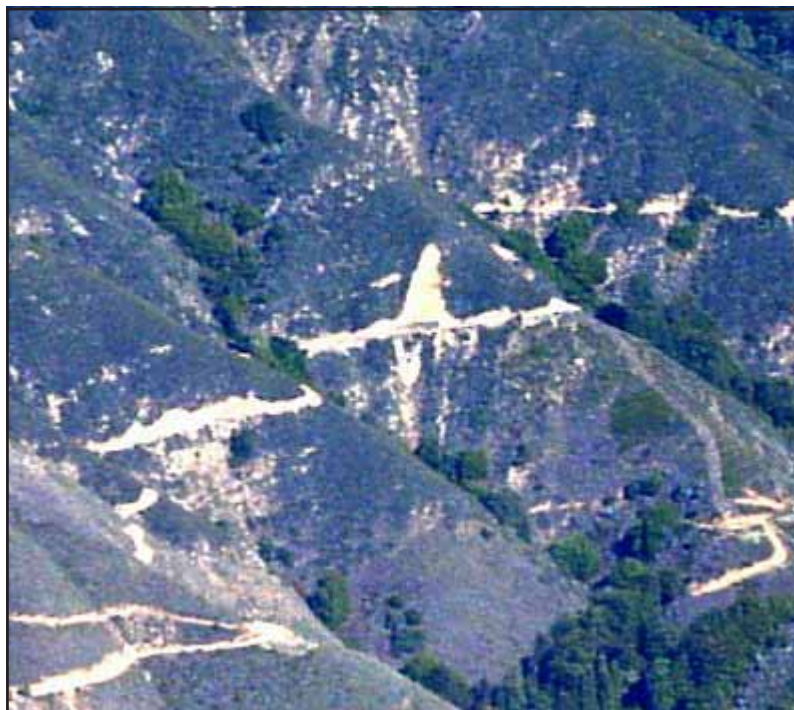
*Figure 19: Shallow soil slip and sediment aprons along the roads in
Joshua Creek Watershed.
Photo: D. Smith October 31, 2004.*

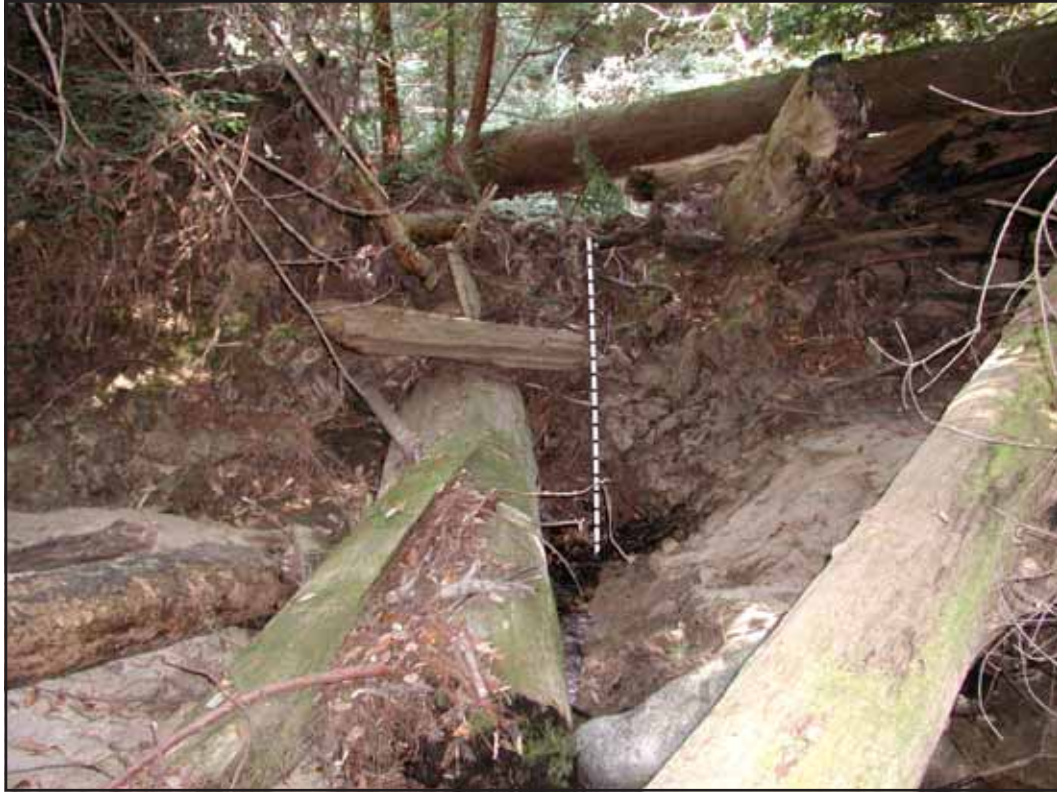
Figure 29. This debris jam (gb04) is likely the limit to anadromous fish in Garrapata Creek. This is the backside of the debris pile looking downstream. Photo: J. Casagrande 11 August 2004. See Casagrande and Smith, 2005 for naming of each logjam.

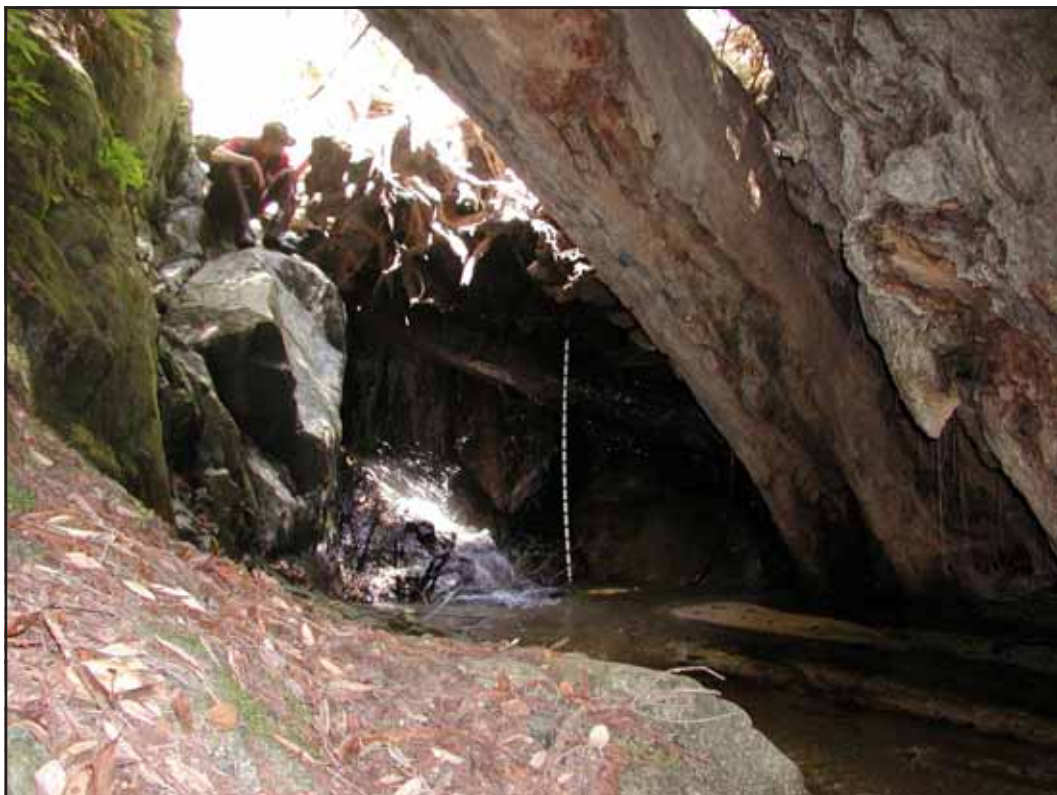
Figure 30. This logjam (gb08) at approximately 3 meters tall is a significant barrier to migration on Garrapata Creek. Photo: J. Casagrande 11 August 2004.

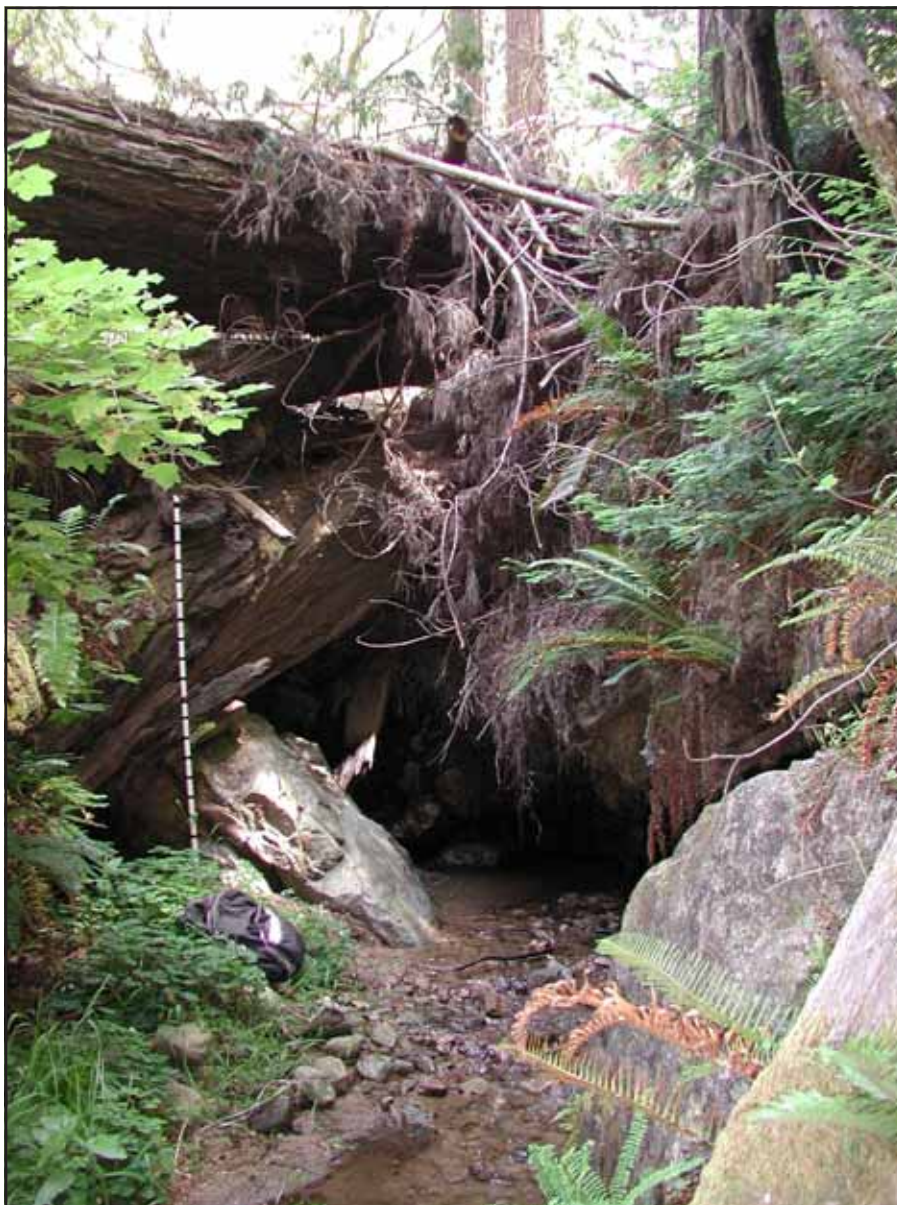
Figure 31. This is large logjam on Joshua Creek (jb08) is a complete barrier to steelhead. Photo: J. Casagrande 3 June 2004.

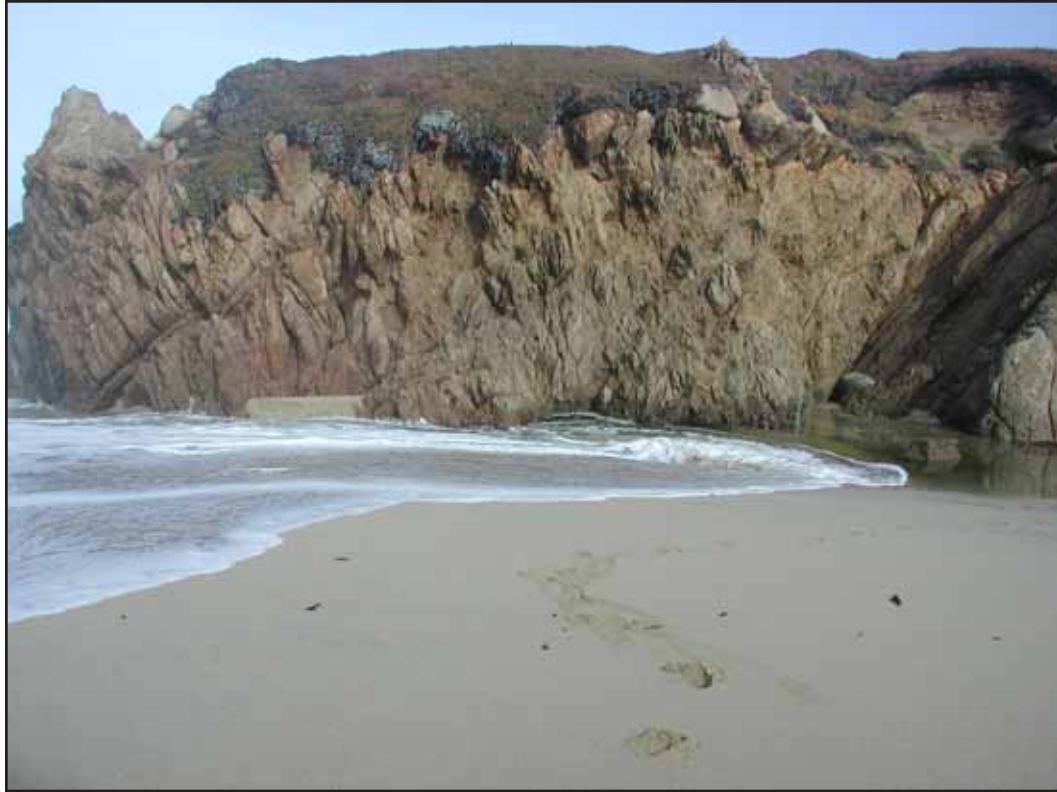
*Figure 33. Ocean waves frequently entered Garrapata Lagoon especially in fall.
Photo: J. Casagrande 30 Nov 2005.*

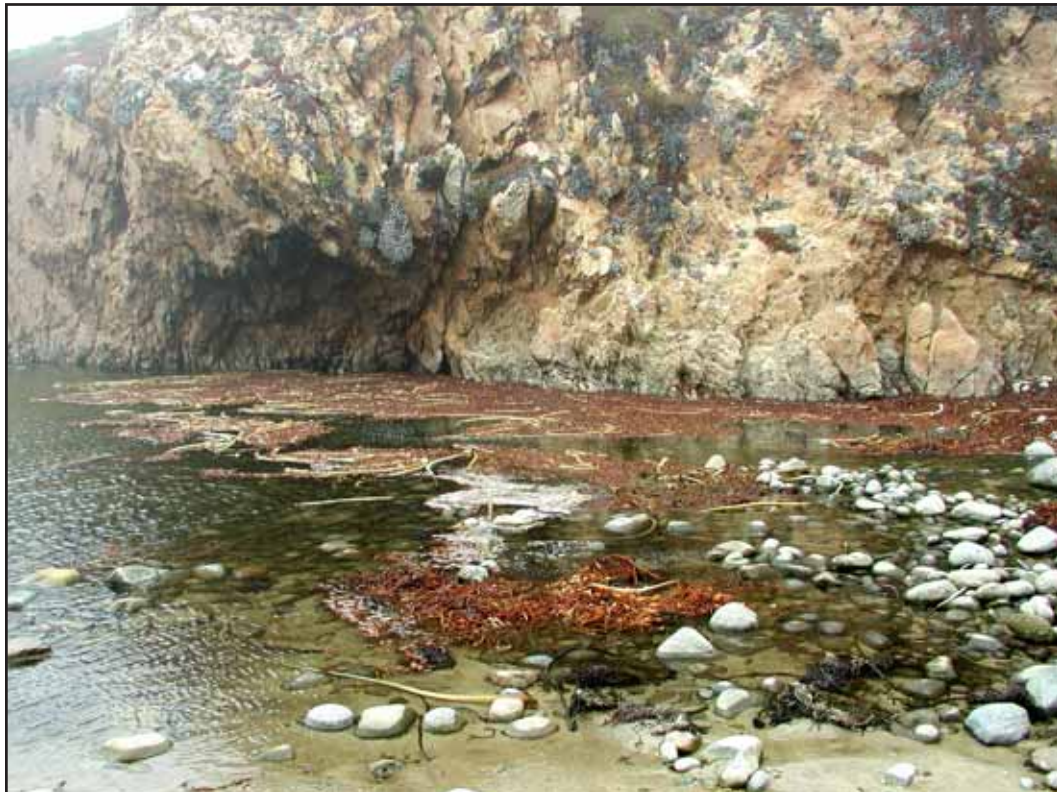
*Figure 34. Large amounts of kelp enter the lagoon during wave events where it will then decompose and take up dissolved oxygen from the water leaving anoxic waters in place.
Photo: J. Casagrande 12 Oct 2005.*

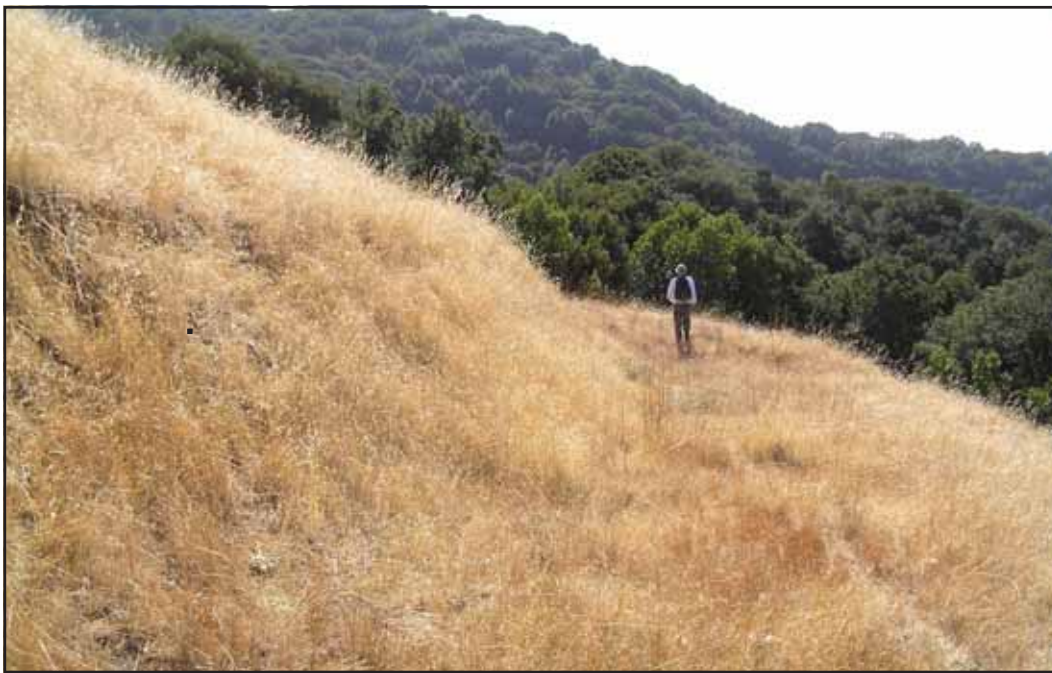
Figure 39: Decommissioned roadbed in upper Wildcat Canyon. This stretch of road does not appear to have had noticeable “treatment” related to road decommissioning, however the simple act of ripping the compacted roadbed could have led to invasion of weedy annuals, as is depicted in this photograph. Photo: N. Nedeff October 2005.
