Post Basin–Complex Baseline Monitoring of the Big Sur River (October, 2008)

Division of Science & Environmental Policy
California State University Monterey Bay
100 Campus Center, Seaside CA 93955–8001

December 19, 2008 (Minor Edits 1/6/09)

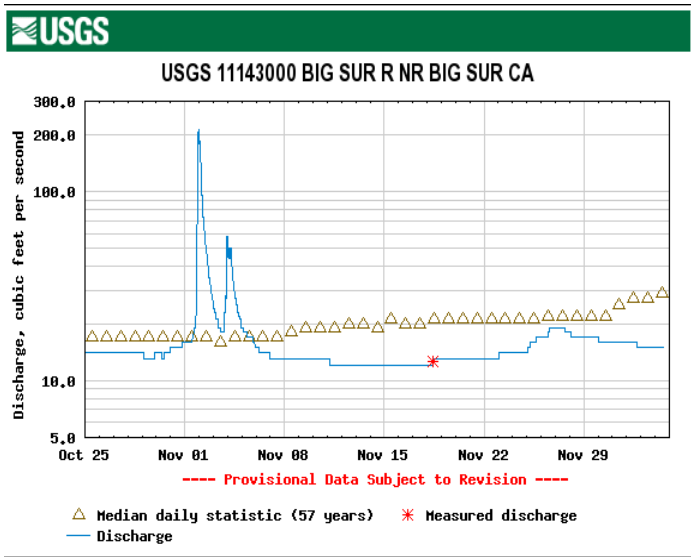
The data for the baseline monitoring is provided below, following the reference section. The particle counts typically show that there was an excess of fine sediment draping the larger framework particles even before run-off impacts occurred. At least two rain events have moved through the watershed since the initial monitoring work was done. The Big Sur River rose to 200 cfs in early November (Fig. 4). When the flow subsided visual and photo monitoring indicated that a new mud veneer was present on the channel bottom and low banks. A photo captured from the new USGS web cam in Pfeiffer Big Sur State Park shows that the rain even of mid December has produced more mud-rich runoff that will deepen the growing mud veneer (Fig. 5). Compare Figure 5 to the water clarity in late September 2008 before the rain (Fig 6).

Figure 4: Stream response to early November rains.

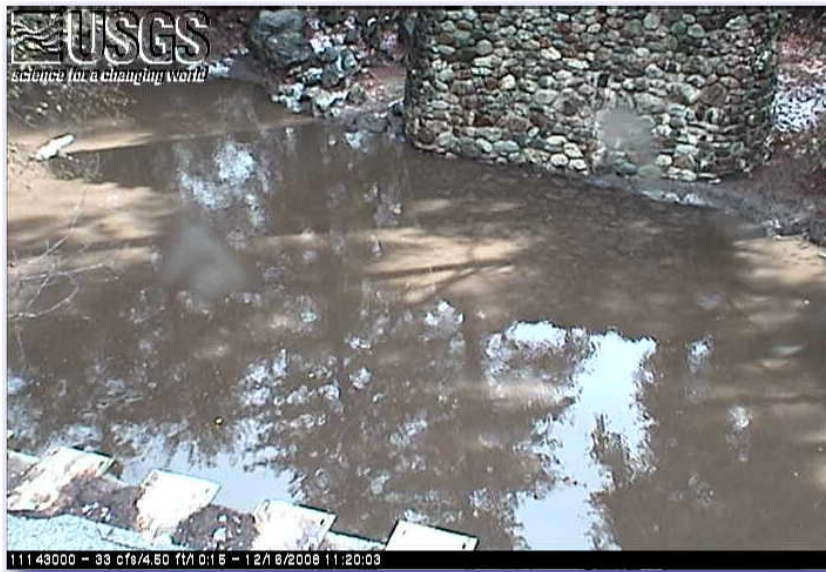
Figure 5: Muddy water resulting from the mid December rainfall.

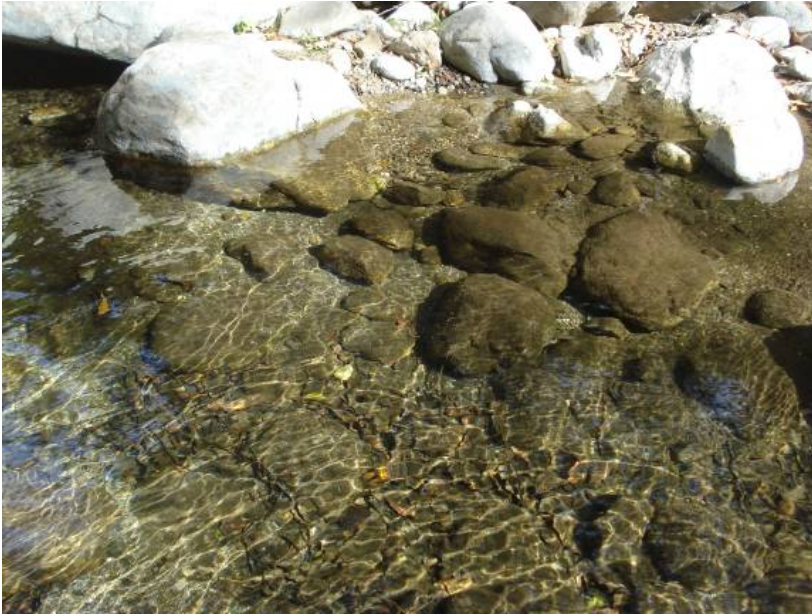
Figure 6: Clear water near USGS gage in late September 2008.

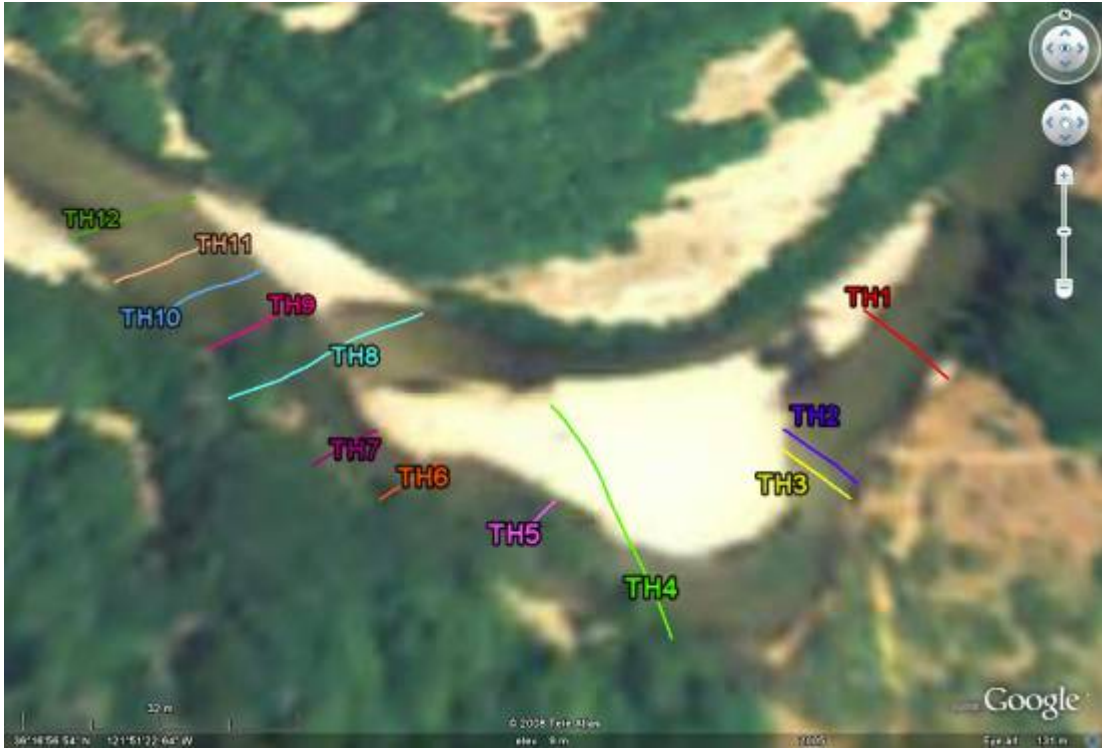
Multiple pebble count transects were performed at both the lagoon head (Fig 9) and mouth (Fig. 10). Sediment transect counts were performed in the river bed and adjacent bars and banks. Randomly chosen individual particles were measured at their intermediate axis with a metric ruler. Fine particles <2mm were counted, but sand and mud particle sizes were estimated based on field observations and not measured. Percent fines, arithmetic mean and standard deviation were calculated for each transect, lagoon head, mouth, and all locations to help determine baseline lagoon conditions. Pebble counts were tallied into particle size classes. Percent pebble counts were graphed into histograms.

Figure 9: Sediment transects at the Big Sur lagoon head location. TH2 is located on a riffle, and TH4 goes across a cobble bar.

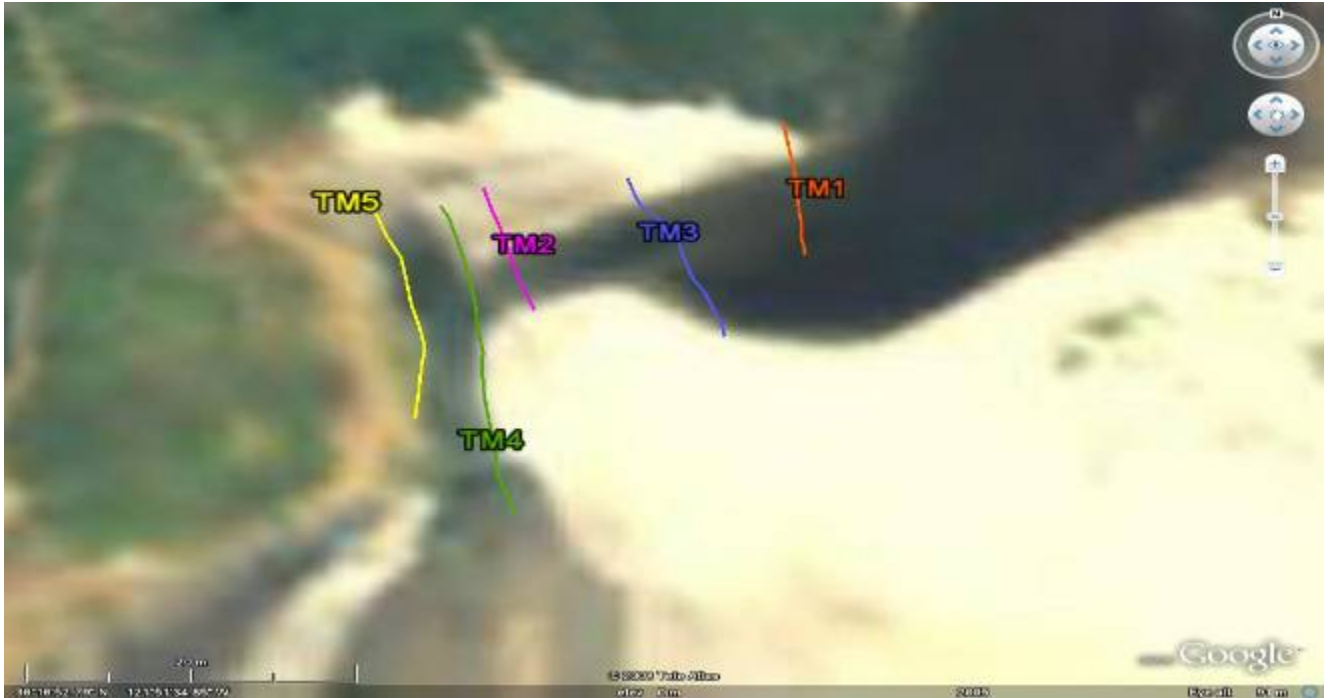
Figure 10: Sediment transects at the Big Sur lagoon mouth.

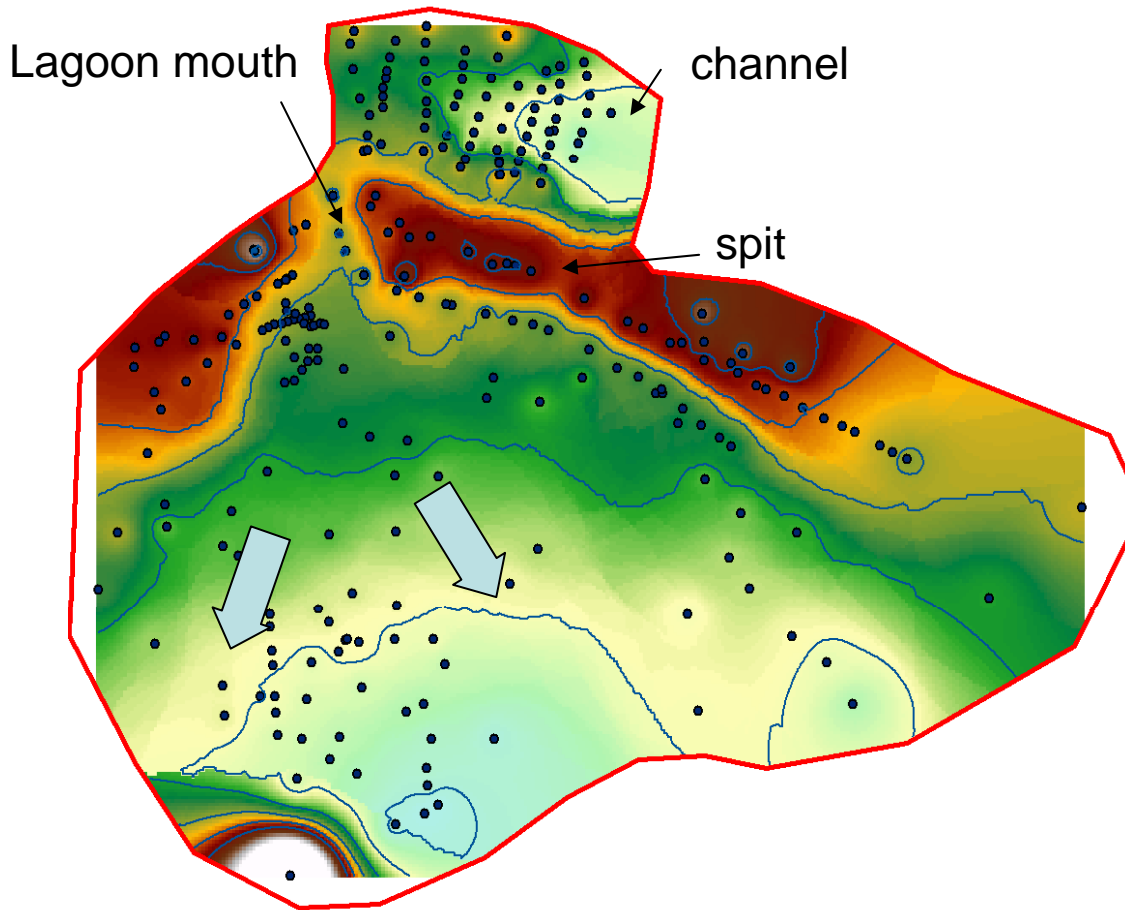
Post-processed field data were imported into GIS where a raster was created using the Inverse Weighted Distance (IDW) tool in spatial analyst. The resulting maps illustrate surveyed locations and interpolated points. Figure 11 shows topography of the lagoon mouth on 11/13/08.

Figure 11: Total station data interpolated into a raster image of the lagoon mouth using Inverse Distance Weighted averaging. Colors correspond to elevation zones where light green and light blue correspond to lowest elevations and red areas represent higher elevations. Red boundary is a user-created line to clip the raster to fit the data points. Points are in a local arbitrary reference frame. Red and white areas have greatest elevations and light green and light blue have the lowest elevations. Rocky cliff extends upward in upper left and bottom of the image. A horizontal sand spit runs parallel to the shore and constricts the lagoon mouth

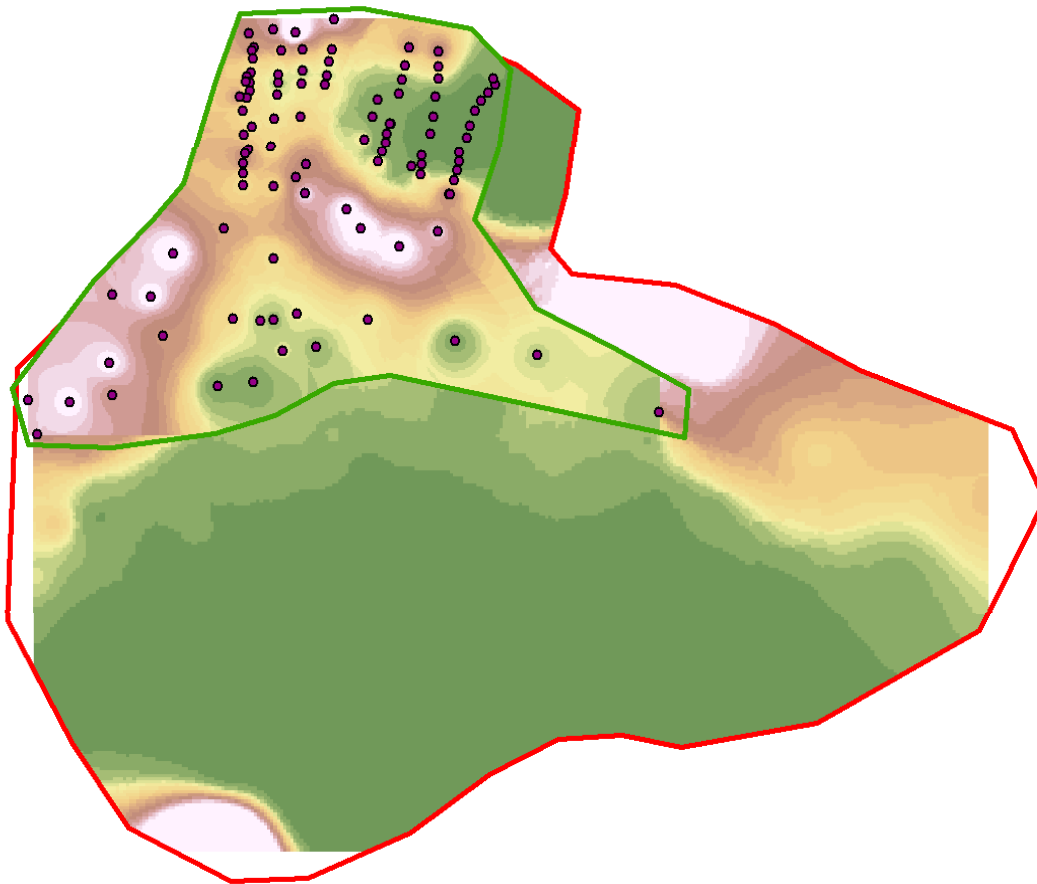
A resurvey of the lagoon mouth on 12/04/08 maps natural variability within the system. Given good point density and overlapping transects between repeated surveys (Fig. 13), comparison of elevation values could quantify variability at the lagoon mouth. Raster subtraction of the survey dates 11/13/08 from 12/04/08 (Fig. 14) yielded approximate change over 3 week period that included several days of large surf.

Figure 13: December 4, 2008 total station data point cloud and interpolated raster plotted on top of November 11, 2008 clipped raster. Both rasters were clipped using appropriate user-created mask. White corresponds to the higher elevations and dark green corresponds to the lower elevations. Color ramp used for each survey dataset is identical, providing the ability to qualitatively examine variability within the system.

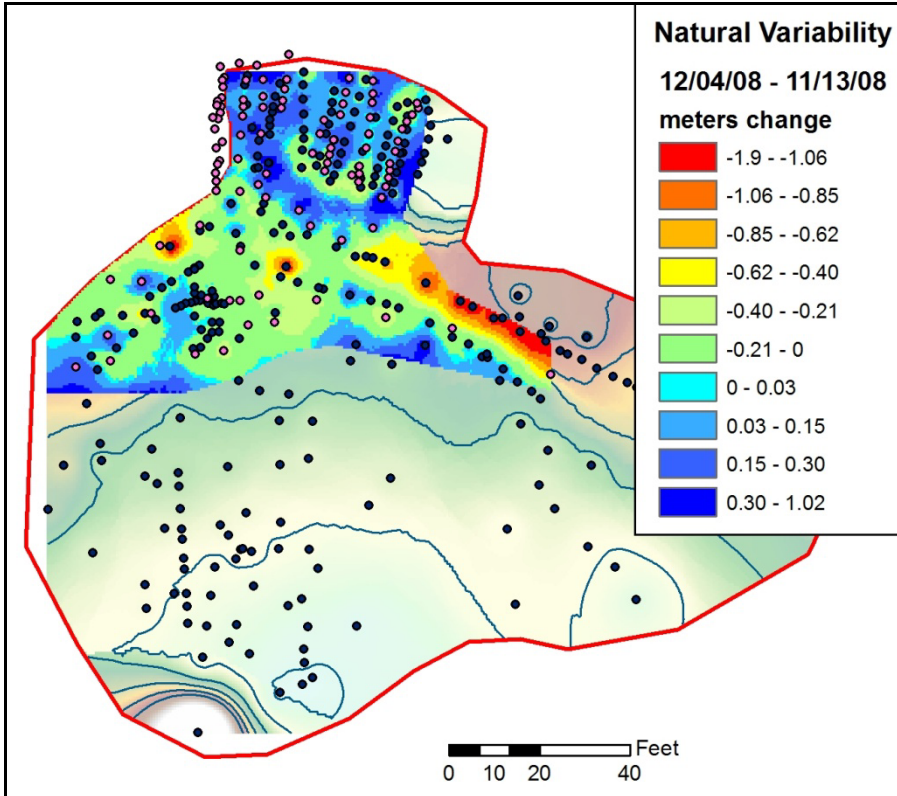
Figure 14: Raster subtraction of November 11th and December 12th clipped datasets plotted over muted November 11th interpolated raster. Point cloud from both surveys are shown. Changes in areas with low point density are less defensible than those with greater point density. Depth changes are in meters and warmer colors indicate erosion while cooler colors indicate accretion.

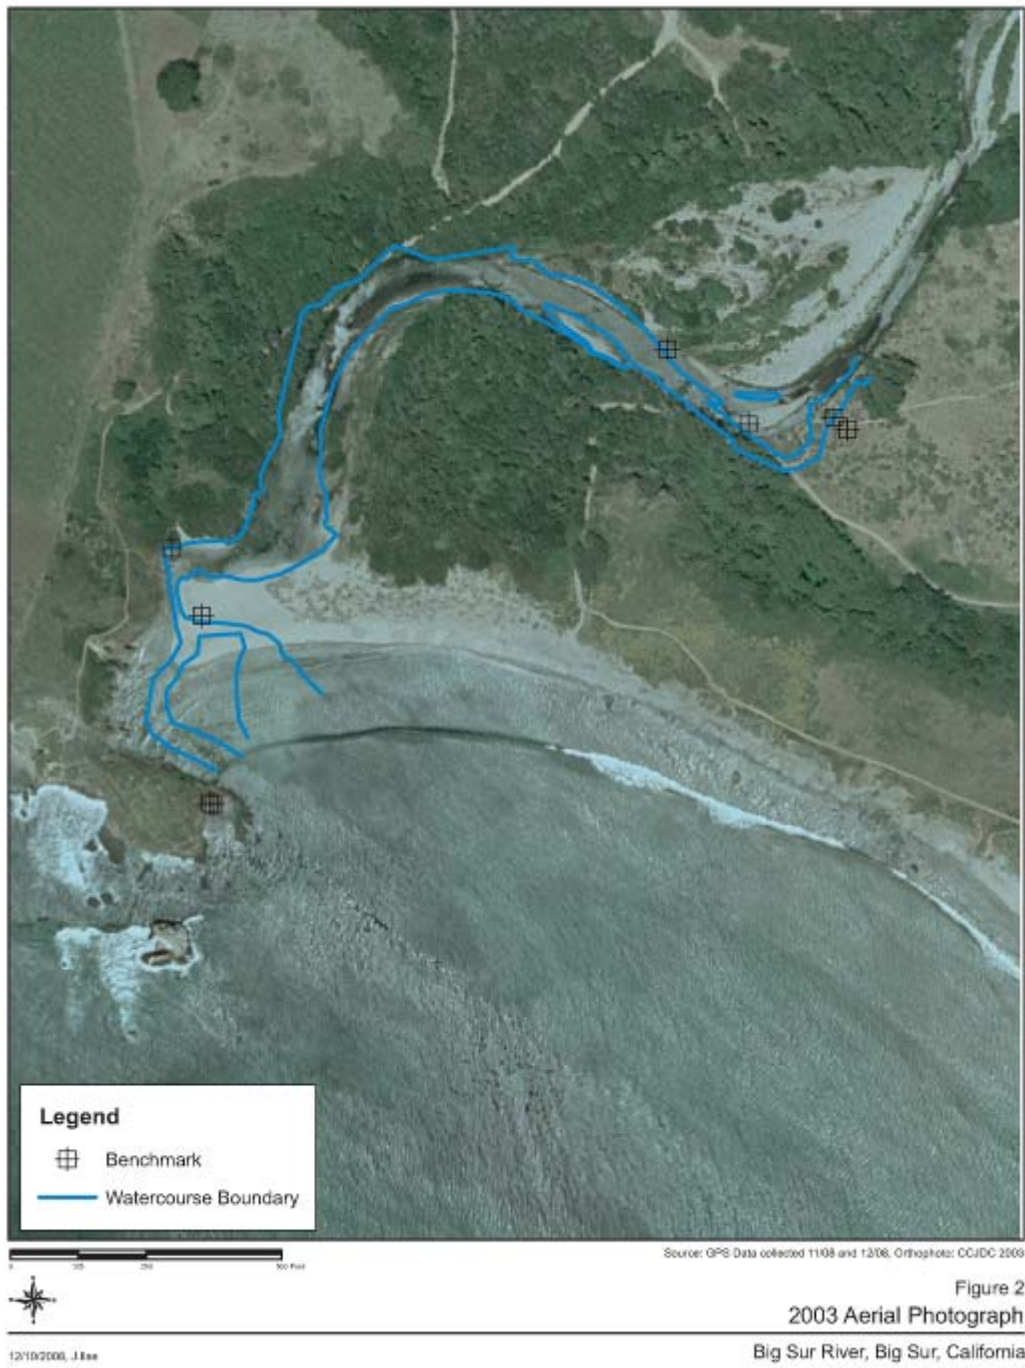
Figure 16: GPS position of channel margins plotted on 2003 aerial photograph.

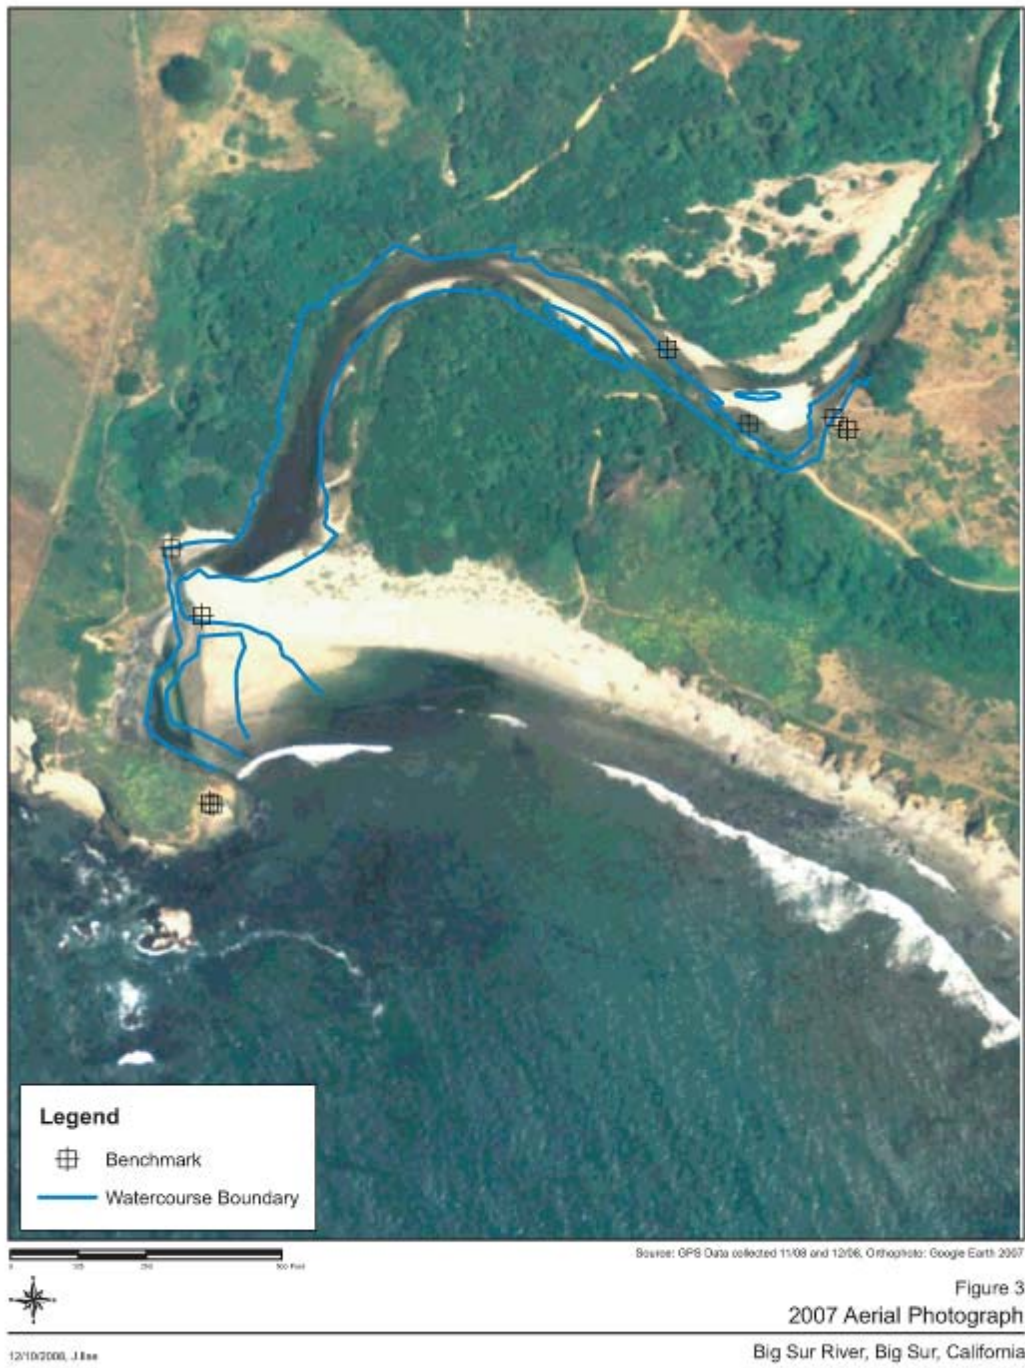
Figure 17: GPS position of channel margins plotted on 2007 aerial photograph.

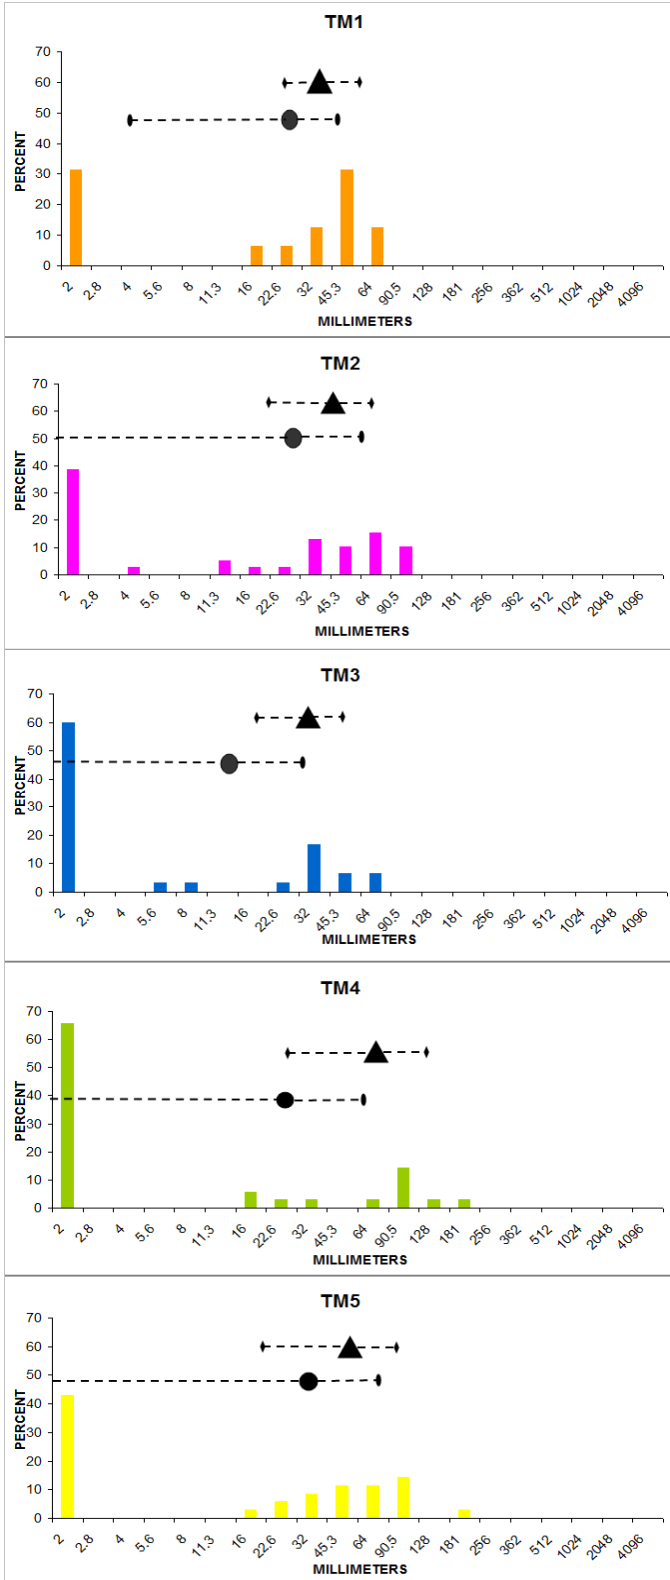
Figure 19: Histograms for lagoon mouth transects showing mean with (circle) and without (triangle) fines. Dashed lines represent standard deviation.

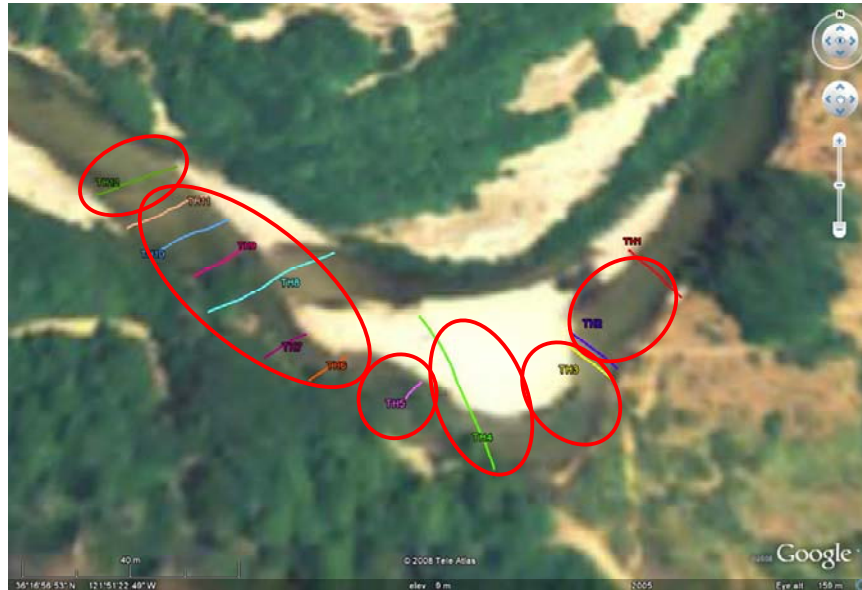
Figure 22. Pebble count transects at the Big Sur River lagoon head in 2008. Red circles indicate the six recommended transect locations for future surveys.

We conducted post hoc power analyses to determine optimal sampling for future efforts. At the lagoon head, we recommend six well–placed transects to adequately capture the variability of the area surveyed (Fig. 22). Pebble counts within each of these transects should be increased to 105 in order to detect a smallest meaningful difference (SMD) of 30 mm ($\alpha=0.05$). Increasing the pebble count to lower the SMD below 30 mm would significantly increase sampling effort. At the mouth of the lagoon, pebble counts could be conducted using either three transects of 105 counts each or five transects of 65 counts each to assess the area sampled during the baseline survey ($\alpha=0.05$). These recommended pebble counts would capture an SMD of 12 mm and 15 mm respectively ($\alpha=0.05$).

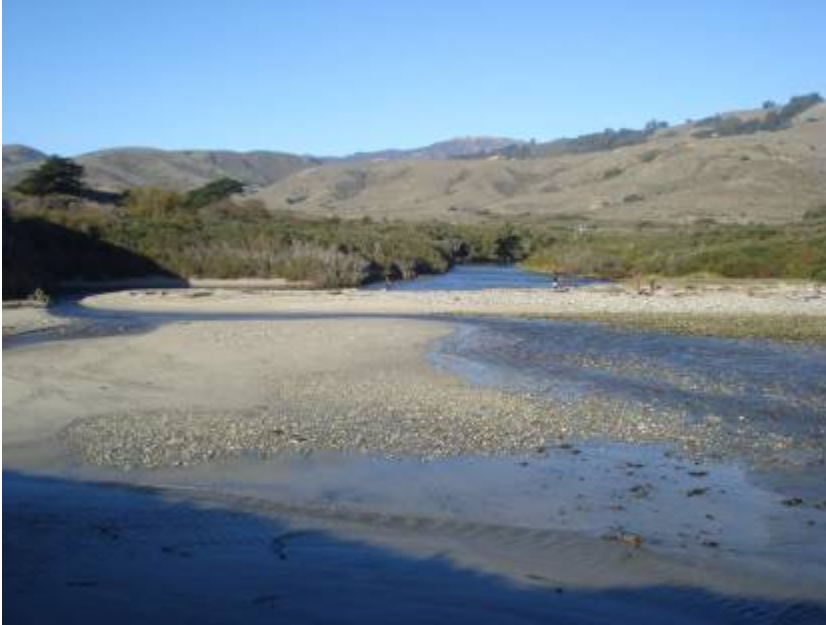
Figure 23: Mouth of Big Sur River Lagoon during low tide. (November 2008)

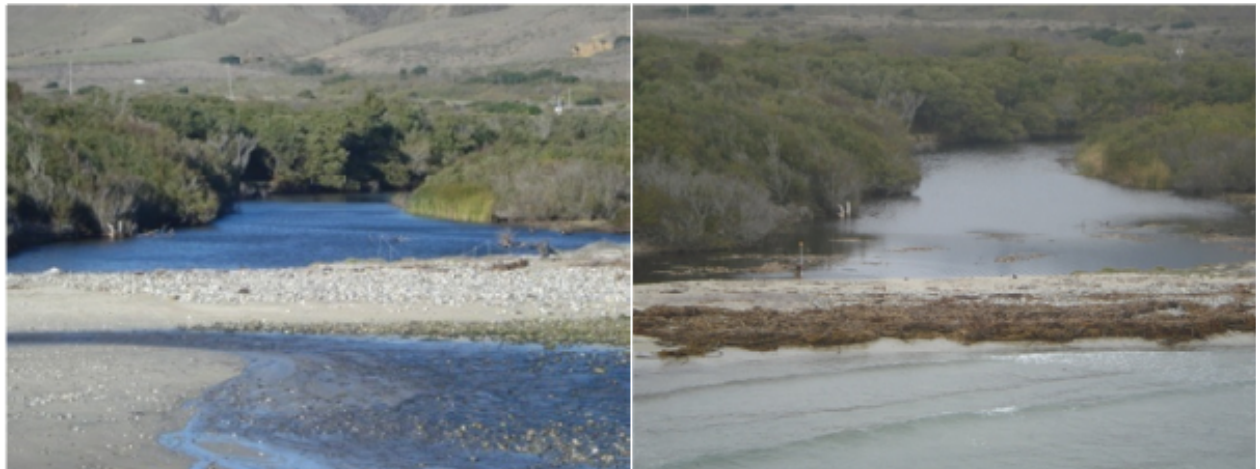
Figure 24: Lower reach, mouth of Big Sur River Lagoon. Time series comparison from November 20th 2008 (left) and December 4th 2008 (right), note kelp deposit.

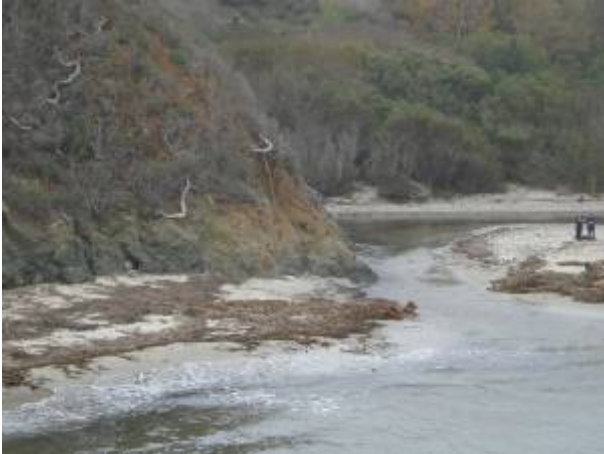
Figure 25: Lower reach, point-of-entry of Big Sur River Lagoon mouth and ocean. (December 2008)

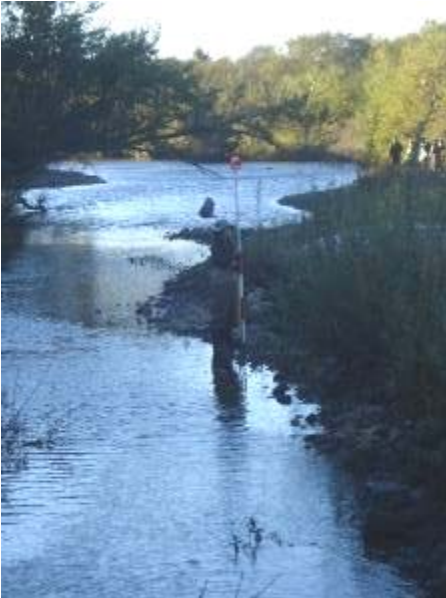
Figure 26 and 27 are views downstream from the right bend at the lagoon head. Figure 28 is the upstream from the lagoon head, immediately above the riffle defining the limit of tidal influence. An initial increase in mud is documented in the substrate along the gravel bar at the Lagoon head (Fig. 29). This mud veneer was not present during a site visit on November 16. Between November 16 and November 20, there was the first significant rain of the water year in the Big Sur watershed. The runoff produced a peak flow of 200 cfs, and apparently brought the first fine-grained sediment yield as well.

Figure 26: Lagoon head. View downstream from gravel point bar (November 2008).

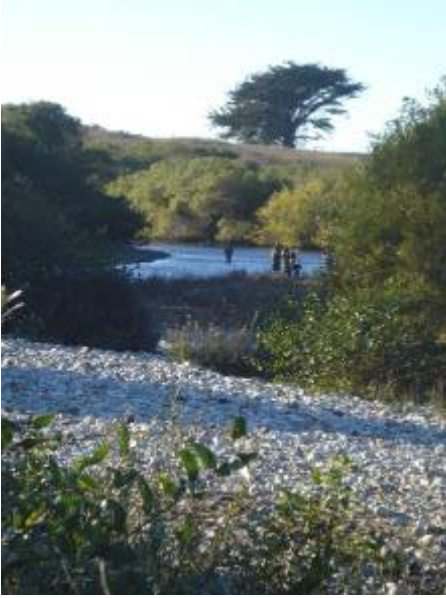
Figure 27: Lagoon head. View downstream across gravel point bar (November 2008).

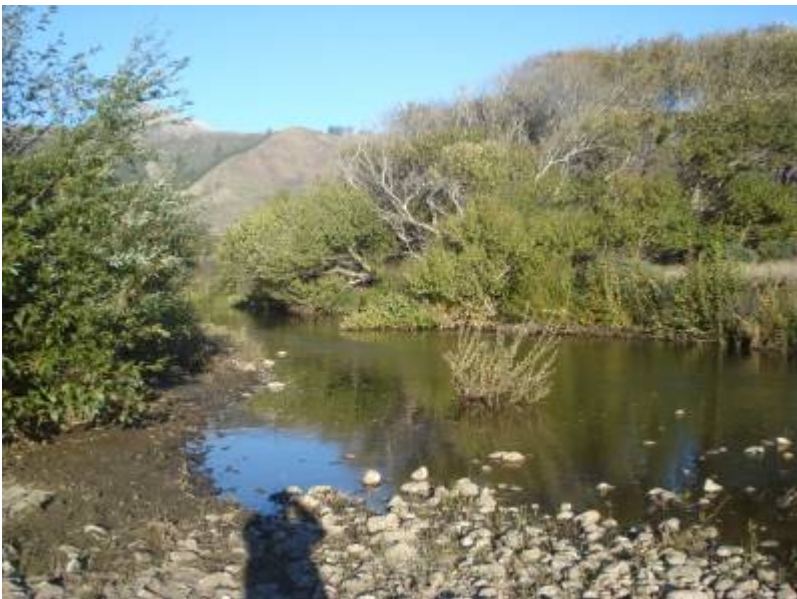
Figure 28: View upstream of Big Sur River Lagoon. Upstream edge of gravel point bar visible in bottom of photo. Note mud veneer on gravel and along bank (November 2008).

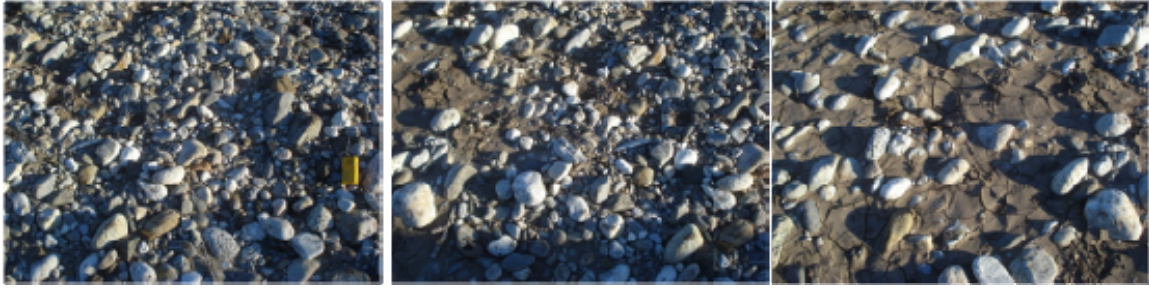
Figure 29: Lagoon head. Various levels of substrate embeddedness at the upstream edge of the gravel bar (November 2008).

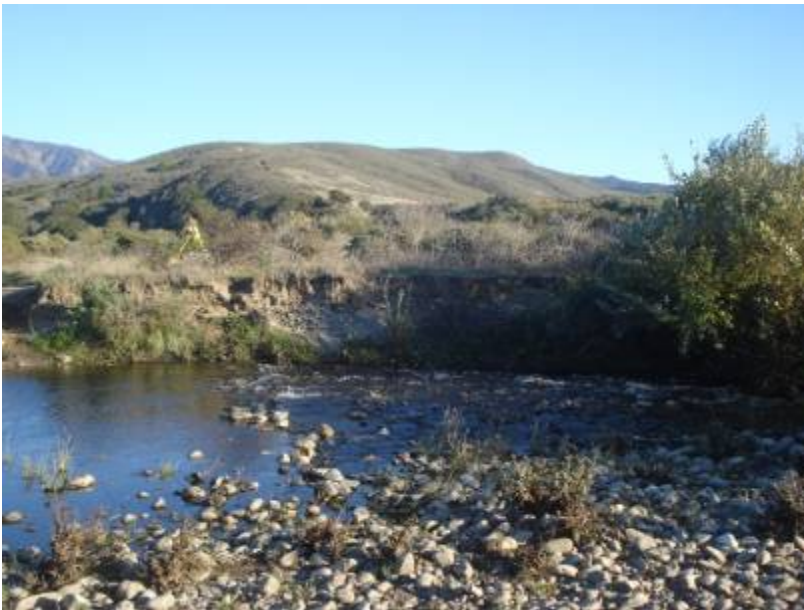
Figure 30: Lagoon head. Riffle delimiting the upper boundary of tidal influence in the river. Raw, freshly eroded bank is at apex of sharp right bend (November 2008).

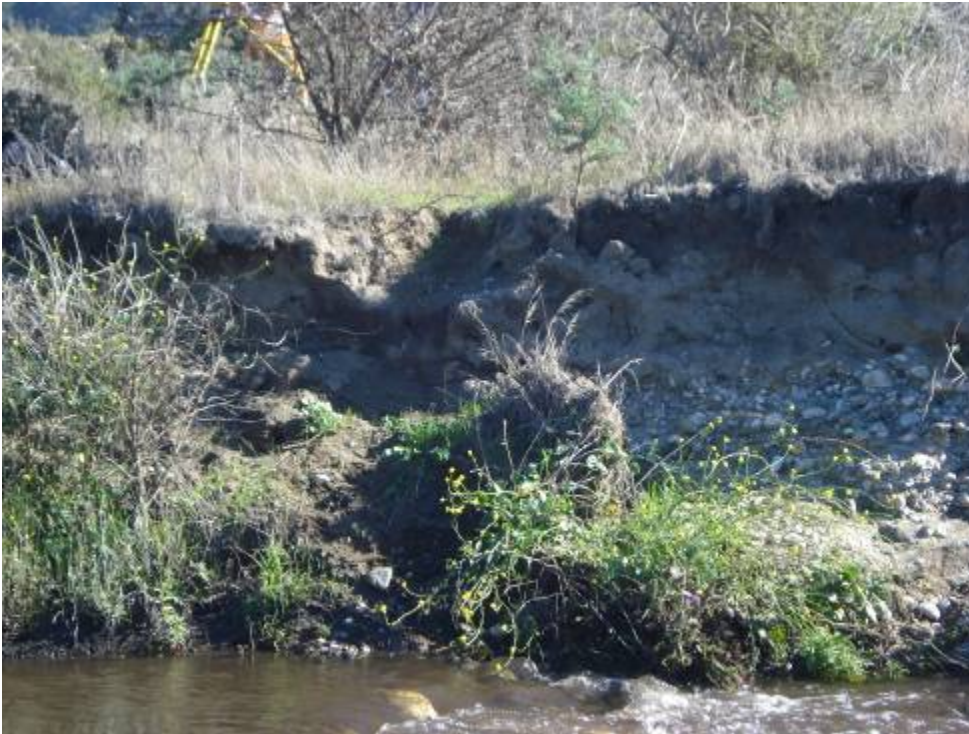
Based on our analysis of historical aerial photographs, and personal observations through time, we predict continued rapid erosion along the outer bank of the bend above the lagoon head. There are few mature trees with complex root systems or young stream-bank willows along the apex of the bend for stabilization (Figs. 30 and 32). The presence of a high longitudinal water-surface slope, tall bank height, steep bank angle, weak floodplain deposits, and lack of root density on the outer bank of a bend with diminutive radius of curvature (Fig. 31) allow us to predict continued rapid erosion at this point in the river.

Figure 32: Detail of weak floodplain deposits underlying eroding terrace (November 2008).

We also expect increased erosion on the outer bank from increased shear stress ($\tau = \gamma RS$) during large storm events in the post-fire rainy season. Shear stress (τ) is defined as stress which is applied parallel or tangential to a face of a material; in this case the hydraulic stress applied to the riverbank. The components of shear stress are the specific density of water (γ), which is equal to 9800 kg/m^3 ; the hydraulic radius (R) of the channel, and the slope (S) of the water surface. Large storm events will likely transport large amounts of sediment downstream. Sediment deposition on the inner bend of the channel will cause the hydraulic radius (R) of the channel to sporadically increase which will cause an increase in shear stress (τ) on the outer bank of the curve.
