Report No. WI-2006-01
31st January 2006

The Watershed Institute

Garrapata Creek Lagoon, Central Coast, California: A Preliminary Assessment

Casagrande, J. & Smith, D. 2006. Garrapata Creek Lagoon, Central Coast, California: A Preliminary Assessment, 2005–06. Prepared for the California Department of Fish and Game and the Garrapata Creek Watershed Council. The Watershed Institute, California State University Monterey Bay, Publication No. WI-2006-01, 62pp.

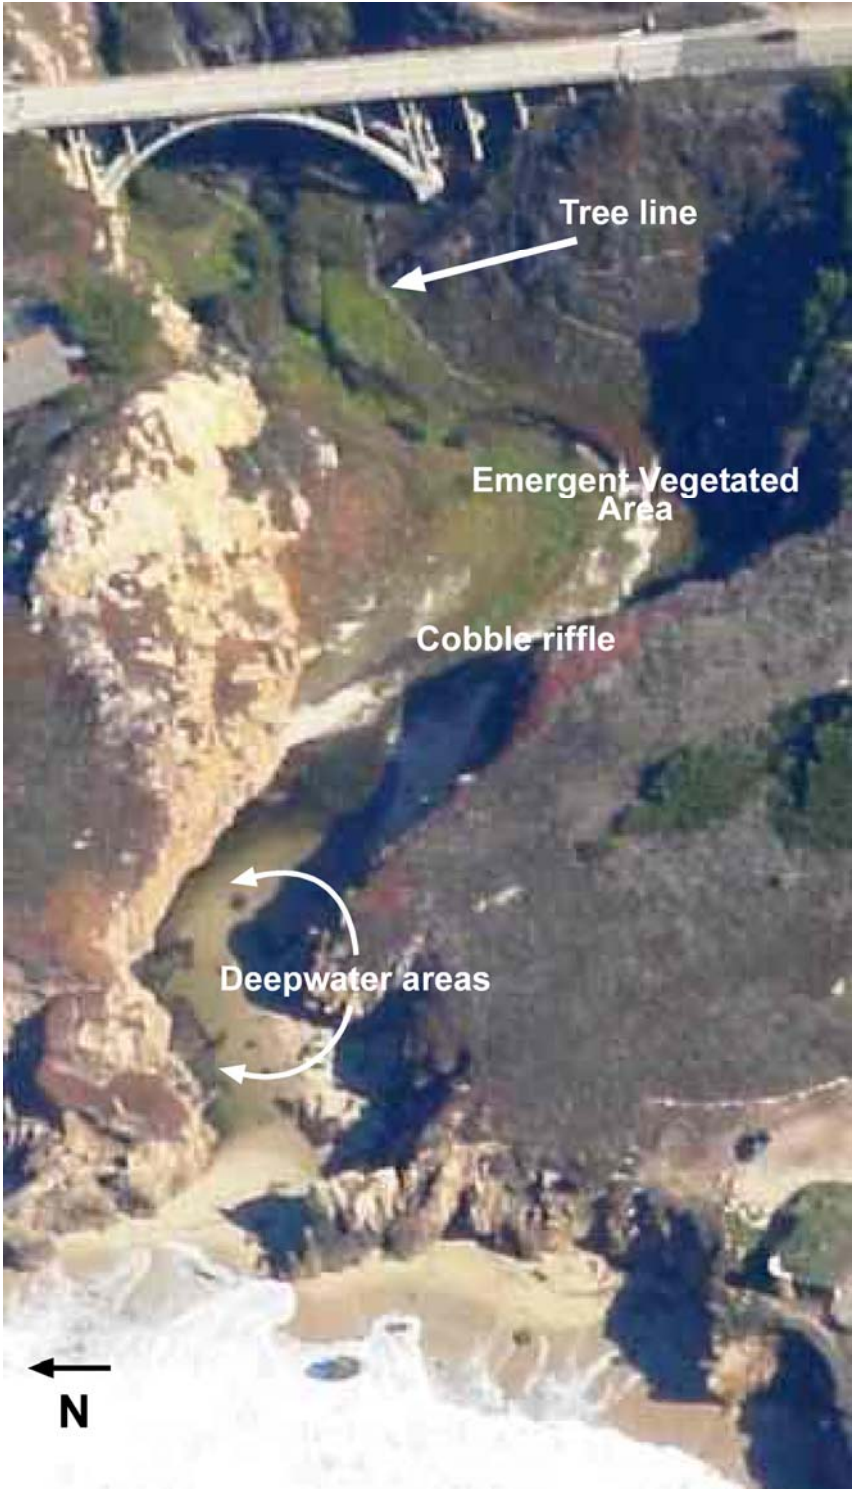
Figure 2.2 Garrapata Creek Lagoon. Photo: Doug Smith, 31 Oct 04.

The lagoon remains relatively shallow throughout the year. Depths in the lagoon are driven by the sandbar height. Typically, the deepest portions of the lagoon are found along the bedrock bluffs to the north (Figs 2.2 & 2.6). A maximum depth during the 2005 season was measured 1.6 m at the base of the northern bedrock. Overhead cover for steelhead is limited in part by the shallow nature of the lagoon, but also due to the lack of emergent vegetation (i.e. pondweed).

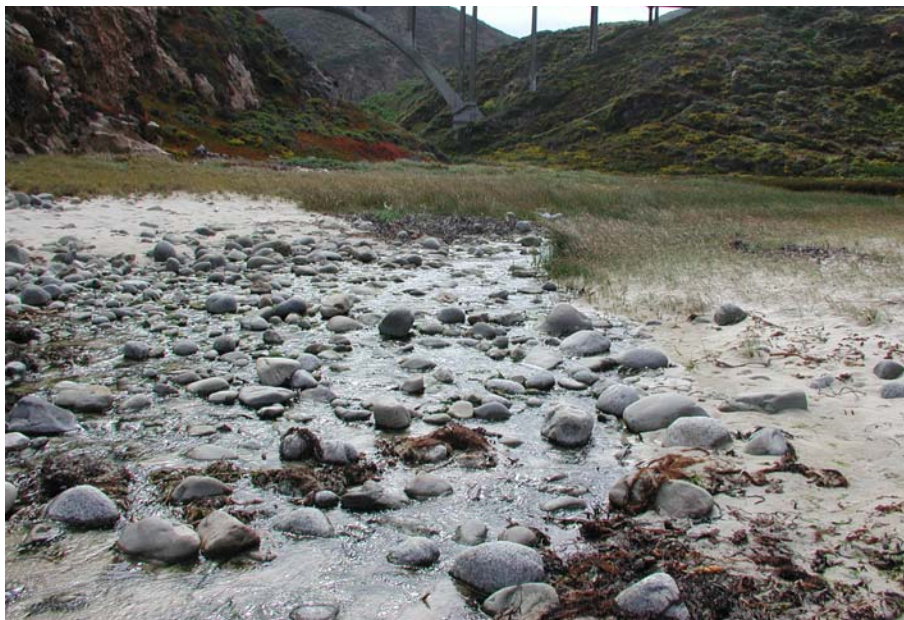
Figure 2.4 The cobble riffle separating the lower portion of Garrapata Creek from the lagoon embayment (looking upstream). Note the kelp accumulations in the foreground indicating the upstream extent of previous wave action. Photo: Joel Casagrande, 1 July 2004.

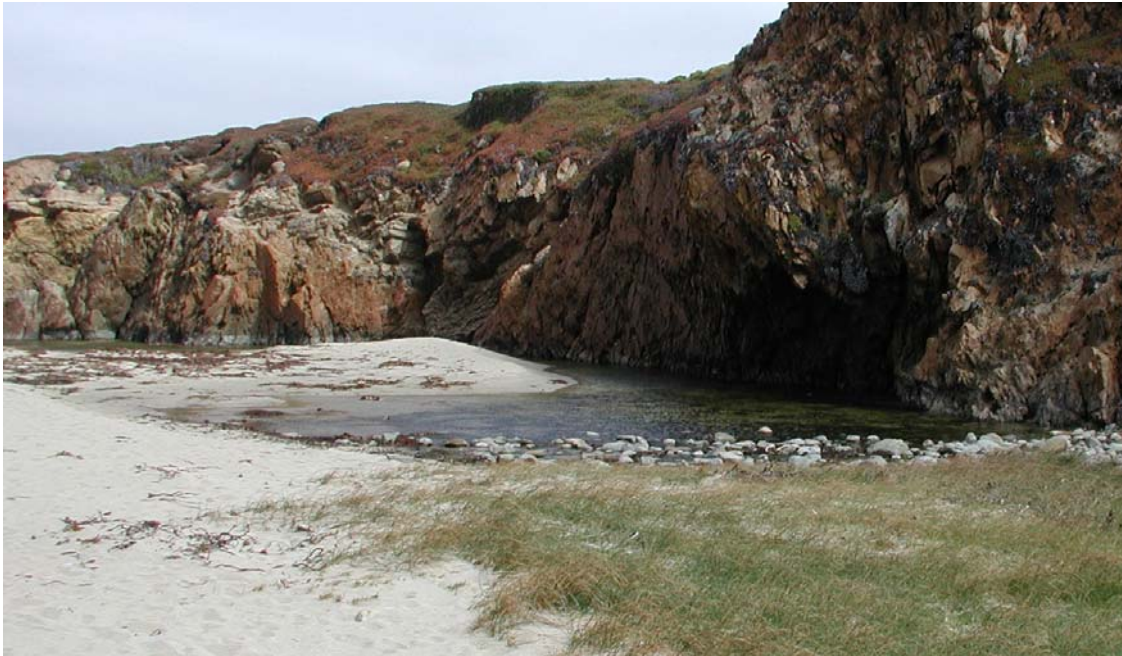
Figure 2.7 The lagoon main embayment in early July 2004. Sand accumulations at mid lagoon nearly separated the lagoon into two halves. This same shape re-occurred in late fall 2005 (See Appendix). Photo: Joel Casagrande, 01 July 2004.

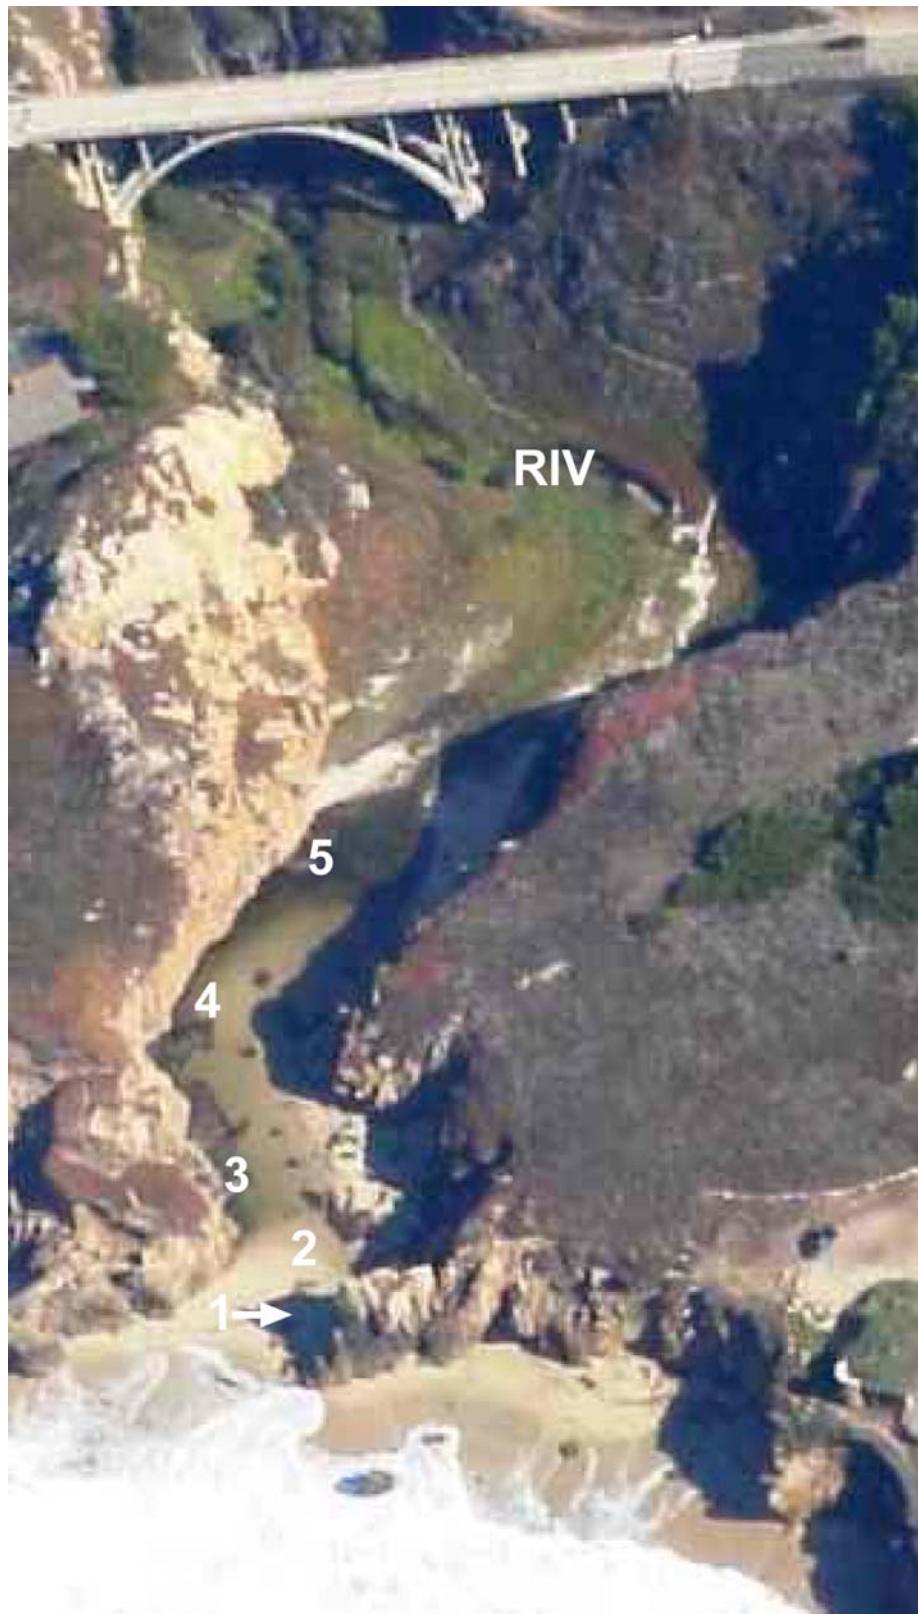
Figure 3.1 Sampling locations in Garrapata Lagoon.

Water quality conditions and macroinvertebrates were assessed at six sites (Figure 3.1) on several different days, although macroinvertebrates were not sampled at every site or on every sampling run. The sites were selected to represent all possible conditions with respect to depth, substrate conditions, and more importantly proximity to the ocean and creek inflow. Four sites were monitored in the main body of the lagoon (Sites 2–5), one in the outflow channel close to the ocean and one upstream in the inflowing creek.

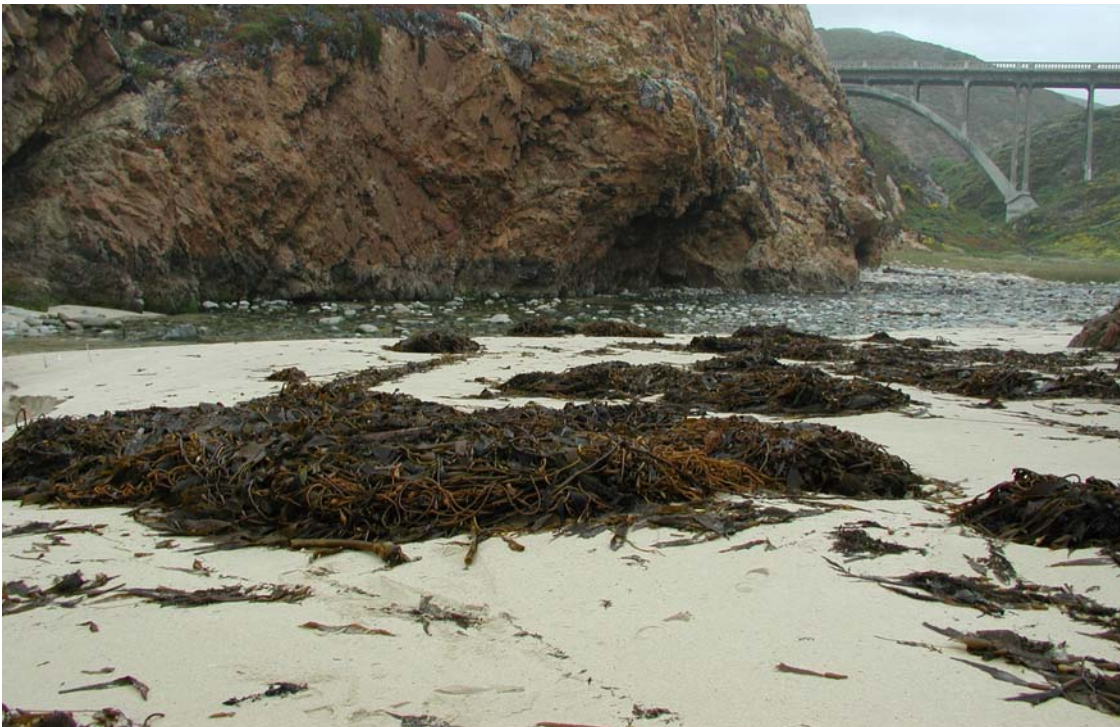
Figure 6.1. Fresh kelp at the lower end of the Garrapata Lagoon. Photo: Joel Casagrande 23 June 2005.

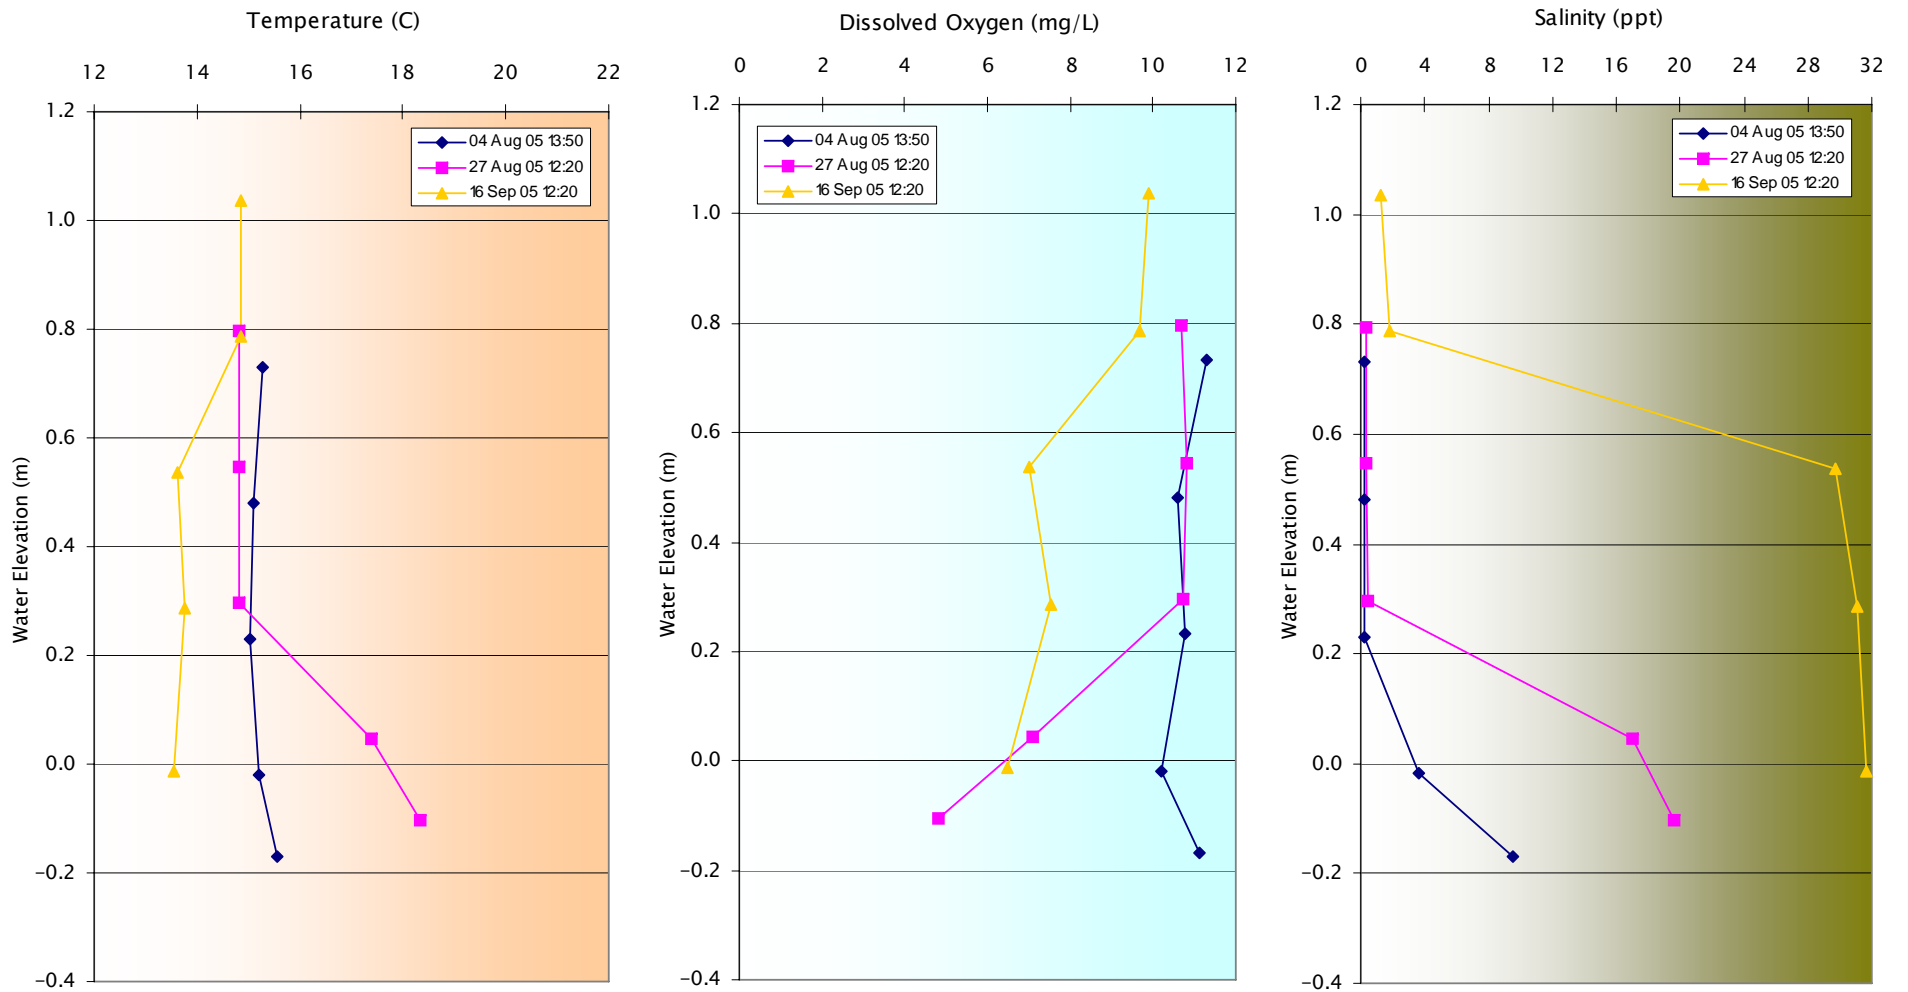
Figure 6.4 Summer water quality profiles (temperature, dissolved oxygen, and salinity) from Site 4 in the Garrapata Lagoon.

The water column in the lagoon was thermally stratified with an apparent halocline (Figs 6.3 & 6.4). This can have adverse consequences for water quality conditions. In general, saltwater on the lagoon bottom traps incoming solar energy, thus warming the bottom waters. Also, because of the density differences between salt- and freshwater, complete water column mixing is reduced substantially resulting in the inability for heavier saltwater to lose heat to the atmosphere. Warmer water temperatures then increase the depletion of oxygen along the bottom due to more rapid decomposition of organic matter (e.g. kelp). Although water quality conditions were suitable, no steelhead were observed in the lagoon,.

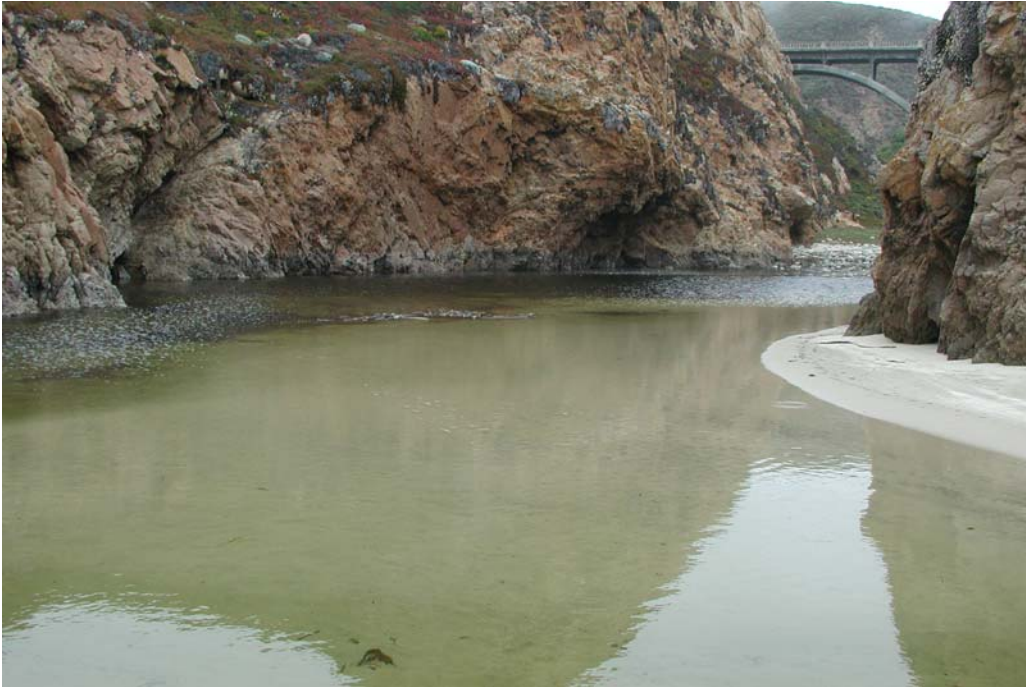
Figure 6.5 Garrapata Lagoon looking upstream. Note kelp floating on surface. Photo: Joel Casagrande, 04 August 2005

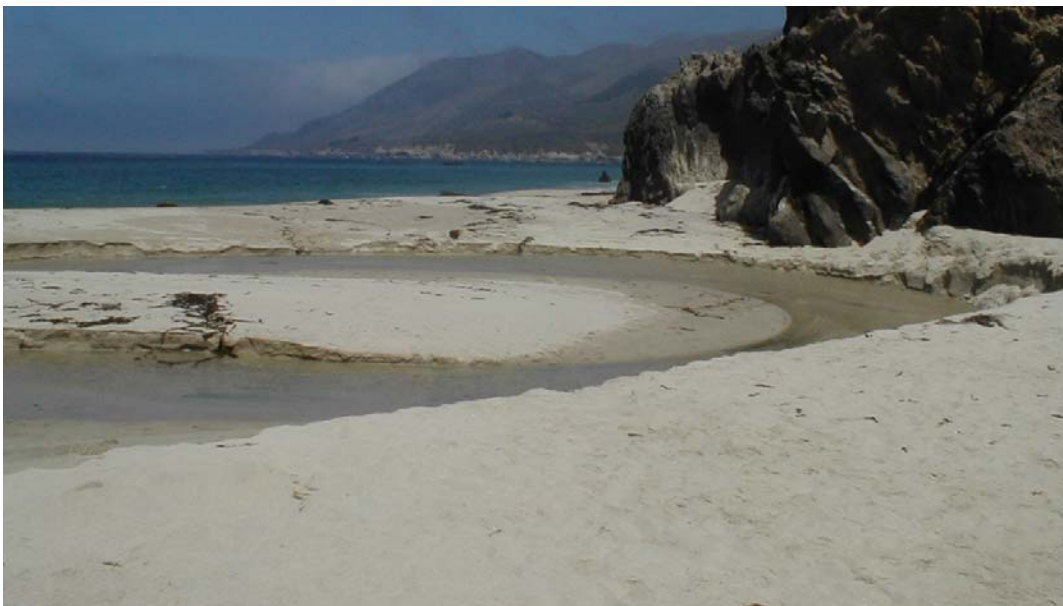
Figure 6.7 The outflow channel connecting the lagoon and the ocean (looking northwest). On August 4th, the channel was straight out along the southern bluff as opposed to the sinuous pattern shown here. Photo: Joel Casagrande, 27 August 2005

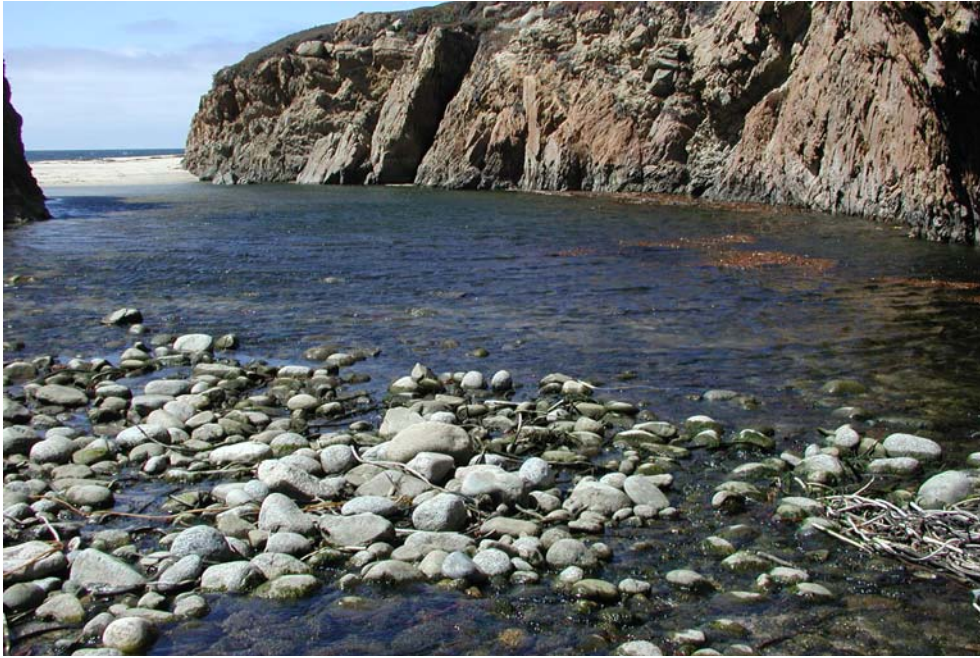
Figure 6.8 The main embayment of the Garrapata Lagoon on September 17, 2005. Note both the presence of kelp accumulated at the base of the bluff in the background and the inundation of the cobble riffle, showing the increasing in water elevation. Photo: Joel Casagrande 17 Sep 2005.

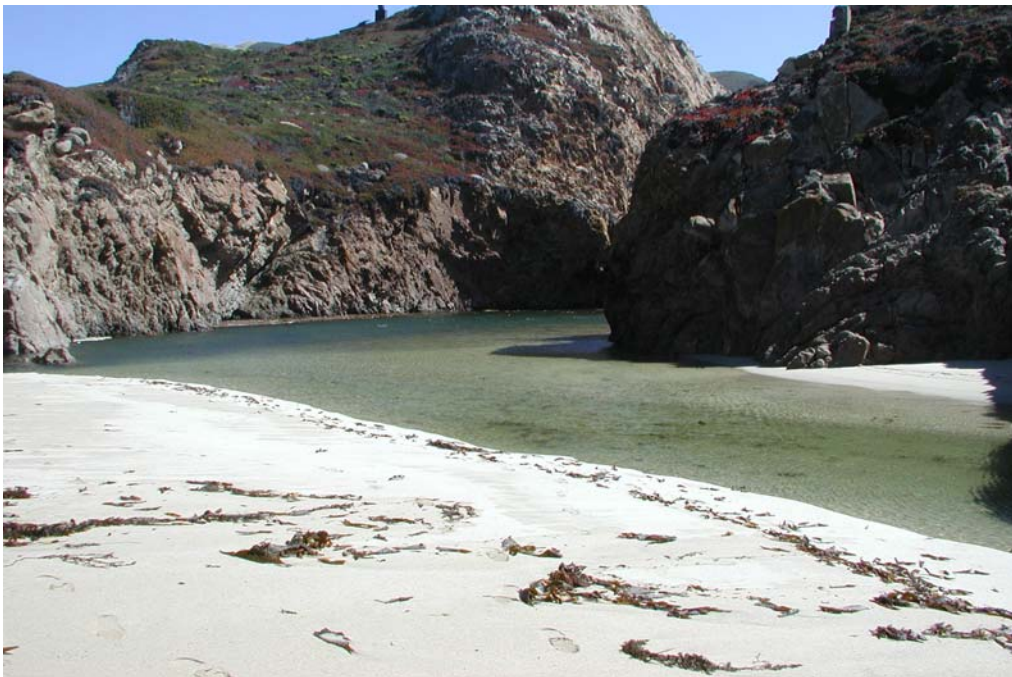
Figure 6.9 The inland side of the sandbar, or back beach, showing kelp deposits from recent waves overtopping the bar at high tide. Photo: Joel Casagrande, 17 Sep 2005.

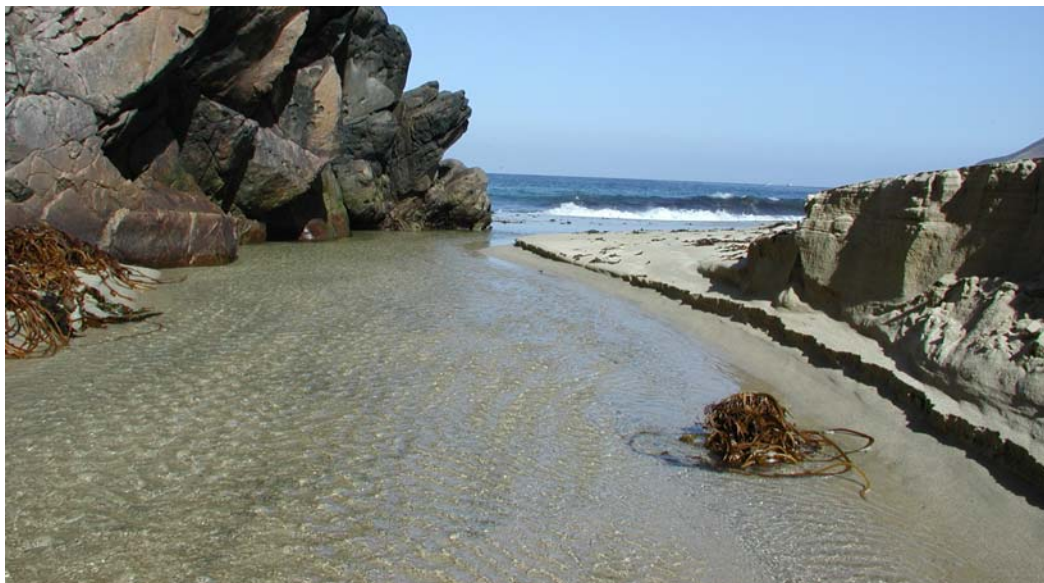
Figure 7.4 The outflow channel of the lagoon. Note the degree of down cutting through the sandbar. This did not exist 10 days prior and suggests a “filling/breaching” event in between the 17th and 27th of September. Photo: Joel Casagrande, 27 Sep 2005.

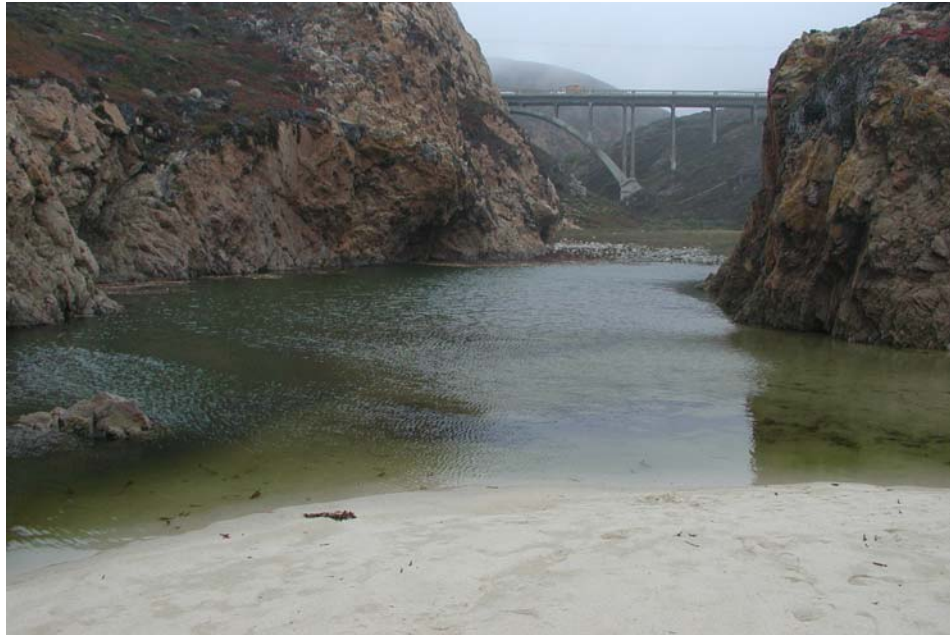
Figure 7.6 A fuller Garrapata Lagoon on October 12, 2005. Compare with Figure 7.1. Photo: Joel Casagrande 12 Oct 2005.

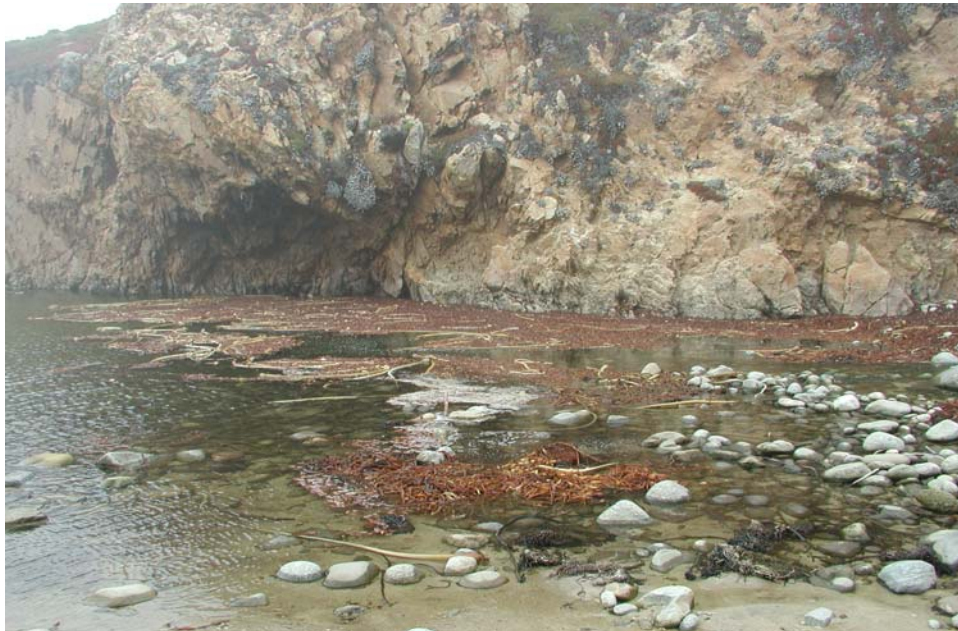
Figure 7.7 Kelp accumulations at the eastern edge of the lagoon near the cobble riffle. Photo: Joel Casagrande 12 Oct 2005.

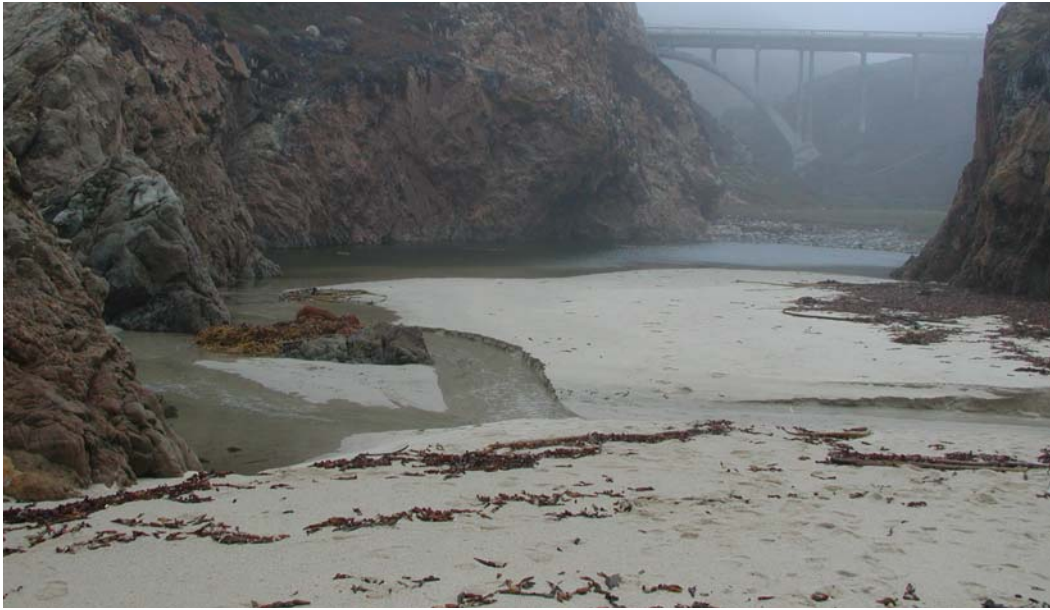
Figure 7.8 Sand deposition due to high surf in the lower half of the Garrapata Lagoon. Note: Compare with Figures 7.1 & 7.6. Photo: Joel Casagrande, 22 Oct. 2005

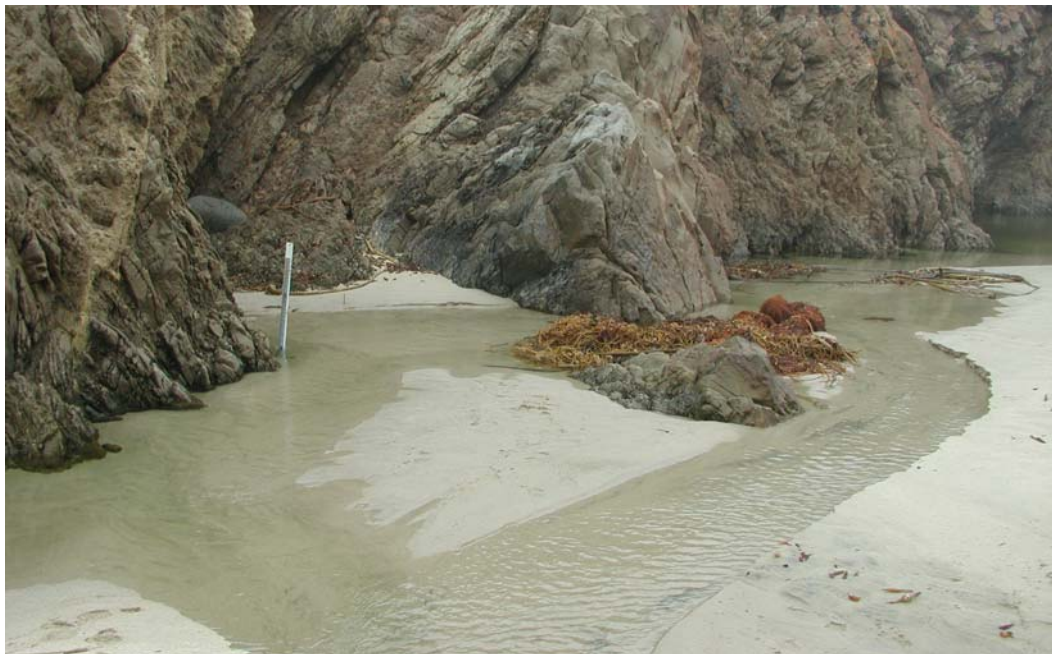
Figure 7.9 Loss of deeper water habitat at Site 3 due to sand deposition. Photo: Joel Casagrande, 22 Oct. 2005.

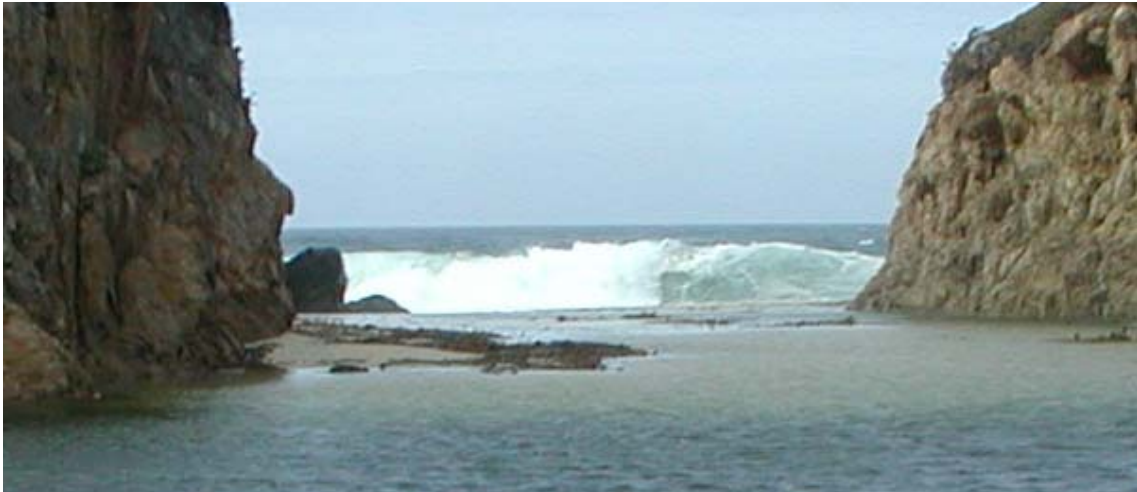
Figure 7.10 Ocean waves breaking on what used to be the sandbar separating the lagoon from the ocean. Photo: Joel Casagrande, 02 Nov. 2005

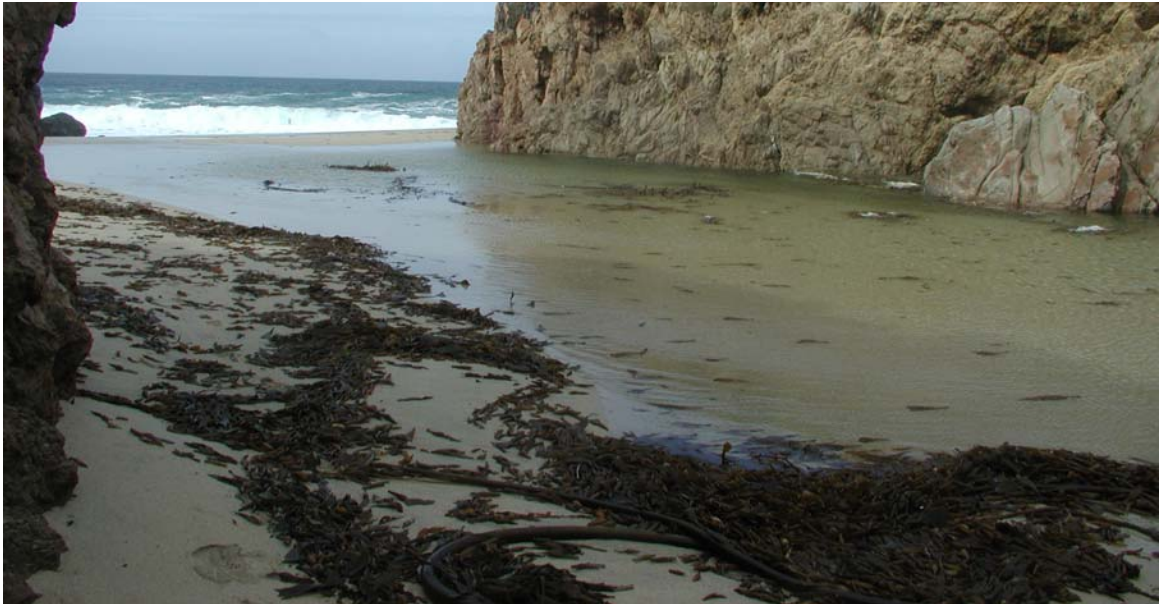
Figure 7.11 The front half of the Garrapata Lagoon. Water depths here were now reduced to inches although Site 3 (just out of view to the right) did re-scour some. Photo: Joel Casagrande, 02 Nov. 2005

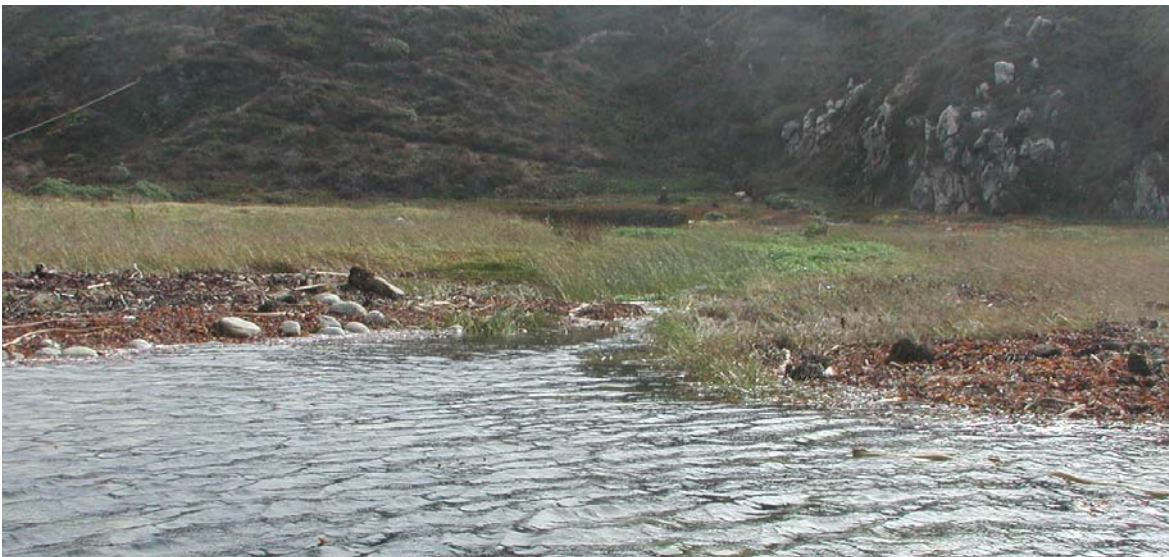
Figure 7.12 The cobble riffle (looking upstream) submerged – a result of significant sand delivery and accumulation in the lower lagoon. Compare with Figure 2.4. Photo: Joel Casagrande, 02 Nov. 2005.

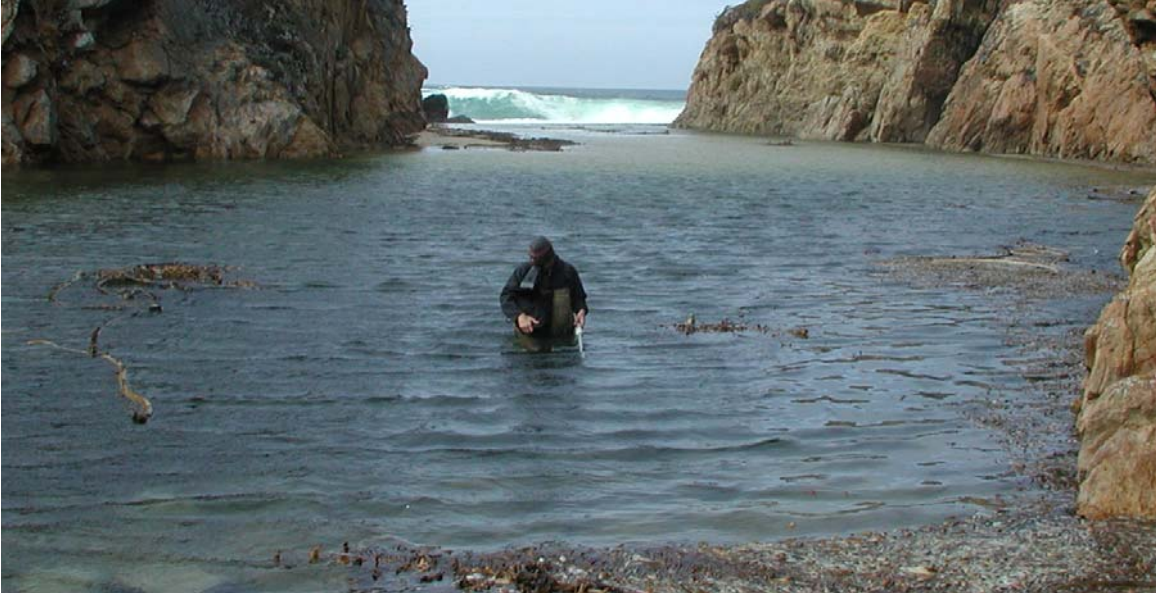
Figure 7.13 Using underwater cameras in an attempt to determining the presence of steelhead and other fish species. Photo: Julie Casagrande, 02 Nov. 2005.

A handheld underwater camera mounted on a rod was used to look for and potentially detect steelhead in the lagoon (Fig. 7.13). The lagoon was checked in a systematic manner walking from side to side (north to south) in an upstream progression. Visibility was approximately 1.5 m. No steelhead, or any other species of fish, were observed after approximately 45 minutes of viewing and no steelhead were observed during bank observations.

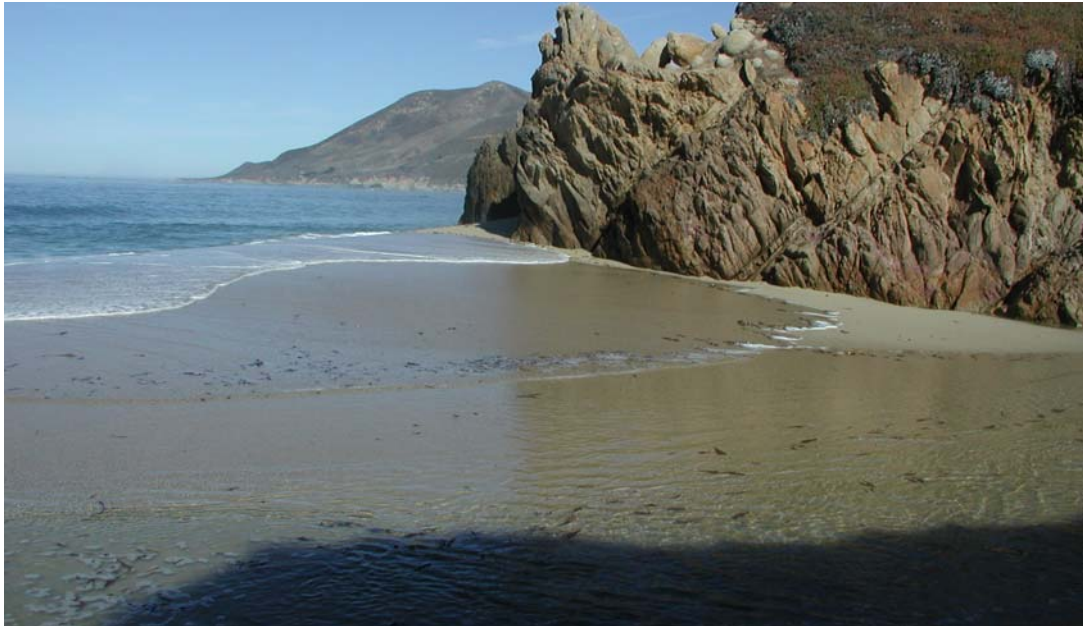
Figure 7.15 Consistent wave overwash into Garrapata Lagoon was observed during high tide. By mid-November, the sandbar height was minimal, a result of recent large surf. Photo: Joel Casagrande 18 Nov 05.

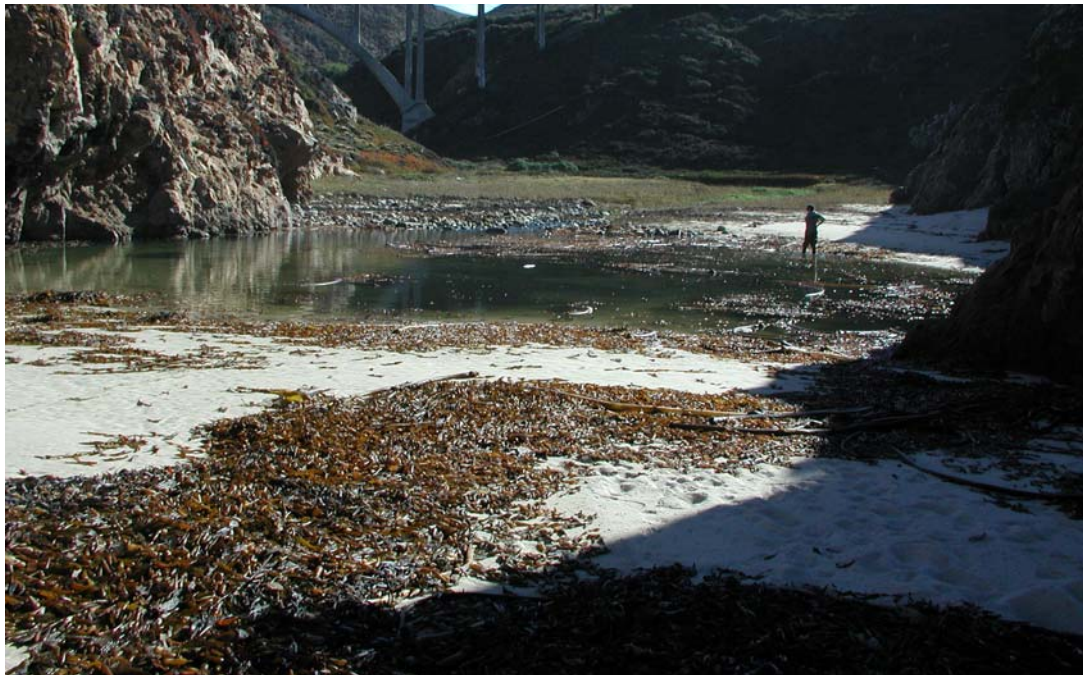
Figure 7.16 Extensive kelp accumulations within the lagoon area on November 18th, also a result of high surf conditions along the Big Sur Coast. Photo: Joel Casagrande, 18 Nov 05.
