Garrapata Creek Watershed Assessment and Restoration Plan

Riparian Element

December 1, 2004

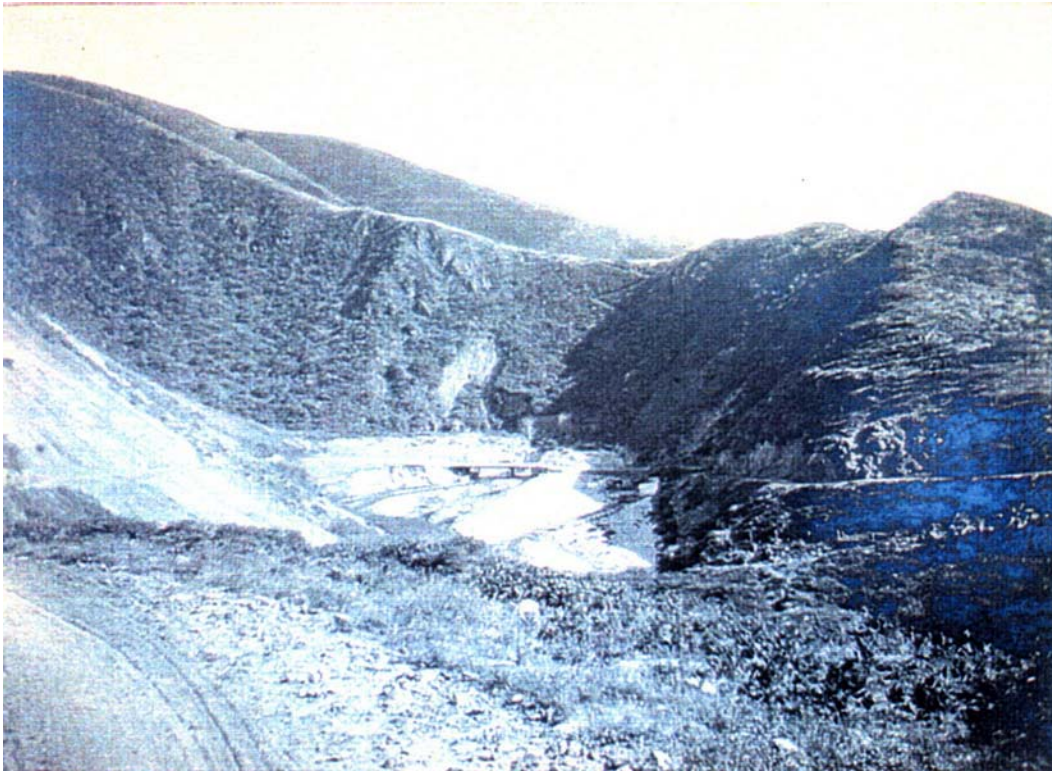
Figure 3 – Garrapata Canyon in 1912. Courtesy Jeff Norman and Kit Phillips.

Figures 3 and 4 are historical photographs depicting the mouth of Garrapata Canyon in 1912. At the time these two photographs were taken, a bridge over Garrapata Creek was situated upstream of the current Highway 1 alignment. Note the complete lack of riparian vegetation and the extent of barren cobble bars on the floodplain south (right) of the old bridge. It appears that access to the canyon bottom was provided by the road that still hugs the south canyon wall immediately downstream of the Highway 1 Bridge. Note also the steep switchbacks that descend to the canyon from the saddle above the bridge on the south side (Figure 3). There were huge floods documented along the Central Coast in 1911 and again in 1914, and it is likely that Garrapata Creek suffered substantial flooding and erosion during these episodic high flow events. Logging activities that destabilized upstream slopes may have contributed to the massive erosion that stripped all vegetation from the banks of the creek. Compare conditions in 1912 with riparian vegetation in July 2004, as shown in Figure 12, page 18.

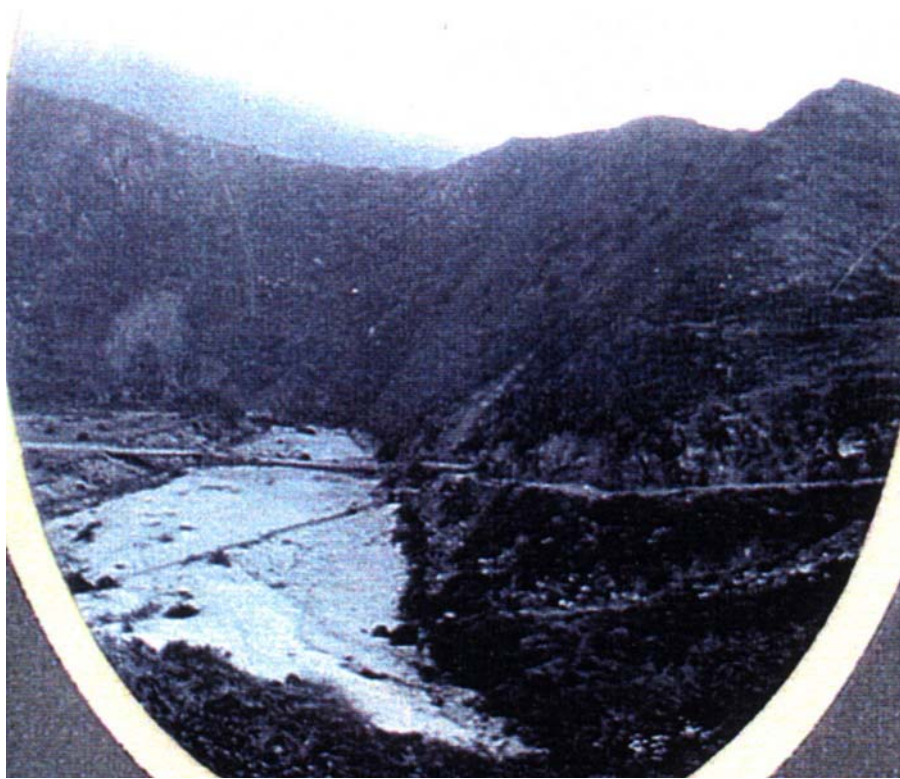
Figure 4 – “Tick Creek”. Courtesy Jeff Norman and Kit Phillips.

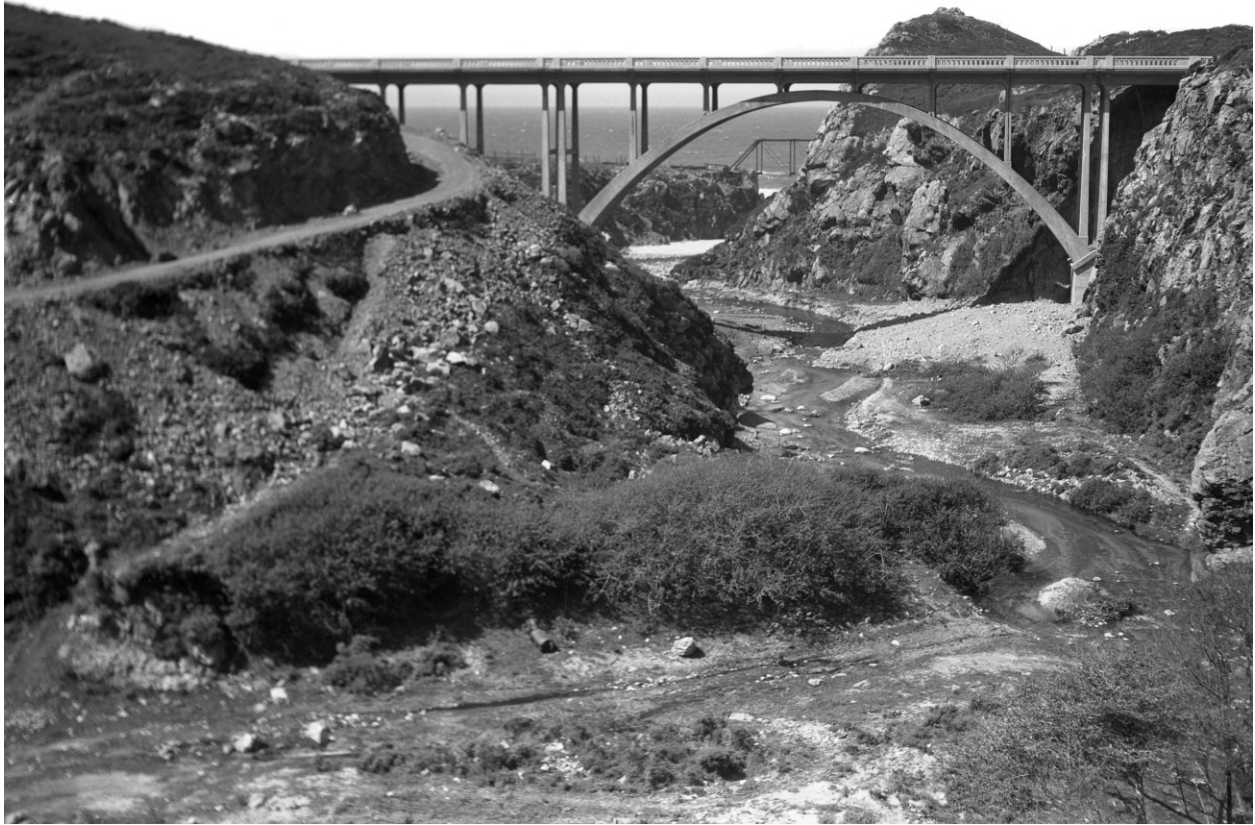
Figure 5 is a photograph of the newly constructed Highway 1 Bridge in the early 1930's. This image is courtesy Pat Hathaway and California Views. In this photograph, the older, metal bridge spanning the Garrapata lagoon still stands downstream of the new concrete archway. Note the sparse willow vegetation and exposed channel banks under the new bridge. Compare streamside vegetation in the 1930's with July 2004, as shown in Figure 14, page 22.

Figure 5 – The new Highway 1 Bridge over Garrapata Canyon. Riparian vegetation in this early 1930's view is very sparse, with discontinuous willow thickets found on exposed sand and gravel bars.

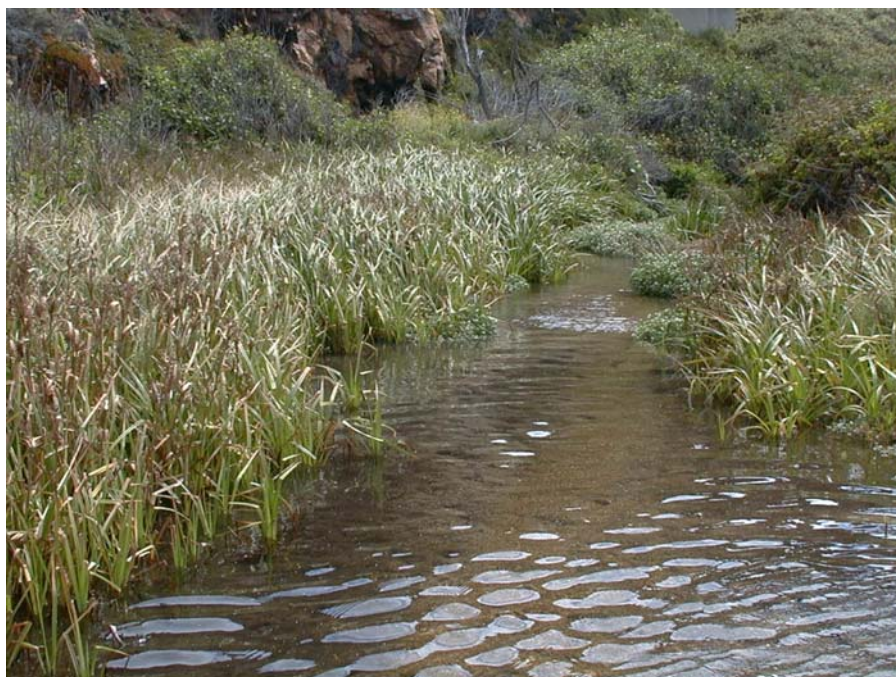
Figure 6 – The mouth of Garrapata Creek at the edge of the coastal lagoon. July 2004.

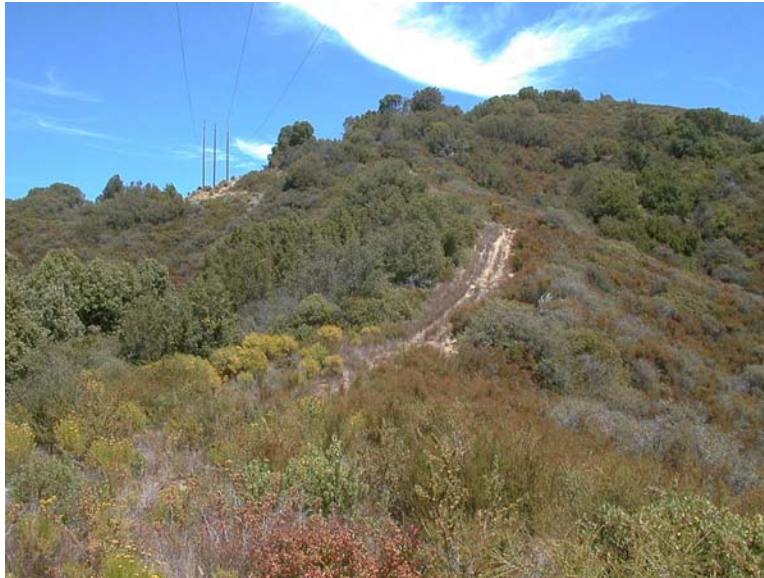
Figure 8 – Mixed Chaparral vegetation and pockets of Canyon Live Oak/California Bay Woodland along PG&E maintenance road in upper Garrapata Creek Watershed. August 2004.

4.1.2 Mixed Chaparral: The farthest inland and highest elevation south-facing slopes in the Joshua, Wildcat and Garrapata drainages include shrub species more typical of inland chaparral communities removed from persistent marine influences. The “inland” vegetation mosaic includes Eastwood’s manzanita (*Arctostaphylos glandulosa* ssp. or var. ?), bush poppy (*Dendromecon rigida*), golden fleece (*Ericameria arborescens*), toyon (*Heteromeles arbutifolia*), coffeeberry (*Rhamnus californica*), and several species of ceanothus, including warty-leaved ceanothus (*Ceanothus papillosus*) and buck brush (*C. cuneatus*). Occasionally, the endemic Santa Lucia monkey flower (*Mimulus aurantiacus* var. *bifidus*), scarlet bugler (*Penstemon centranthus*) and California buckwheat occur (*Eriogonum fasciculatum*).

4.1.4 Canyon Live Oak/California Bay Forest and Woodland: The Canyon Live Oak/California Bay habitat is a variant of Mixed Evergreen Forest, however it usually has a more open canopy and occurs in small, discontinuous patches tucked into drainages on more xeric (dry) south-facing slopes. This habitat is dominated by Canyon live oak (*Quercus chrysolepis*) and California bay (*Umbellularia californica*). Areas with closed canopies are considered forest types, while areas of more open canopy cover qualify as woodland. Often the Oak/Bay woodland includes shrubby forms of canyon live oak that intergrade with ceanothus and other shrubs typical of both the Mixed Evergreen Forest and Mixed Chaparral.

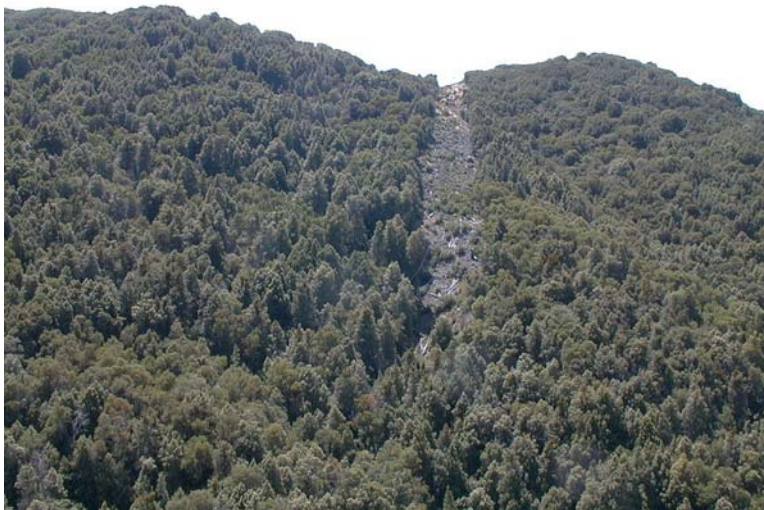
Figure 9 – Mixed Evergreen Forest along PG&E powerline right-of-way in upper Garrapata Creek Watershed. August 2004.

4.1.3 Mixed Evergreen Forest: The forested hill slopes on north-facing aspects are generally damper and more shaded areas of the watershed. These slopes are vegetated with a variable mixture of tanbark oak (*Lithocarpus densiflora*) and California bay (*Umbellularia californica*), with scattered canyon live oak (*Quercus chrysolepis*) and madrone (*Arbutus menziesii*). Closer to the ocean, coast live oak (*Quercus agrifolia*) increases in the mix of other evergreen species. Beneath the canopy, hairy honeysuckle (*Lonicera hispidula*), coffeeberry (*Rhamnus californica*), and the endemic Santa Lucia gooseberry (*Ribes sericeum*) occur. The gooseberry is found only in moist canyons of the Santa Lucia Range and is considered rare, but not endangered by the California Native Plant Society (List 4).

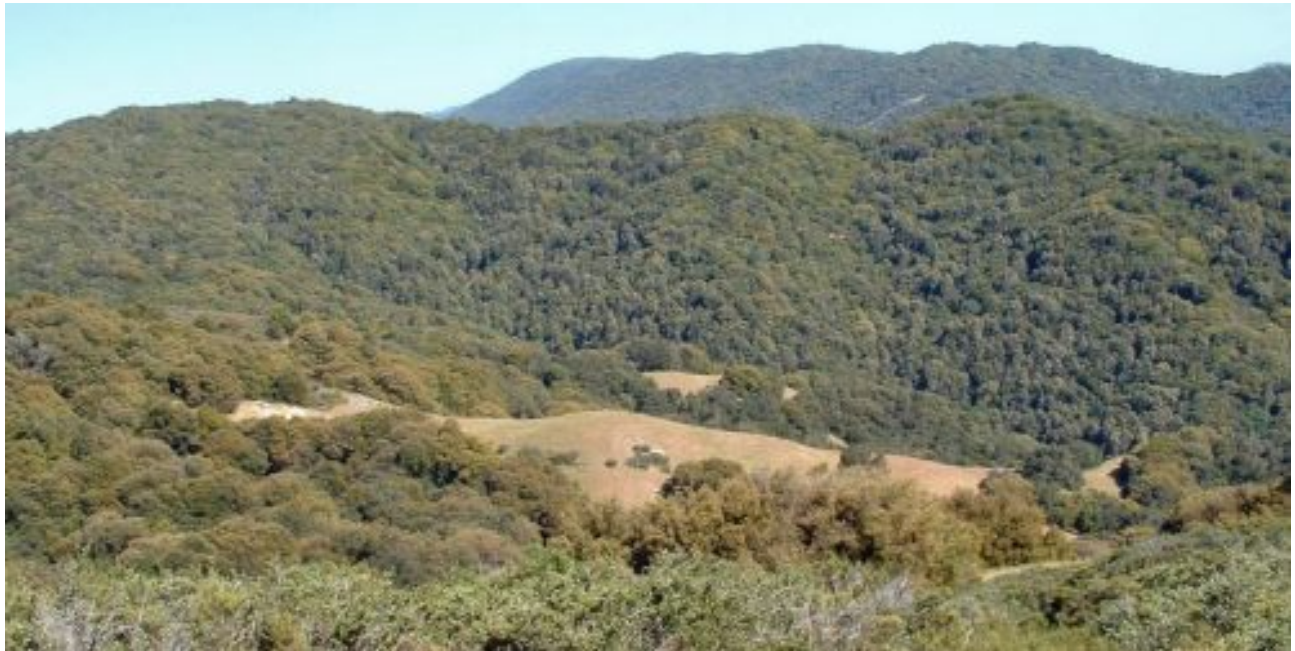
Figure 10 – Patches of Grassland vegetation in upper Wildcat Canyon Watershed.
Photograph by Gordon Johnson, May 2004.

4.1.6 Grassland: Grassland ecosystems in the GCW occur on the northern margin of the Joshua Creek drainage and in small, discontinuous patches in the uppermost watershed areas of Wildcat Canyon. As mentioned in the text above, most of the Grassland in the study area is dominated by non-native, annual species, however there are large patches of native perennial grasses that speak to the biological significance of these habitats. Common native species at higher elevations include purple needle grass (*Nasella pulchra*) and western ryegrass (*Elymus glaucus*). Non-native annuals include wild oats (*Avena fatua*), rugput brome (*Bromus diandrus*), Italian ryegrass (*Lolium mutiflorum*) and barnyard foxtail (*Hordeum leporinum*), as well as many others.

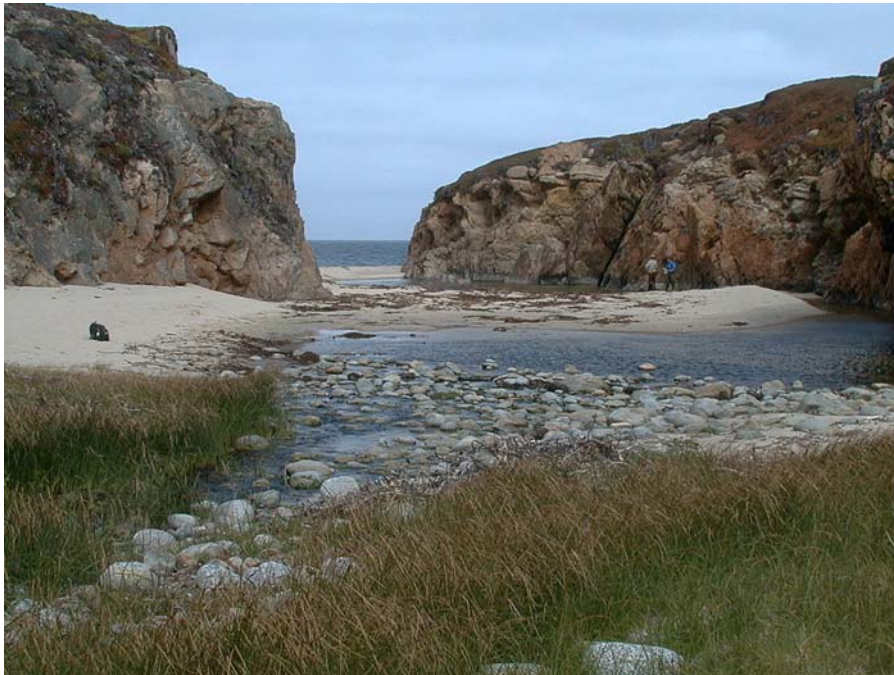
Figure 11 – The coastal edge of the Garrapata Creek Watershed where Garrapata Creek meets ocean water in the coastal lagoon. July 2004.

4.1.12 Coastal Brackish Marsh: The mouth of Garrapata Creek empties into a coastal estuary that periodically forms a lagoon when wave action builds up a berm of sand that blocks flow out to the ocean. The mixing area of fresh and salt water has a very interesting collection of wetland plants which grade from typical riparian types into backwater emergent species and salt marsh plants that are subjected to persistent saline influences. Freshwater wetland plants like chain fern (*Woodwardia fimbriata*), arroyo willow (*Salix lasiolepis*), iris-leaved rush (*Juncus xiphioides*), common monkey flower (*Mimulus guttatus*), horsetail (*Equisetum arvense*), and small-fruited bullrush (*Scirpus microcarpus*) grade into habitats where more salt-tolerant species like silver-weed (*Potentilla anserina* ssp. *pacifica*), Baltic rush (*Juncus balticus*), California bulrush (*Scirpus californicus*) and dune sedge (*Carex* sp.) occur. Dune sedge has stabilized the margin of the sand dunes, as well as the fine terrestrial sediments deposited at the mouth of the creek.

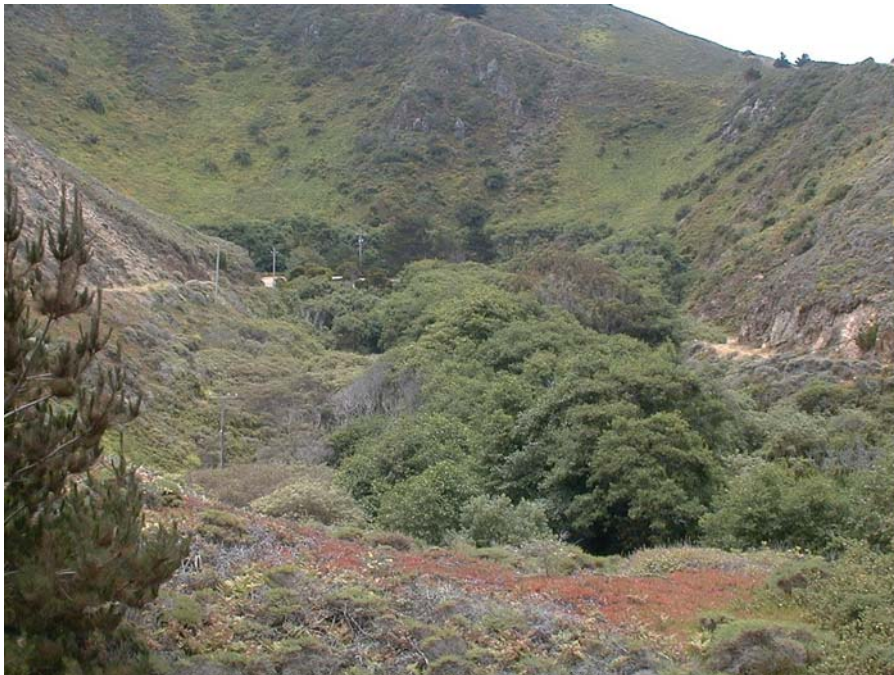
Figure 12 – Red Alder/Arroyo Willow Riparian habitat near the mouth of Garrapata Canyon. July 2004.

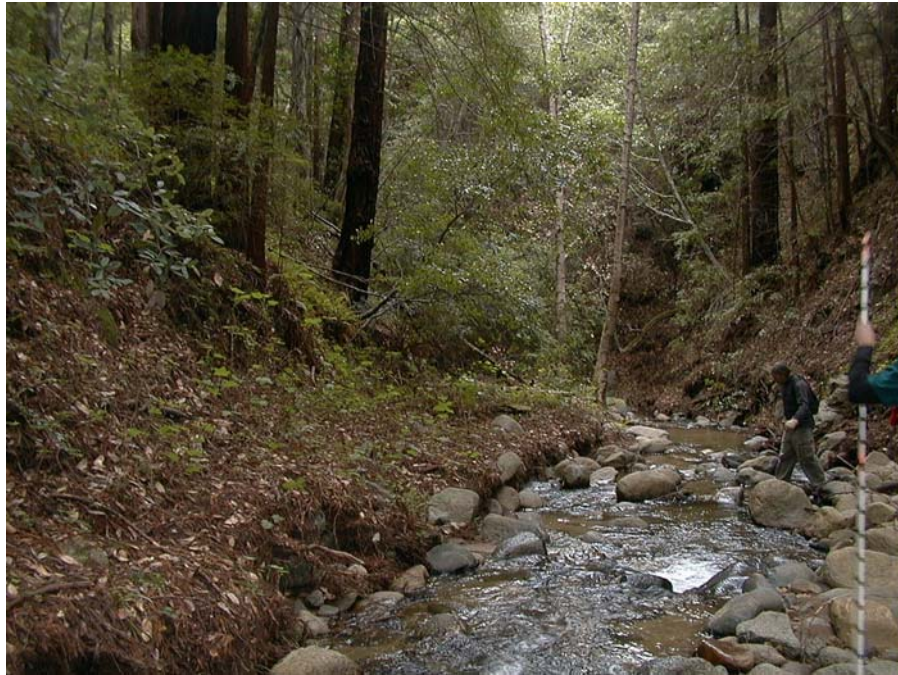
Figure 13 – Redwood Riparian habitat along middle reaches of Garrapata Creek.
Note the relatively wide floodplain, which is unvegetated and covered with a
thick layer of redwood duff. March 2004.

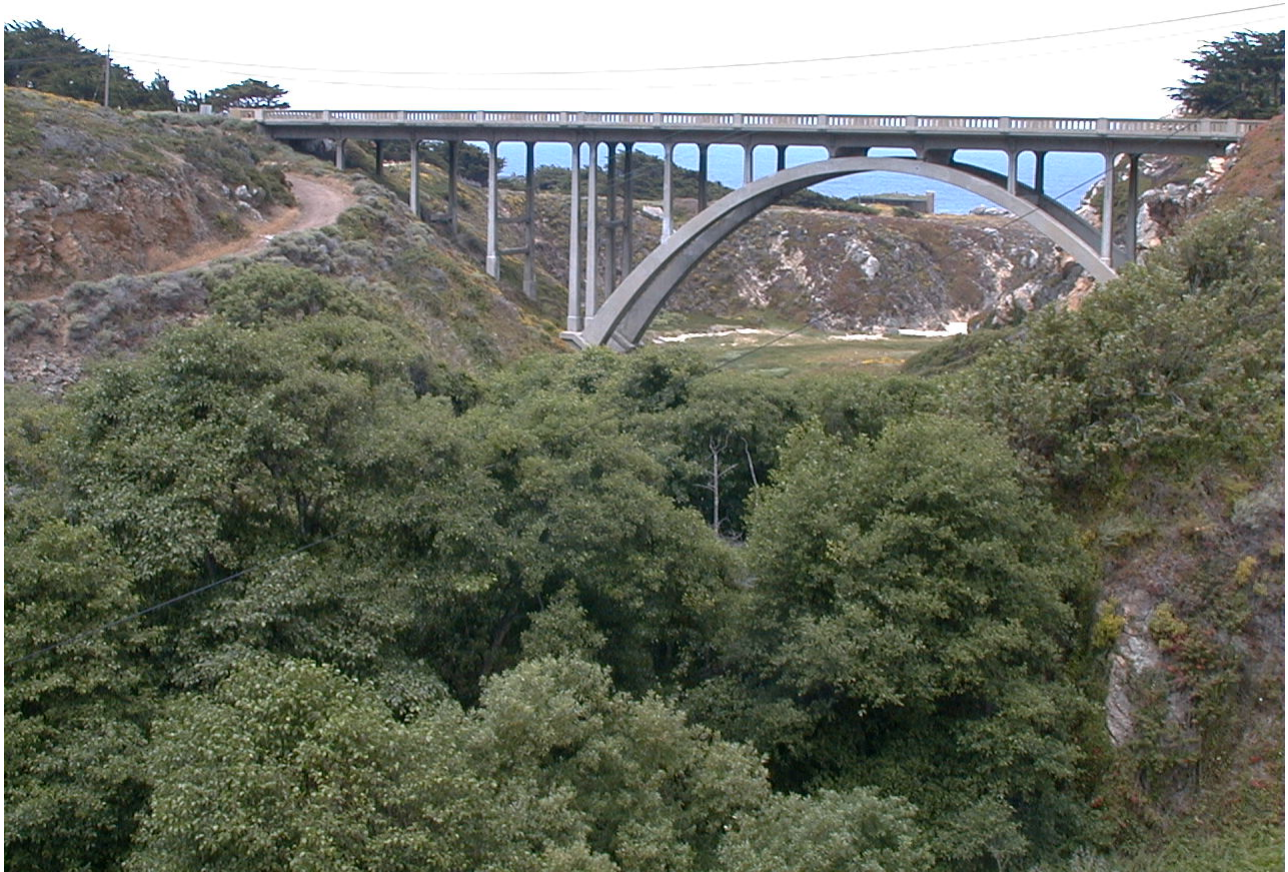
Figure 14 – Garrapata Creek mouth at Highway 1. July 2004.

The mouth of Garrapata Canyon narrows between bedrock outcrops that support the arched span of the Highway 1 bridge. Downstream of the bridge, the creek eventually mingles with brackish water in the interesting estuarine/lagoon habitat that includes a variety of freshwater and salt marsh species. The coastal edge of true riparian habitat is a small grove of arroyo willow and red alder trees that are stunted and pruned by persistent, salt-laden, on-shore winds. Near the mouth of the canyon, the unusual porcupine gooseberry (*Ribes menziesii* var. *hystrix*) occurs as a component of

the tangled arroyo willow/red alder scrub. The channel margins of the creek support typical Lower Watershed Riparian habitat with notable occurrences of western water hemlock (*Cicuta douglasii*), small-fruited bulrush (*Scirpus microcarpus*), common three-square (*Scirpus pungens*), common monkey flower (*Mimulus guttatus*), native blackberry (*Rubus ursinus*) and a variety of fern species.

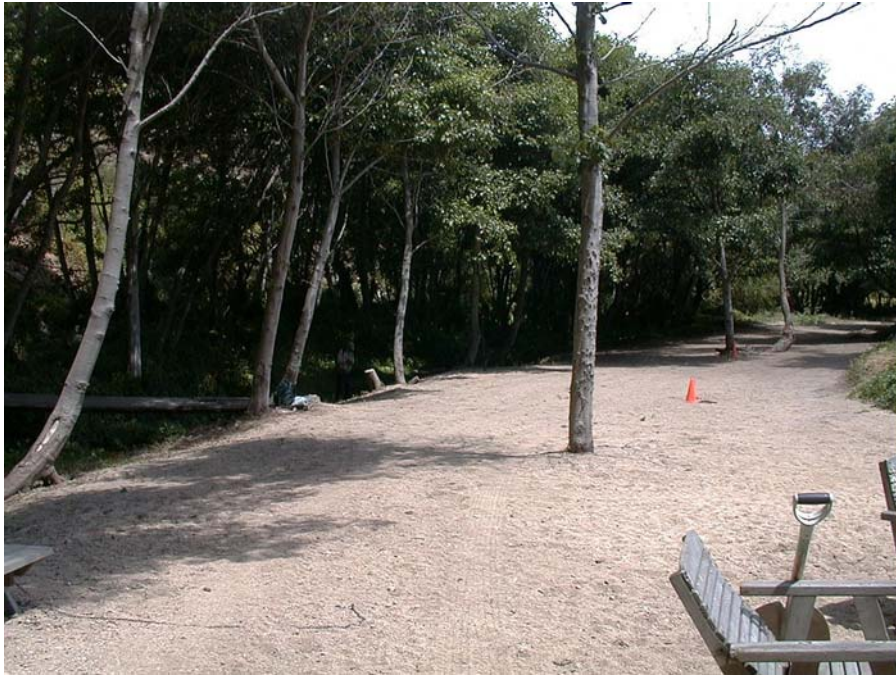
Streambanks devoid of vegetation allow streamflow to accelerate, pick up loose sediment, and potentially undermine the stability of *in-situ*, as well as downstream riparian habitat areas. Sites where vehicular roads cross the stream, as well as sidecast material and sediment generated by natural landslides or drainage off unpaved roads, provide sediment influxes that exacerbate already high levels of both suspended load and bed load. Large cleared areas centered at approximately 1720-feet upstream of the river mouth do not provide understory vegetation or plants to trap sediment and stabilize stream banks. This particular site (Figure 15) is a non-functional riparian

area because it lacks understory, has extensive areas of exposed bare ground (300 feet of bank), and can not provide vegetation or large woody debris that will moderate streamflow and potential future degradation. Despite its geomorphic position on a point bar of the channel, and despite a discontinuous line of alders situated at the top of the bank, the lack of protective ground cover will promote the erosive capacity of the stream through this reach and increase sediment loads.

Figure 15 – Cleared area along lower Garrapata Creek. Lack of riparian vegetation increases erosion hazard. July 2004.

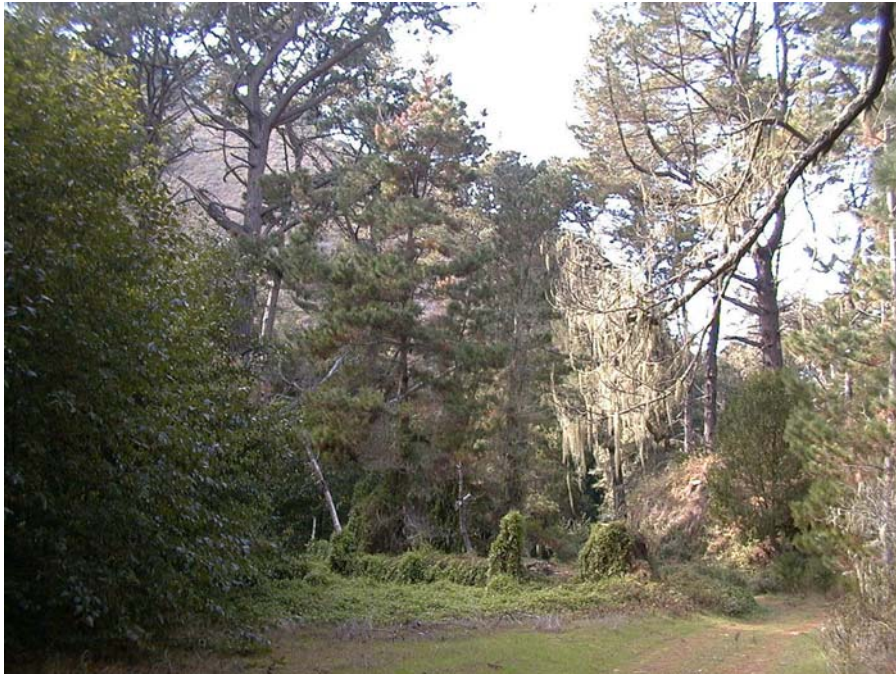
In addition to Cape ivy and sticky eupatorium being very serious threats to the integrity of the riparian community in lower Garrapata Creek, the large stands of Monterey pine, cypress and eucalyptus create habitat conditions that do not favor the recruitment of native species. These tree species were likely introduced at various stages in the settlement of Garrapata Canyon and now tower above the surrounding stream corridor. Mixed stands of huge eucalyptus and Monterey pine extend from the area near the Trout Farm to beyond the pond at Glen Deven Ranch. Seedling pines and eucalyptus continue to proliferate in reaches of the canyon where wide terraces are crossed with overflow channels that carry flow only during the highest stages. In one area of lower Glen Deven Ranch, several braided channel areas of the floodplain include mid-stream bars that are approximately 10-feet above the active channel. Eucalyptus provides the overstory in this region, with occasional red alder and pine. The understory of wood mint, blackberry and chain fern in these areas is being overcome by Cape ivy, yet seedling pines and eucalyptus have managed to survive despite the ivy and very shaded conditions.

Figure 16 – Monterey pine, blue gum eucalyptus and Cape ivy dominate the riparian corridor in this reach of Garrapata Canyon. November 2004.

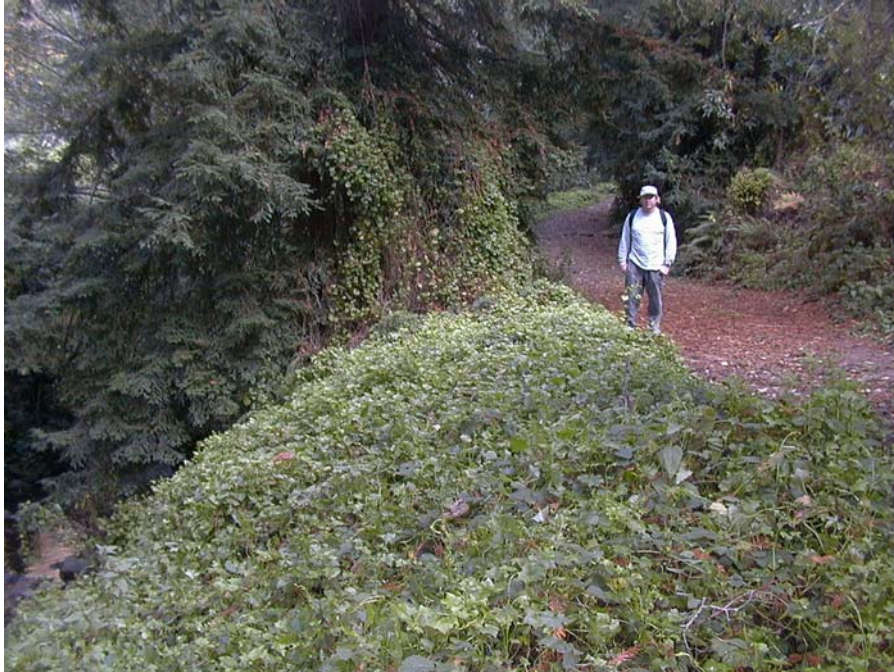
The stream in the area adjacent to the Glen Deven pond has been constrained by the berm and roadway that creates the northern flank of the pond. Slopes above the pond are prone to spring activity, saturated soils, and landsliding, as this area occurs in the trace of the Garrapata Fault zone. The pond area is biologically valuable as open water habitat, however the stream corridor and floodplain in this reach are functionally at risk because of the dense eucalyptus-dominated habitat that precludes the establishment of native species. Recovery of native riparian forest vegetation in this portion of the watershed will be difficult because of the extent of Cape ivy, eucalyptus and pine invasion.

Figure 17 – Roadway in mid-Garrapata Canyon constrains the active channel of the creek. English ivy veneers the embankment. November 2004.

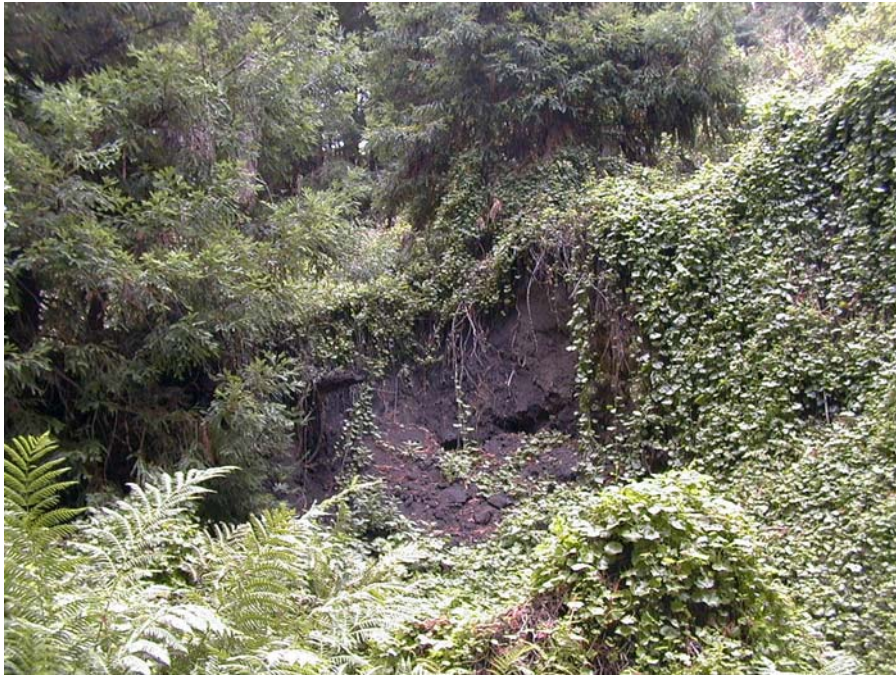
The lower reaches of Joshua Creek downstream of the waterfall support typical Redwood-Riparian habitat with vegetation characteristic of this natural community. Unfortunately, light gaps and areas where slope failure along the stream channel have occurred also produce disturbances being actively colonized by insidious Cape ivy. Figure 18 is a growing slope failure that resulted from an unstable streambank being undercut at the site of a massive tree-fall.

Figure 18 – Cape ivy has invaded the light gap created in the canopy by slope failure and tree-fall along Joshua Creek. November 2004.

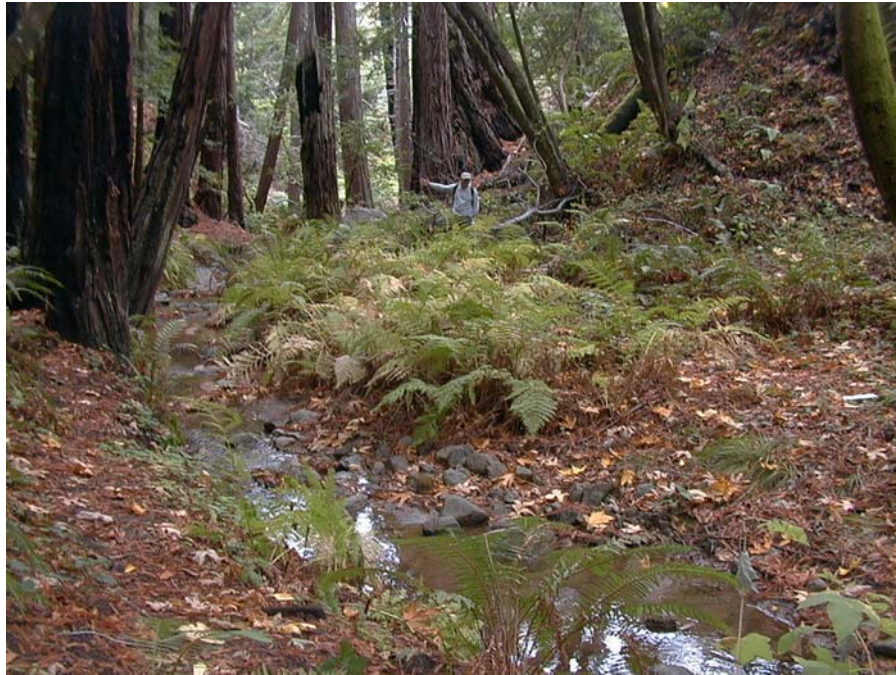
Figure 19 – A wide area of floodplain along Joshua Creek. This site has been relatively stable long enough for chain fern and sedge to mature. November 2004.

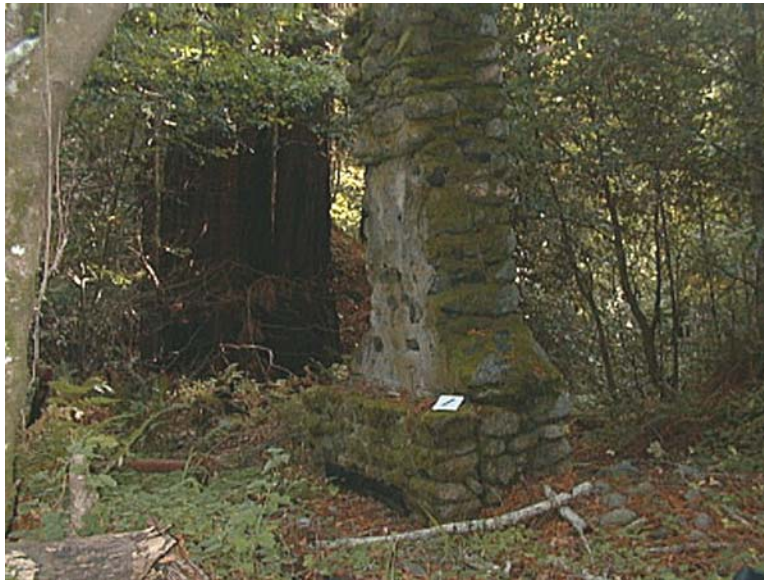
If this is the case, then the original grade where the old cabin was constructed was much lower and coarse sediment has accumulated to a depth of several feet since the structure was built.

Figure 20 – Coarse sediment up to mantle of hearth at Wildcat homestead. November 2004.

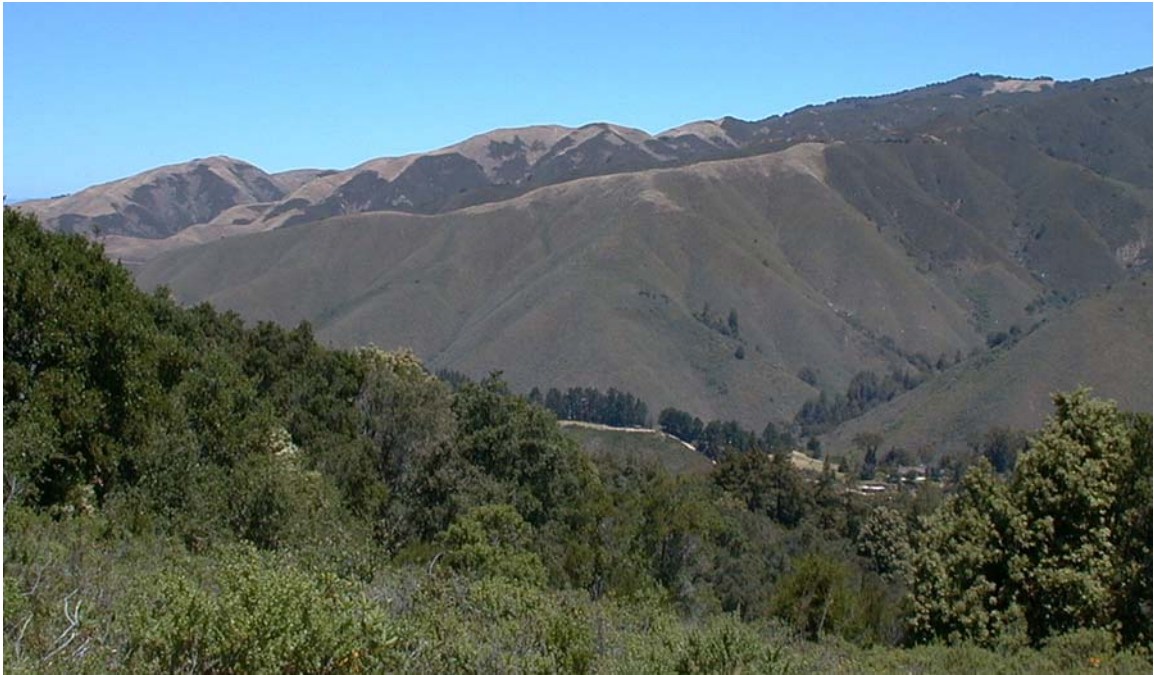
Figure 21 – Lower Wildcat Canyon watershed looking north from Rocky Ridge. July 2003.

Riparian vegetation along lower Wildcat Canyon reflects the deep shade and meager establishment sites typical of narrow channels in Redwood-Riparian habitat. The most floristically diverse riparian patch is also the widest location in the lower canyon where the old homestead occurs. The coarse cobble at this site supports western coltsfoot (*Petasites palmatus*), blackberry (*Rubus ursinus*), mugwort (*Artemisia douglasiana*), elk clover (*Aralia californica*), leopard lily (*Lilium pardalinum*), thimbleberry (*R. parviflora*) and a variety of ferns. A few large red alder occur over the open understory, where unfortunately a small patch of Cape ivy has recently become established.

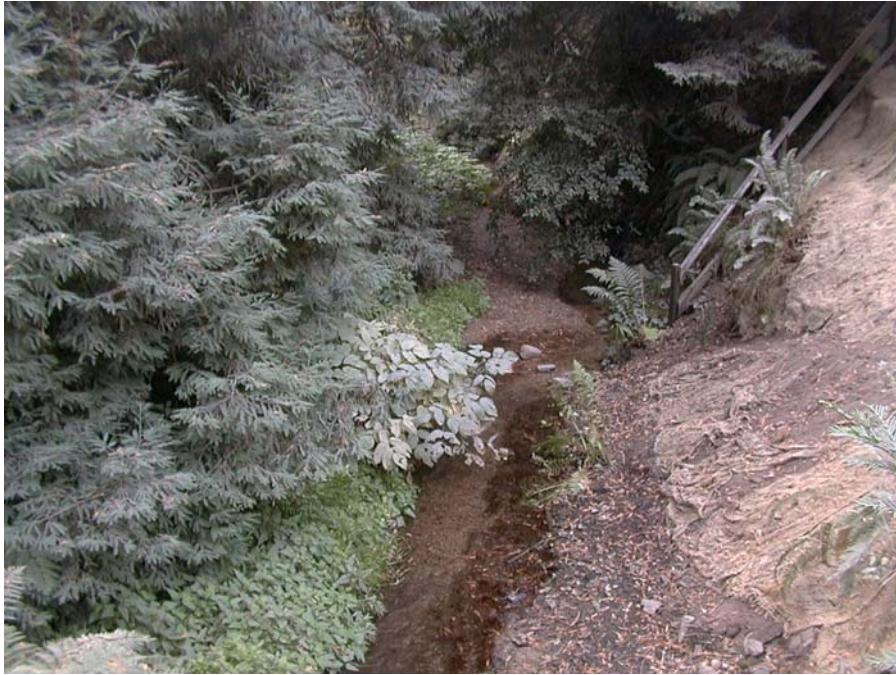
Figure 22 – Downstream of Garrapatos Road bridge over Garrapata Creek. The barren right bank has been protected by jute netting and is ready for revegetation with native riparian plants. October 2003.

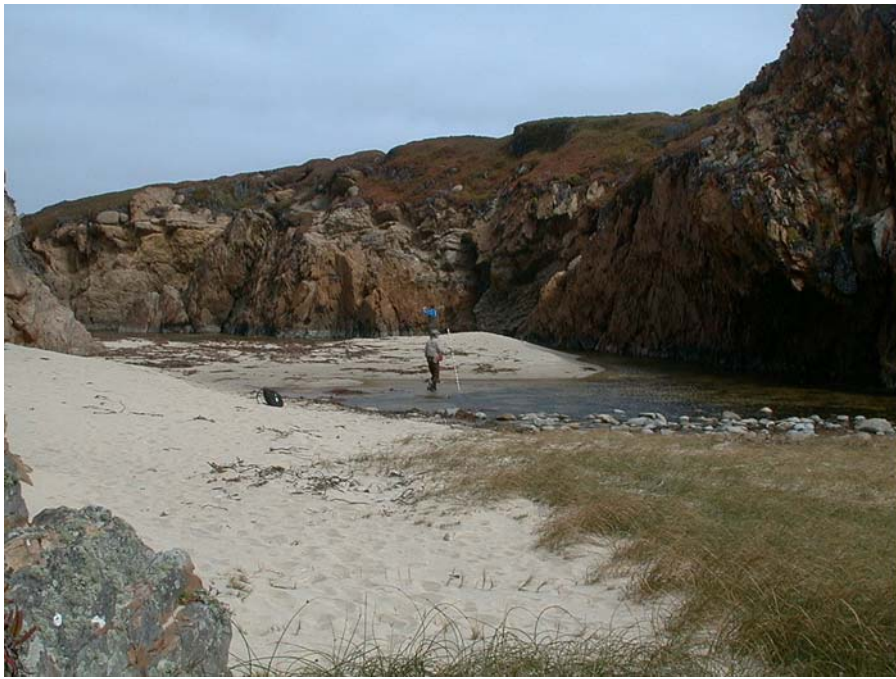
Figure 23 – The Garrapata Creek Lagoon provides valuable rearing habitat for Federally Threatened steelhead. July 2004.
