# Garrapata Creek Watershed Council

## Garrapata Creek Watershed Assessment

### Phase Two: Upper Watershed

December 15, 2005

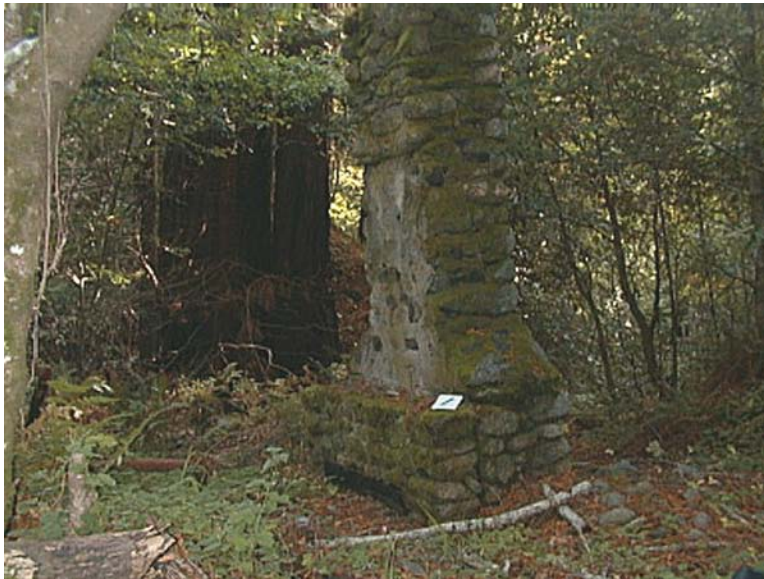
Coarse sediment up to the mantle of the fireplace at Wildcat Canyon homestead near the waterfall. November 2004.

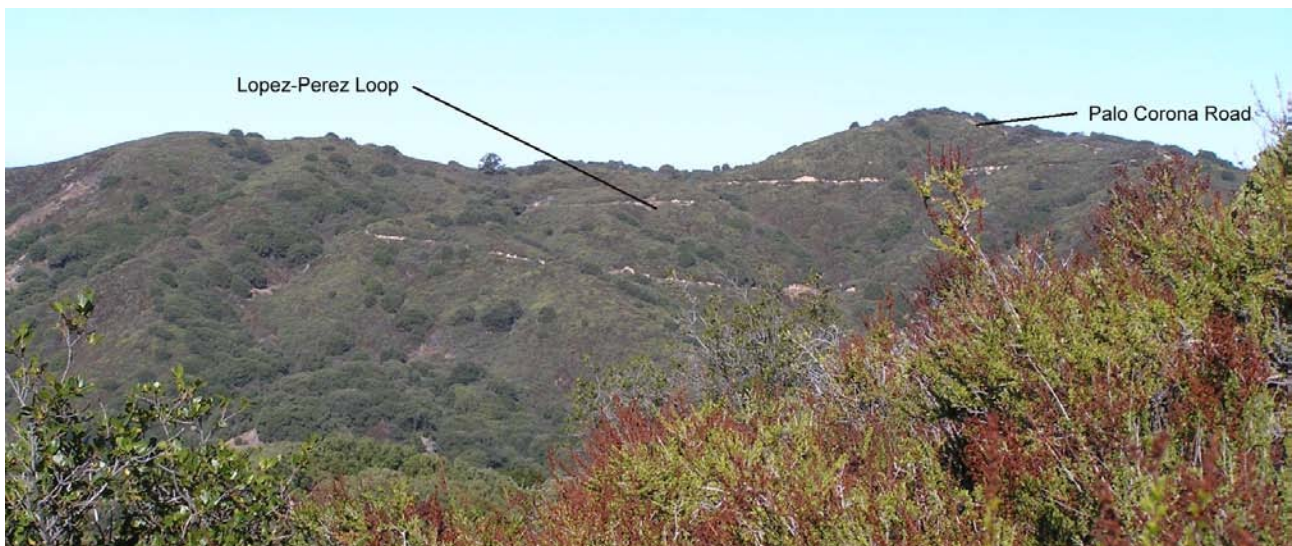
The upper portion of the Lopez-Perez Loop seen from the Garrapata Ridge Road.

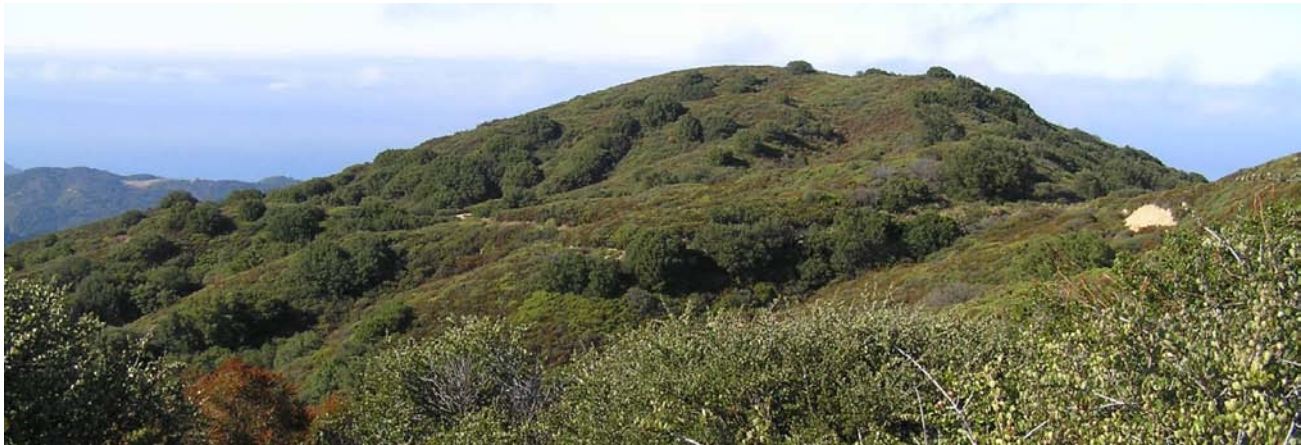
Upper portion of Lopez-Perez Loop traverses through dense Mixed Chaparral and small groves of Coast Live Oak and Canyon Live Oak Woodland. The saddle on the right side of the photograph separates the Wildcat Canyon and Joshua Creek watershed basins.

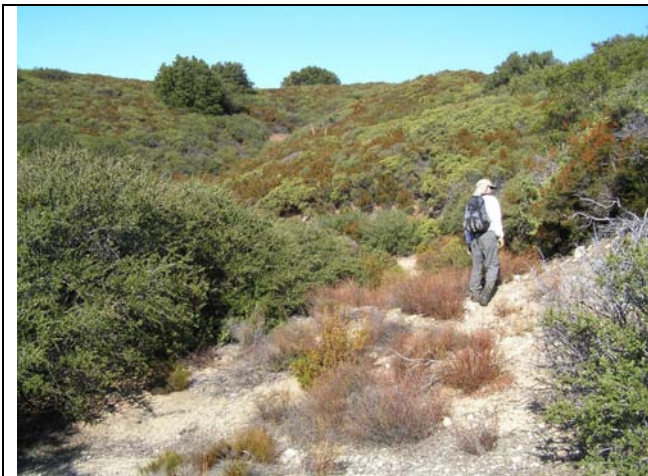
Revegetating roadbed along the upper portion of the Lopez-Perez Loop. Low shrubs are mostly deer weed and widely scattered rush rose.

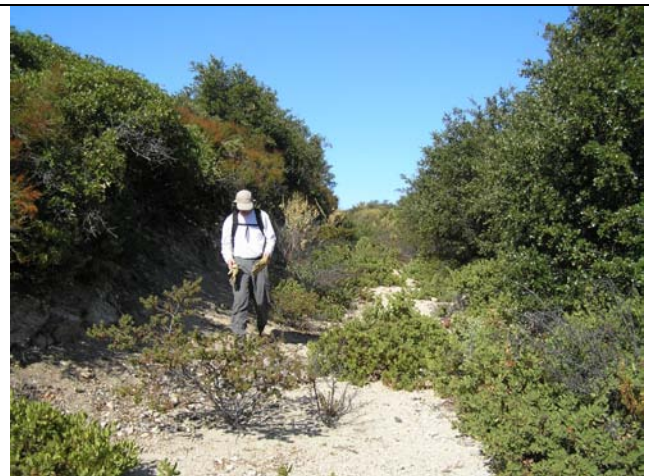
Roadbed along Lopez-Perez Loop. Note steep road cut at left. Manzanita and warty-leaved ceanothus occur in roadbed.

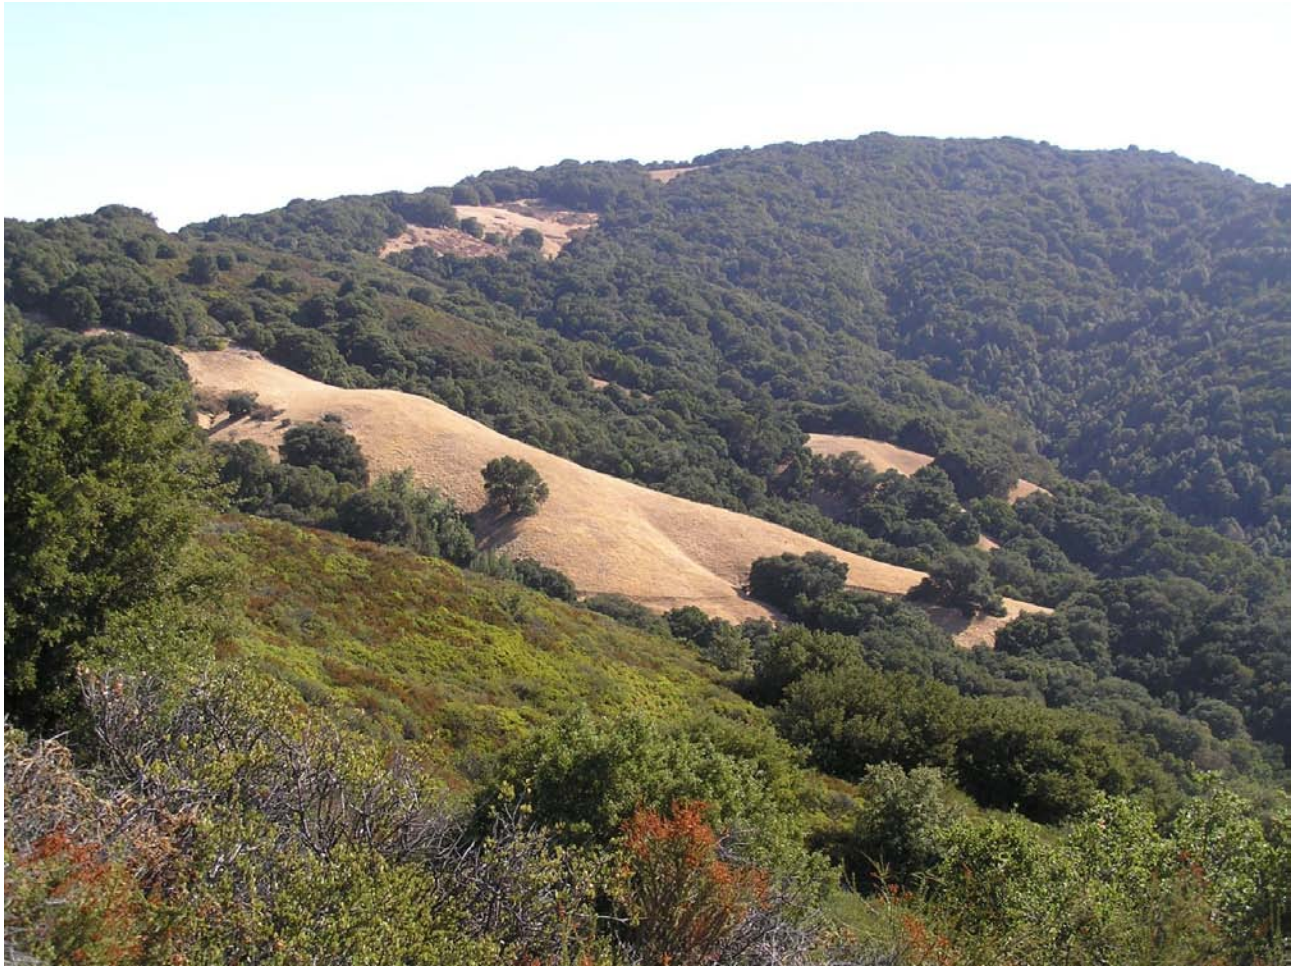
Mixed Chaparral areas along the upper portion of the Lopez-Perez Loop - view towards the south and Grassland areas in upper Wildcat Canyon watershed. Note trace of Lopez-Perez Loop across lower grassy slope. This grassy area is to the southwest of the hunt camp situated at the junction of a short connector road and the Lopez-Perez Loop.

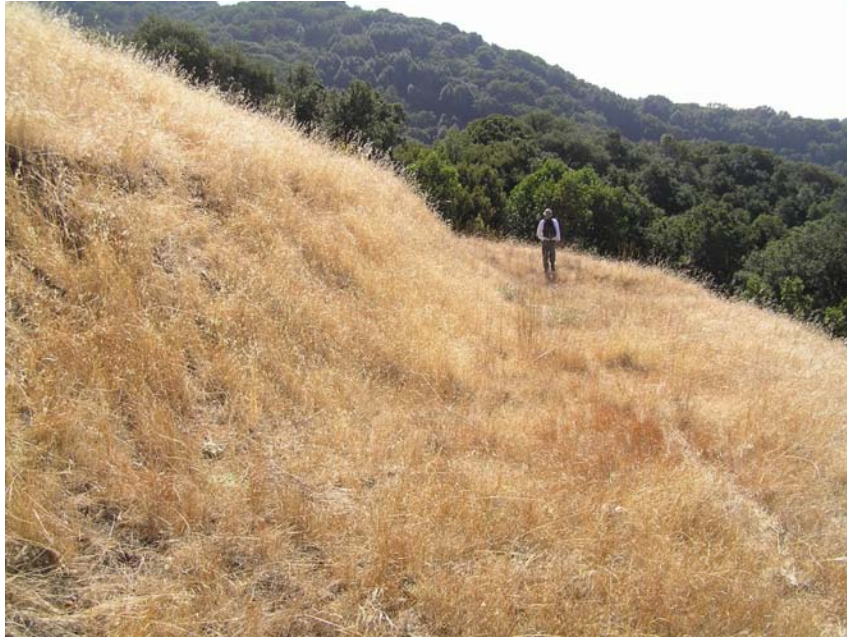
Decommissioned roadbed in Grassland area along the Lopez-Perez Loop southwest of the hunt camp. This stretch of road does not appear to have had noticeable "treatment" related to road decommissioning, however the simple act of ripping the compacted roadbed could have led to invasion of weedy annuals, as is depicted in this photograph.

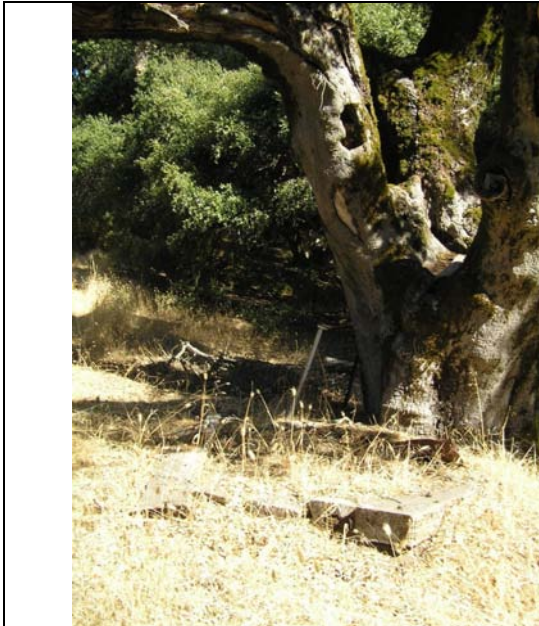
The hunt camp along the Lopez-Perez Loop had been visited in early October 2005, as evidenced by matted grasses in the tire tracks of quad-type all-terrain vehicles. The hunt camp had several rusted bed frames, piles of debris, and stacks of thick, milled redwood lumber.

Hunt camp at junction of Lopez-Perez Loop and short road connecting to Palo Corona Road. Bed frame is leaning on enormous canyon live oak tree.

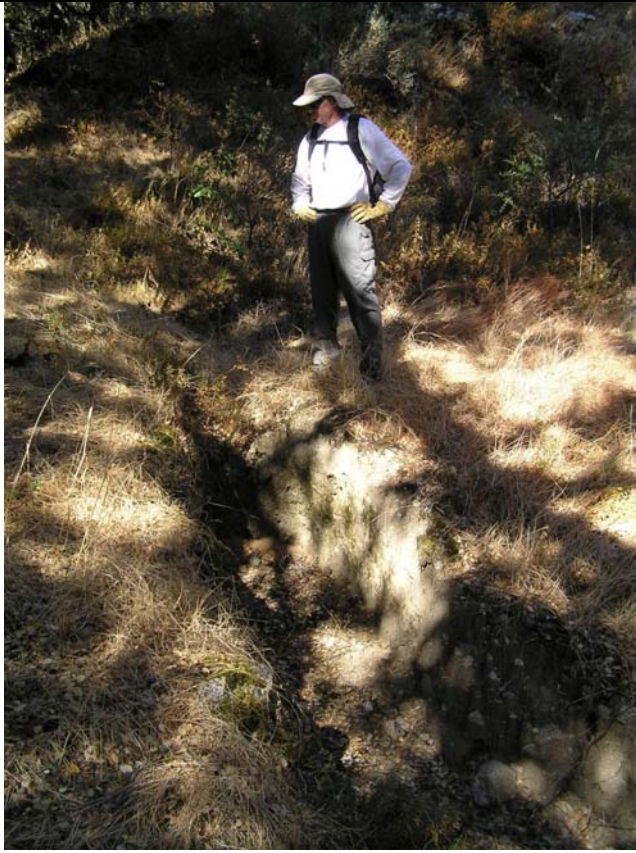
Headward erosion creating gully along Lopez-Perez Loop where road decommissioning may not have occurred in 1990/1991. Roadbed fill across small, ephemeral stream is being actively eroded and sediment is moving down-slope.

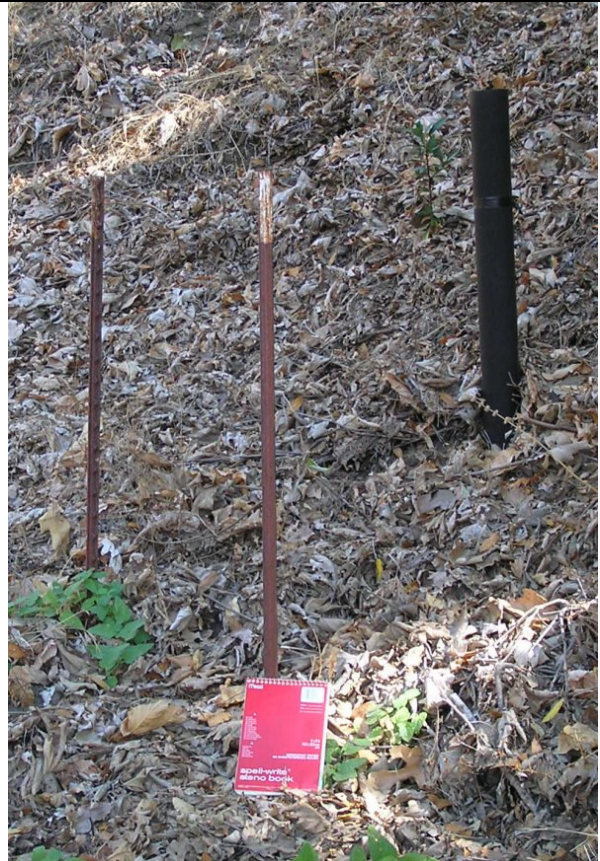
Oddly placed metal T-posts and 3" diameter perc tube near hunt camp along Lopez-Perez Loop. Mountain quail were seen near this location, a very "coastal" and low elevation occurrence for this species.

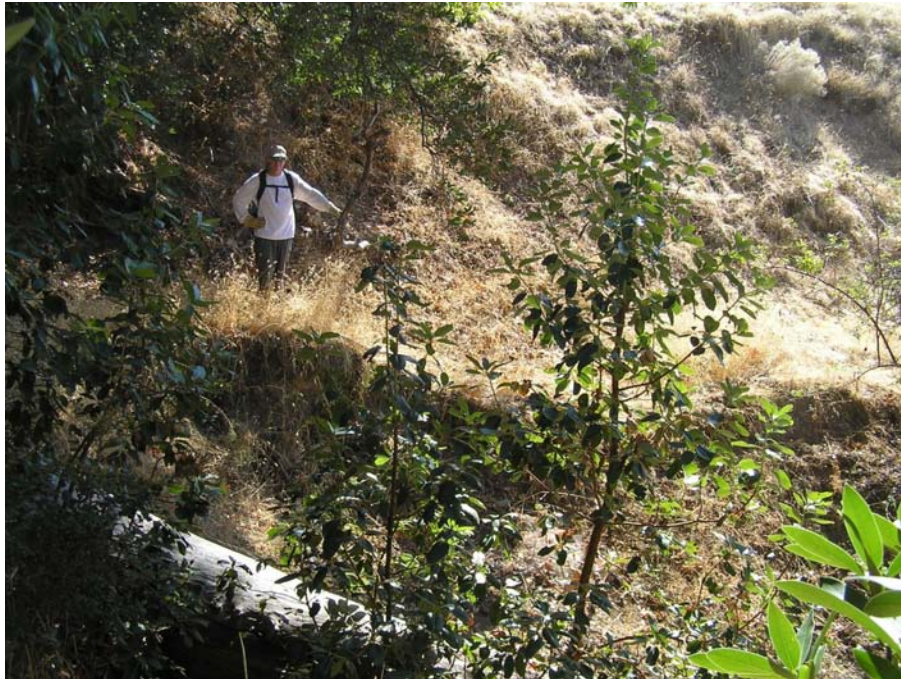
Active erosion creating gully at seasonal stream crossing along Lopez-Perez Loop near hunt camp.

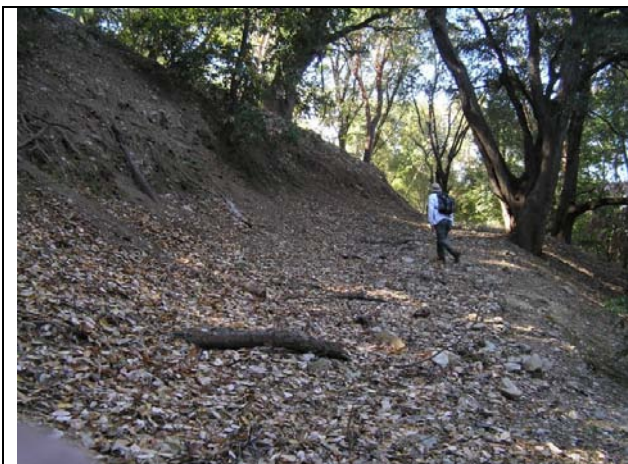
Decommissioned roadway is slightly out-sloped between upper section of Upper Wildcat road and Palo Corona Road. Out-sloping may be a function of natural soil and duff accumulation along inboard side of roadcut.

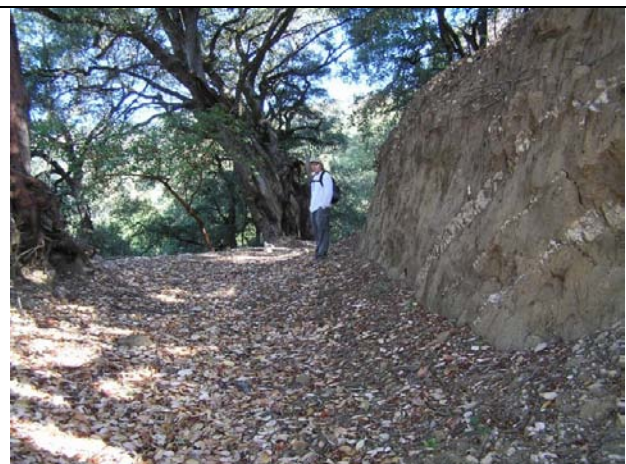
Decommissioned roadway and steep roadcut between upper section of Upper Wildcat road and Palo Corona Road.

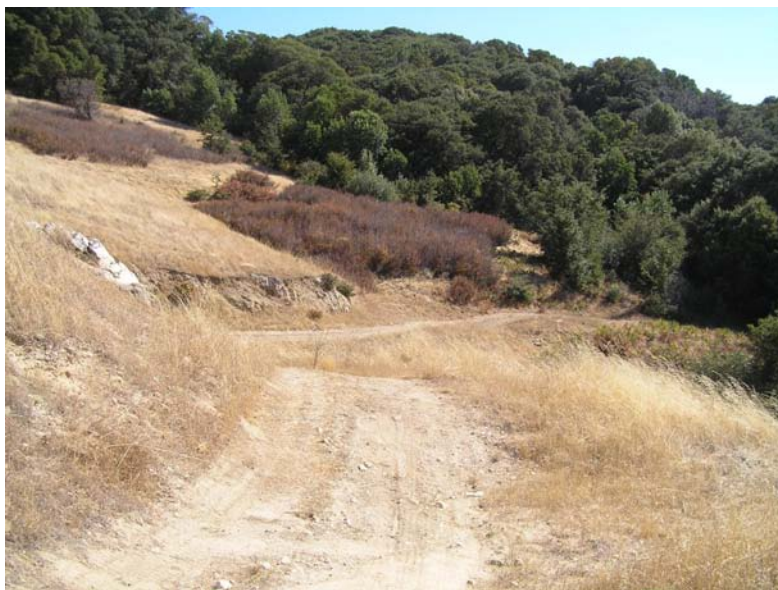
Upper section of the connector route into upper Wildcat Canyon experiences frequent vehicular traffic that enters the area via the Rancho San Carlos and other private holdings.

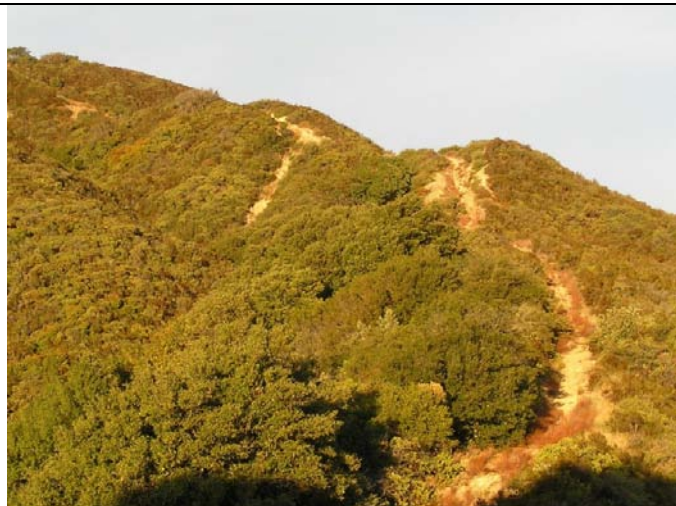
Extremely steep sections of Garrapata/Wildcat Ridge Road, with soil movement originating from improperly graded roadbed. Sediment is likely not being delivered to stream drainages, as this slide occurs upslope of densely vegetated Evergreen Forest and Mixed Chaparral habitat.

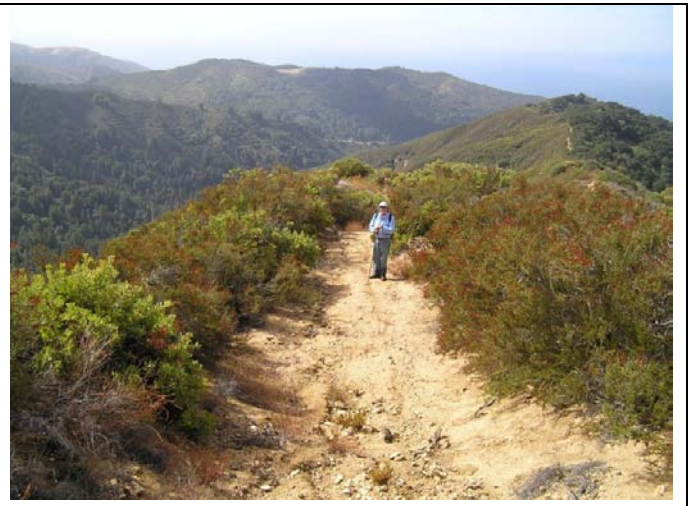
Barren, rocky soil along Garrapata/Wildcat Ridge Road with chamise and occasional manzanita in Mixed Chaparral habitat on either side.

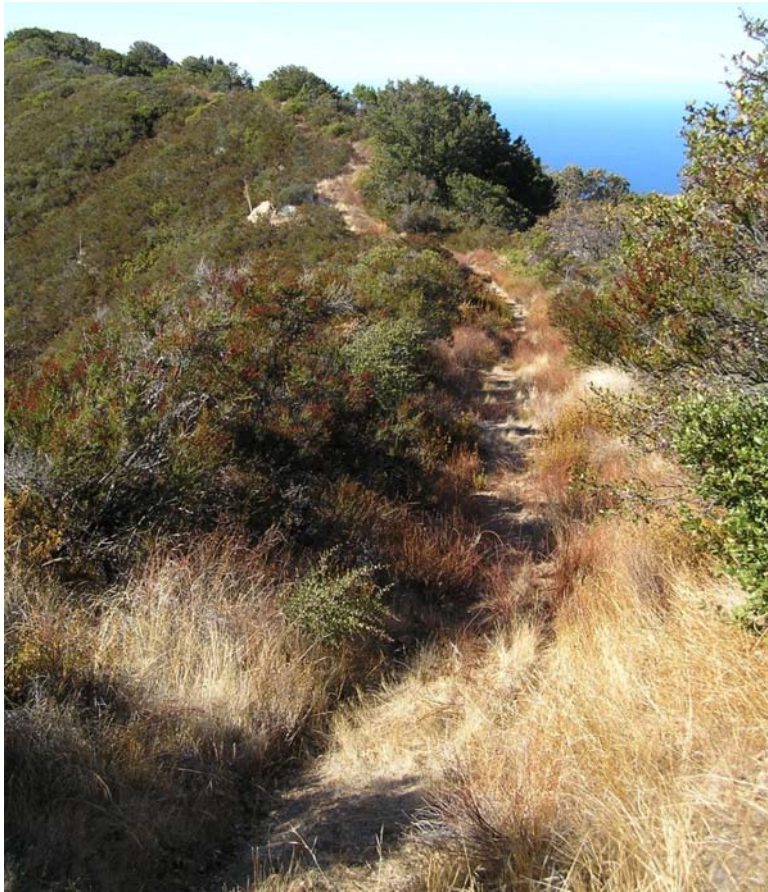
Well-vegetated section of roadbed along Garrapata/Wildcat Divide ridgeline. Annual grasses, deer weed and rush rose characterize the plant cover in this area.

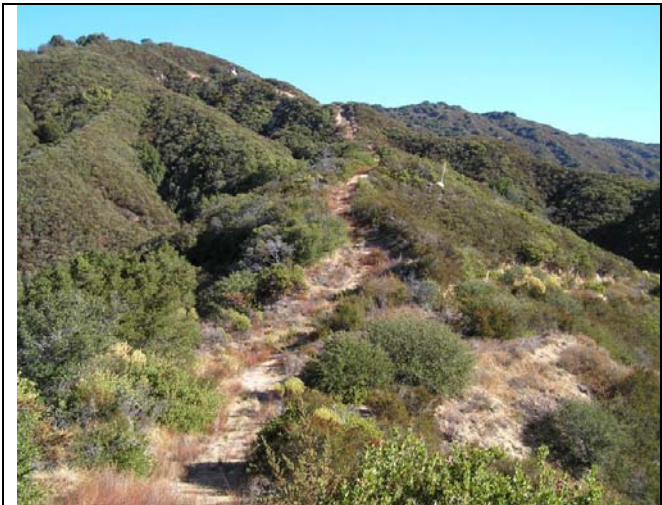
Junction of Garrapata/Wildcat Ridge Road, decommissioned "Connector" to Wildcat Canyon on left, and decommissioned spur road on right (looking towards the east). Entry points to "Connector" and spur are densely vegetated with Mixed Chaparral shrubs.

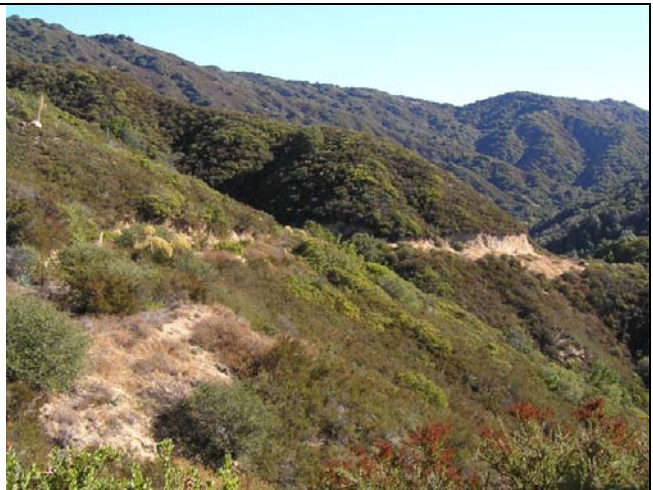
View of decommissioned spur road immediately to the right of junction with Garrapata/Wildcat Ridge. Note tall road cut and evidence of landslide below the head wall of the decommissioned road.

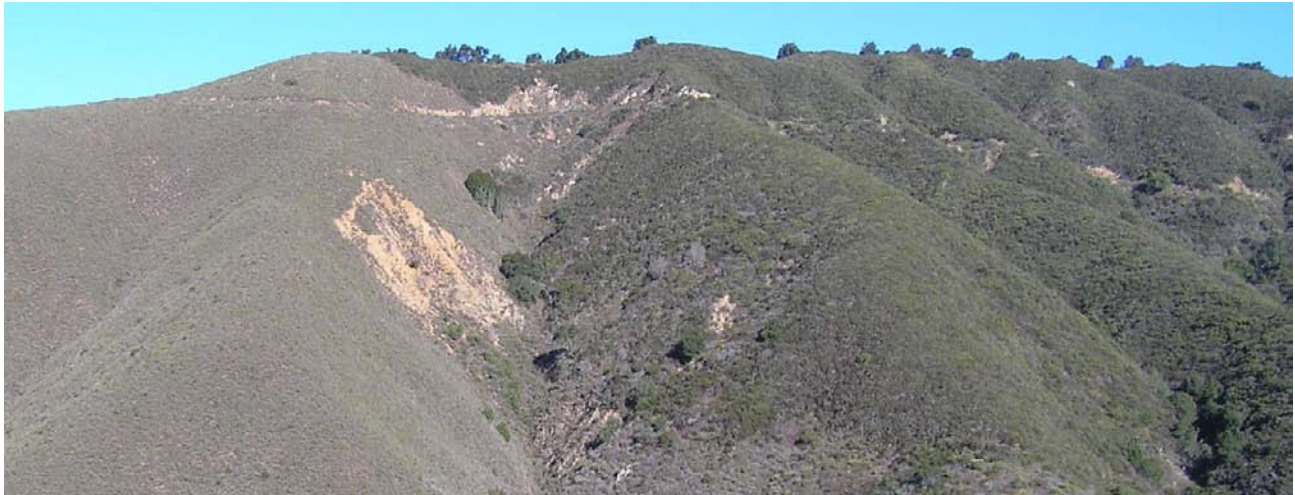
The western nose of the Garrapata/Wildcat watershed divide and the section of the roadway that descends into Garrapata Canyon below. View is across Garrapata Canyon from the King Road on the north-facing side of the drainage basin. Vegetation dramatically changes from the marine-influenced Northern Coastal Scrub on the left, to Mixed Chaparral on the right. A small, natural slope failure has occurred below the roadway, which speaks to the occasional, natural landslides that will occur from time to time in this steep terrain.

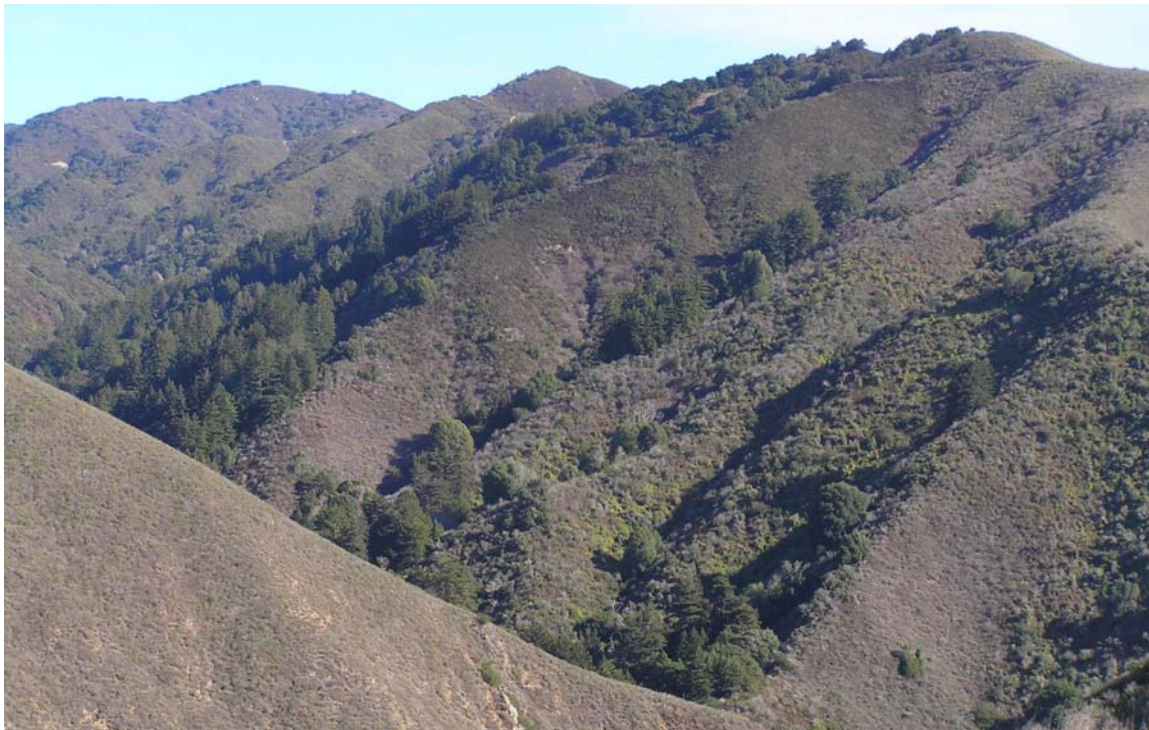
View looking upstream into lower and mid-Wildcat Canyon from the Glen Deven Ranch. The nose of Garrapata Ridge and the roadway that descends to the right down into the Garrapata Creek canyon is visible on the top right of the image. The road at the nose of Garrapata Ridge also veers towards the left into Wildcat Canyon. This route was not investigated for this study and remains an interesting opportunity for future survey. This road first appears on the 1983 USGS quad and may be associated with logging activities reported to have occurred in Wildcat Canyon during the 1950's and 1960's.

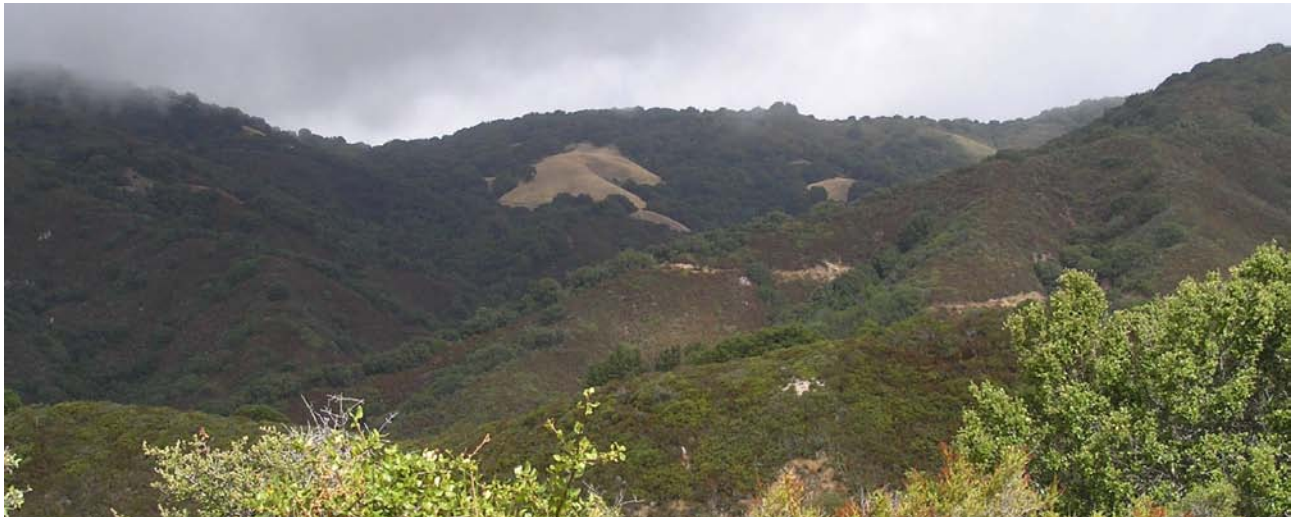
The trace of the route in the right-center of the image is the decommissioned "Connector" road that joined the Garrapata/Wildcat Ridge Road and the roads along the north-facing flank of Wildcat Canyon.

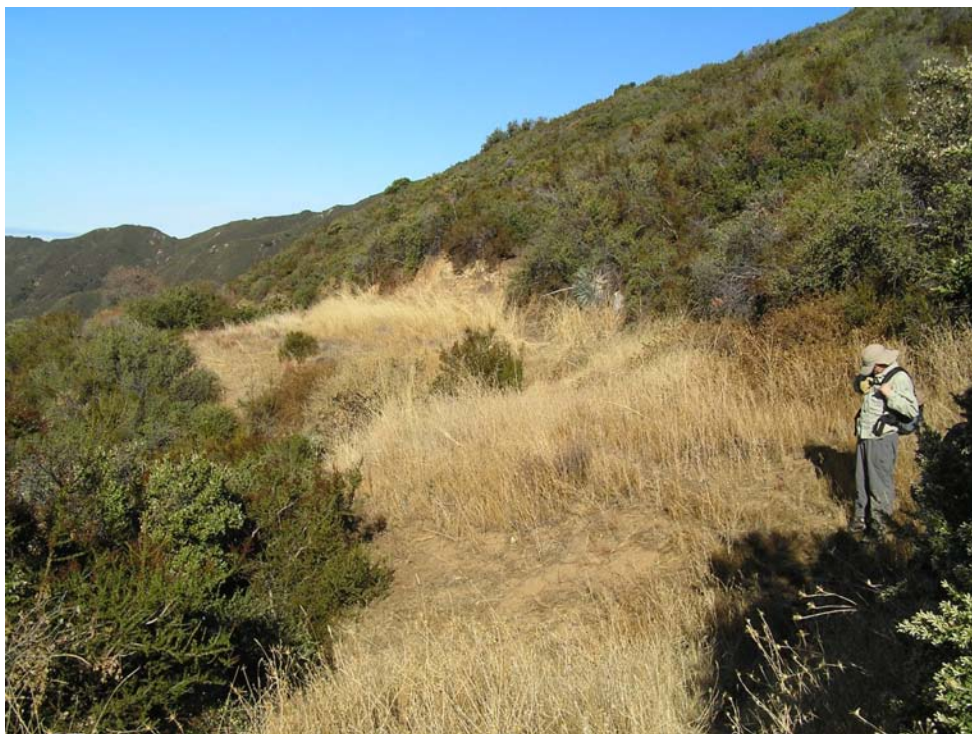
View of the "Connector" road, which has been heavily invaded by yellow star thistle and other non-native, invasive plants. Topographic contour has been restored by road decommissioning at this location.

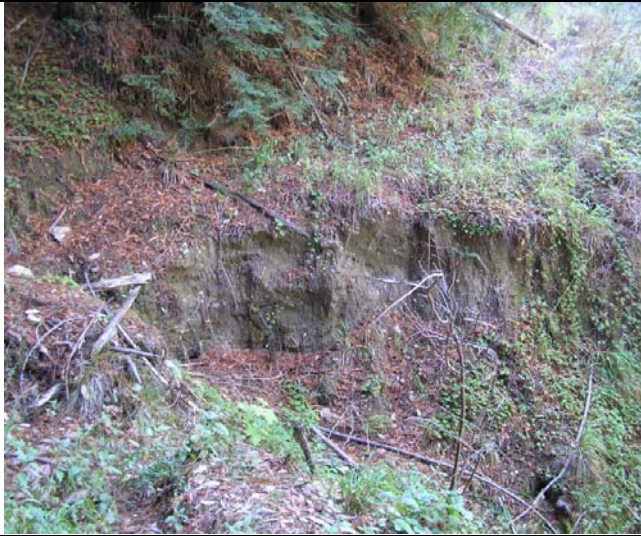
Location where fill of roadbed has failed leaving a 5-foot scour that may supply sediment during episodic events. Duff and redwood sorrel cover helps to mitigate potential future erosion at this location, however fill is unstable and may continue to erode.

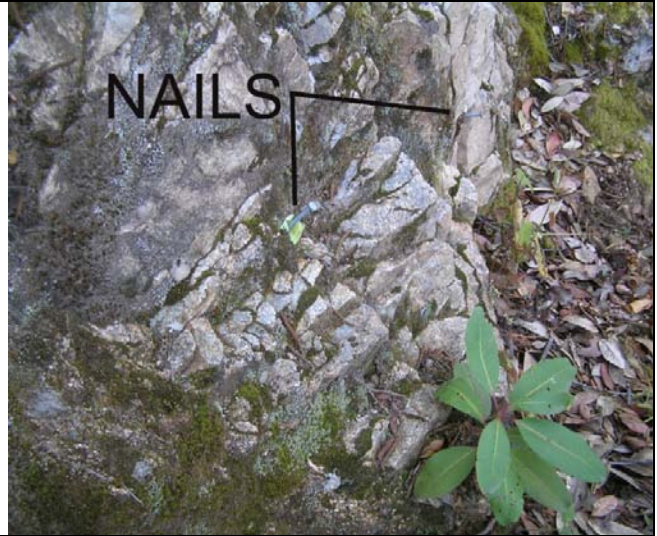
Nails hammered into solid rock of roadcut. One nail had a small piece of yellow flagging still attached, which suggests these marked 1991 road treatment sites. Nails may have been originally installed at waist level above the old roadbed, which has been elevated approximately four feet with accumulated soil and leaf litter. Madrone seedling has recruited at this site.

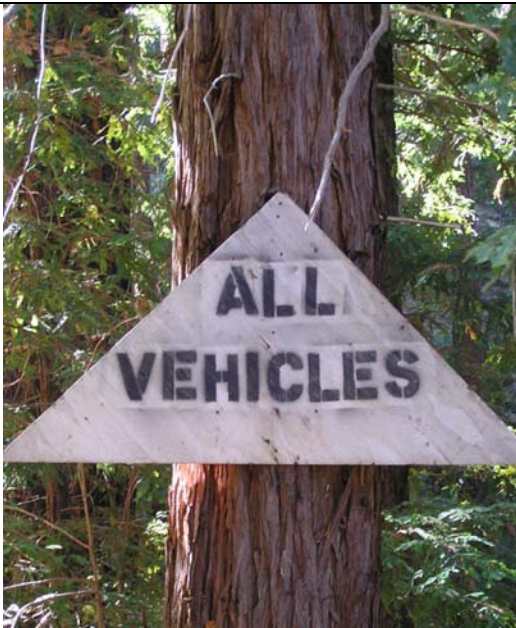
Road sign still in place along decommissioned Lower Wildcat road.

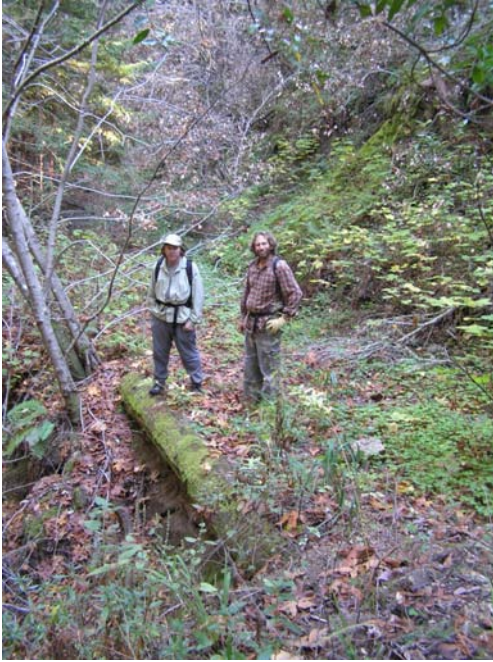
Very old bridge constructed out of redwood logs. No visible erosion is apparent along this reach of the road down into Wildcat Canyon. Redwood Forest supports a dense understory.

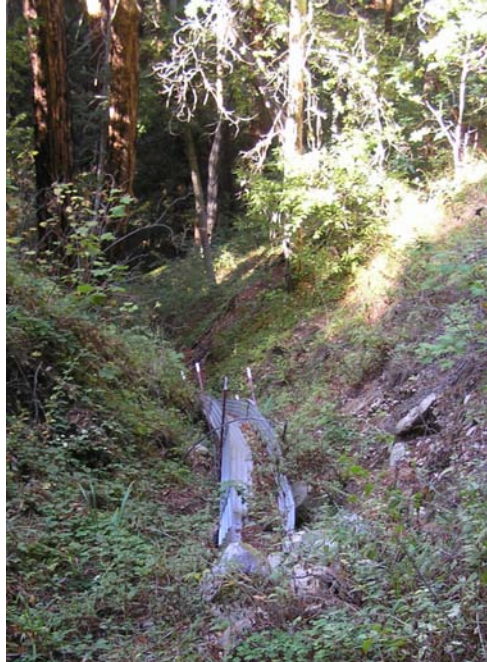
Open culvert constructed of corrugated tin along old roadway down into bottom of Wildcat Canyon. Metal T-posts supporting downstream end of culvert have not rusted, indicating their relative youth compared to other cultural features in the bottom of the canyon.

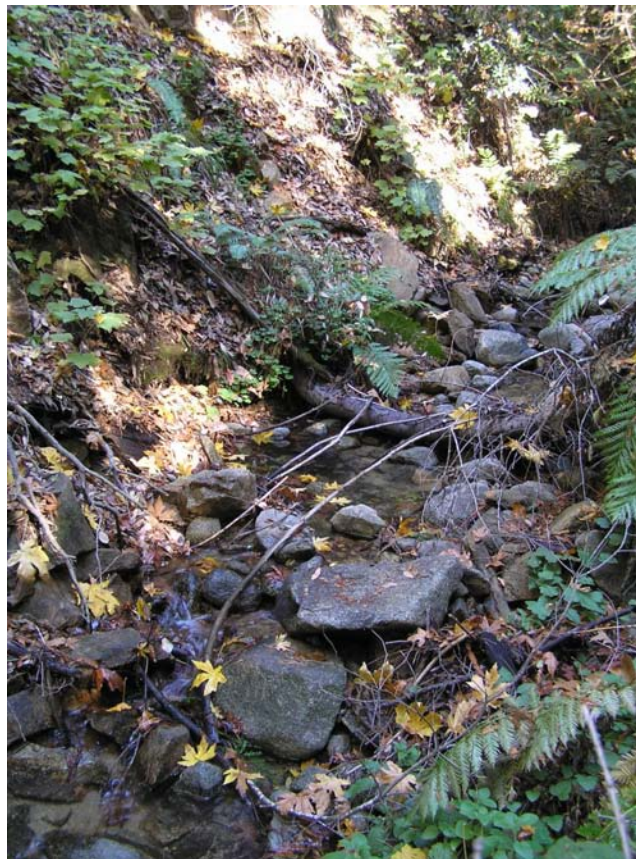
Wildcat Canyon Creek in narrow, bedrock-controlled channel near crossing of old logging road. Classic Redwood Riparian habitat with chain fern, redwood sorrel and thimbleberry.

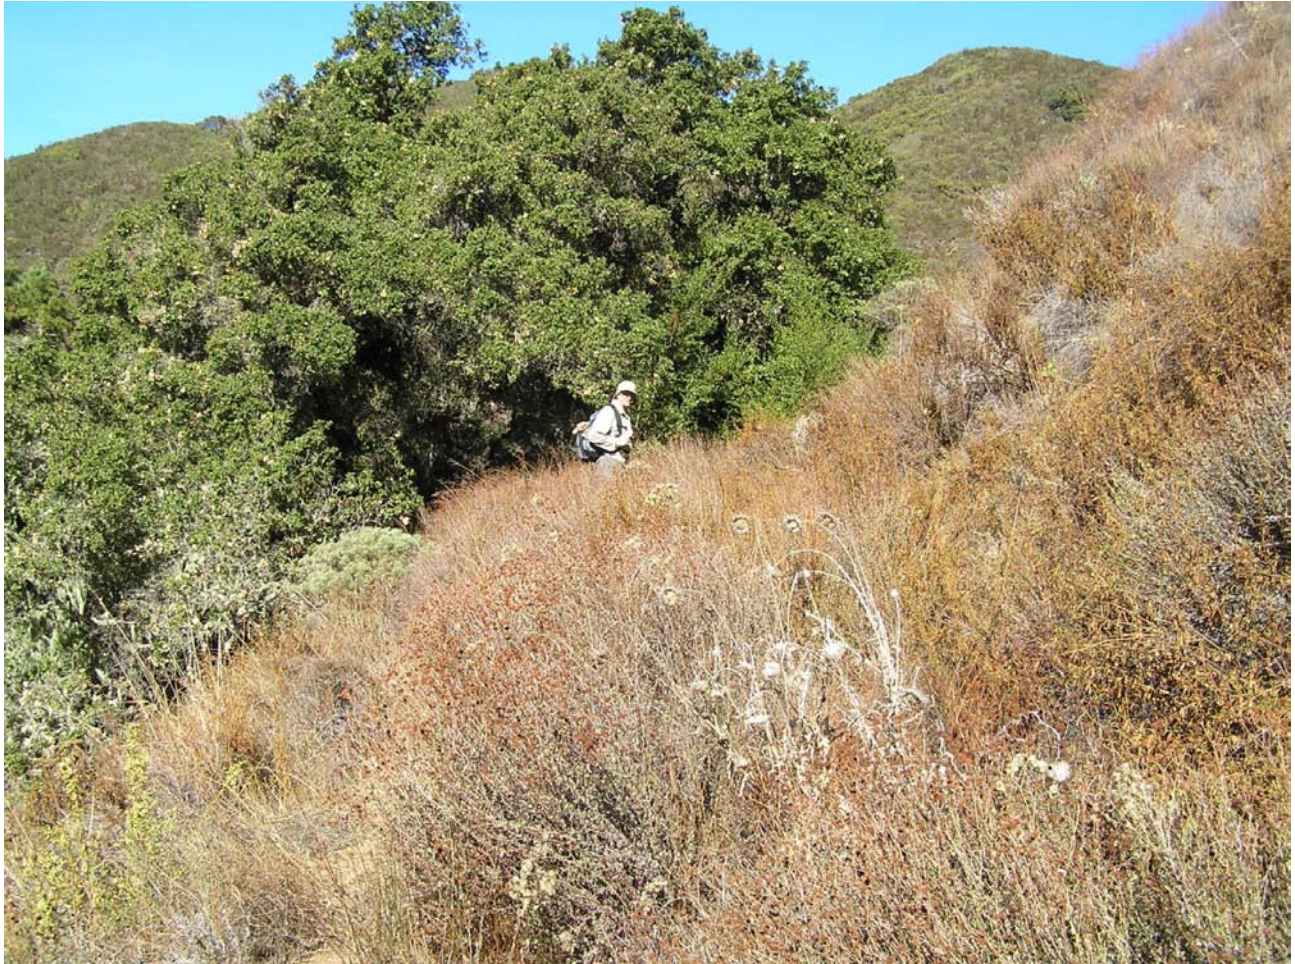
Near the terminus of decommissioned roads surveyed in Wildcat Canyon. Roadbed is all but obscured by dense Northern Coastal Scrub vegetation and canopy of Mixed Evergreen Forest habitat. Non-native milk thistles are in the lower center of the image and a thick patch of seacliff buckwheat occurs between the man and the thistle plants. Extensive stands of seacliff buckwheat are found on northwest-facing slopes in this portion of the canyon.

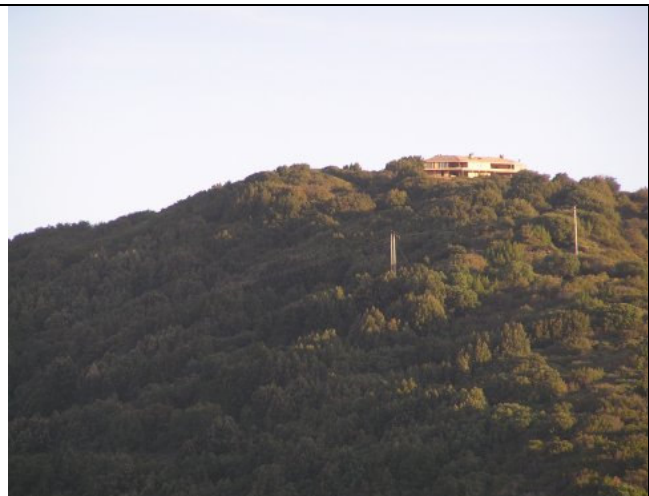
Power lines that span Garrapata Canyon are below the new home west of Twin Peaks. This structure has been built since the August 2004 photo on page 14.
