BIG SUR RIVER STEELHEAD ENHANCEMENT PLAN

Prepared for:
Department of Parks and Recreation
Monterey District
2211 Garden Road
Monterey, CA 93940

Prepared by:
Denise Duffy & Associates, Inc.
947 Cass Street
Monterey, CA 93940
Contact: Josh Harwayne

March 2003

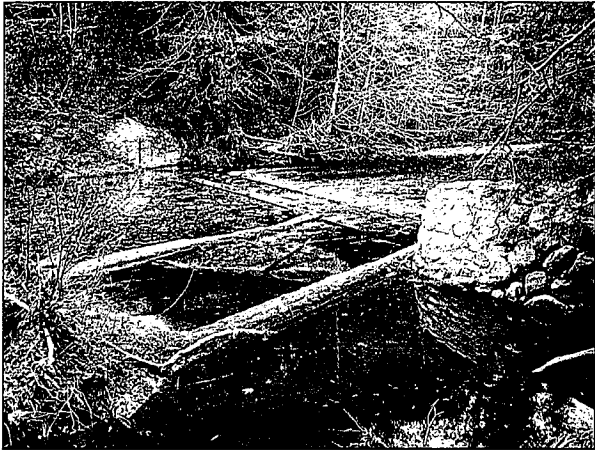
Old diversion dam site. (PBSRM 0.13) This existing structural grade control feature is one of 8 old instream grade controls that affect channel width/depth dimensions in PBS.

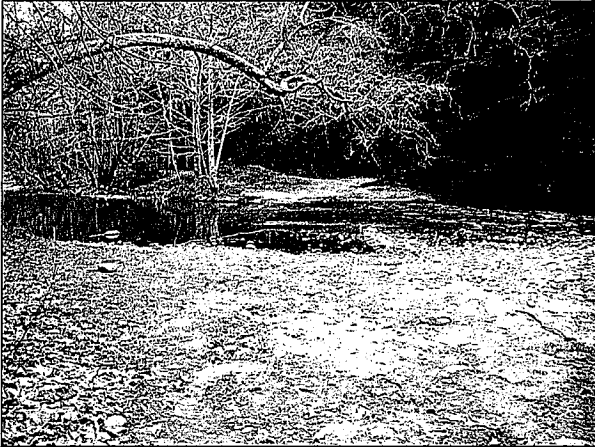
Group camp at-grade vehicle ford and seasonal footbridge, February 2002 spawning season conditions. (PBSRM 0.26)

- Site J..... Complete design, permit and construct proposed year-round multi-use bridge to minimize instream trampling (CP-11).
- Site K..... Construct bioengineered revetment at Hwy 1 road bank failure (CP-9)

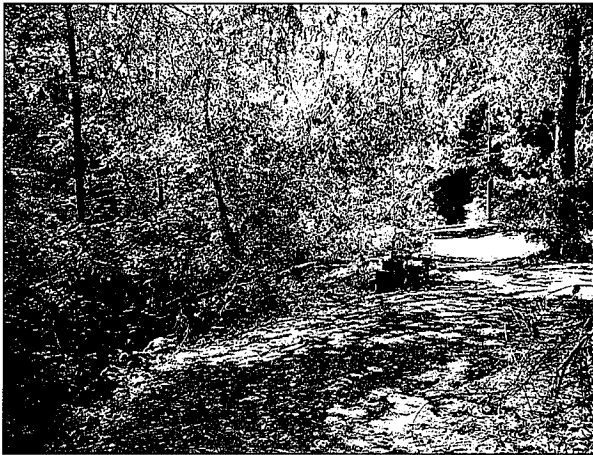
Service road/trail between Highway 1 bridge and Group Camp, limits left bank riparian habitat. Existing alluvial wells extend along this bank behind stone wall. (PBSRM 0.57)

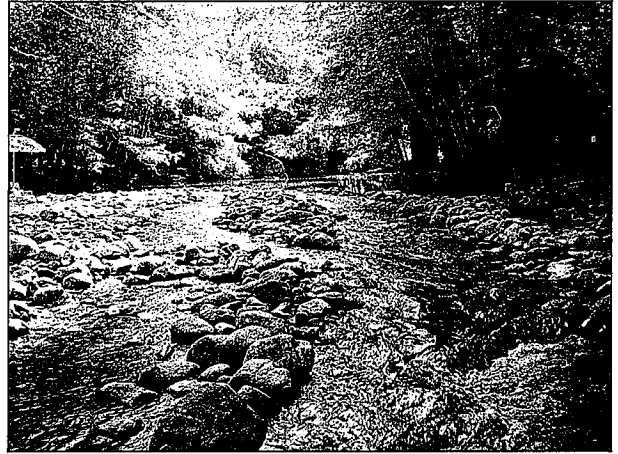
Concentrated recreation use in Main Camp bedrock pool and downstream riffle. (PBSRM 0.99)

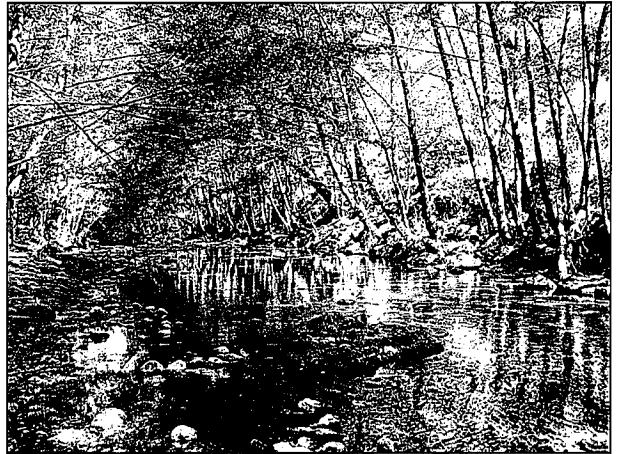
Narrow, even-aged alder riparian zone confined by right bank access road. (PBSRM 1.15-1.20)

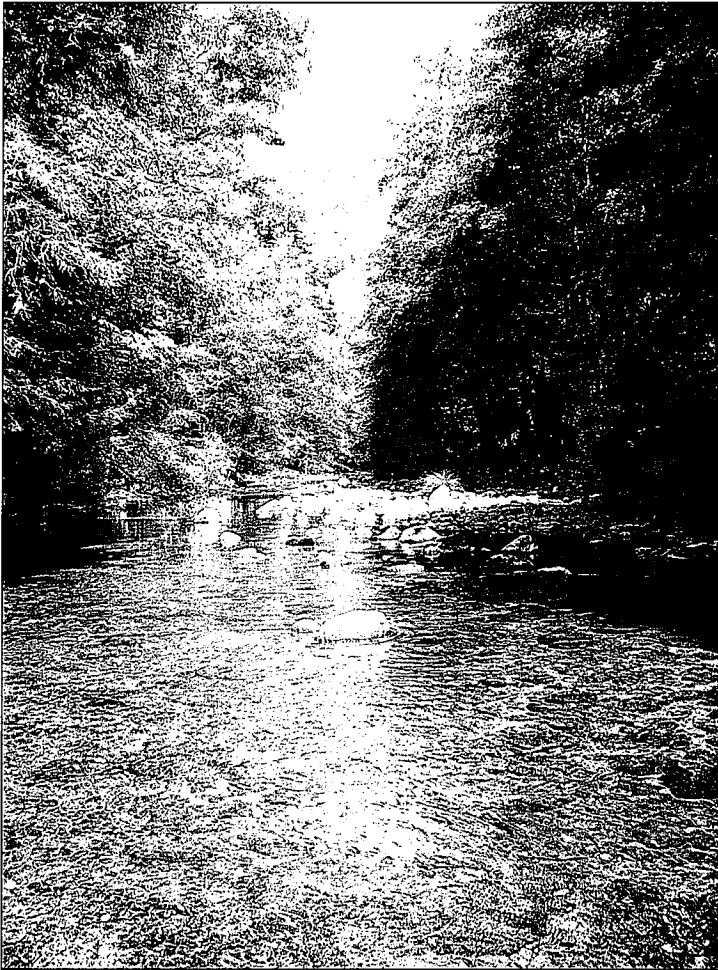
Severe bank trampling and heavy recreational use below USGS Big Sur Gage. Persistent modification of downstream control riffle by construction rockdams in the vicinity of PBSRM1.98, limits accuracy of realtime-remote gaged low-flow measurements. As a result, summer baseflows are most often estimated by USGS staff and are considered poor records. (PBSRM 2.02)

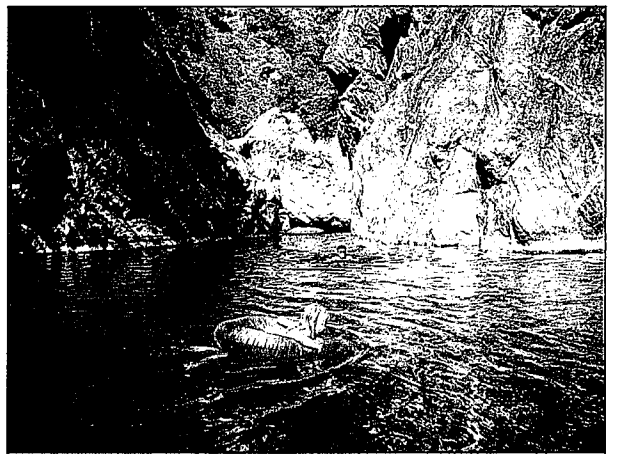
Up to 400 people per day use the Gorge pools, often bringing with them substantial amounts of litter. Despite heavy use, snorkel surveys found YOY, 1+, and 2+ fish abundant in the Gorge's step pools and boulder riffles (PBSRM 2.29).

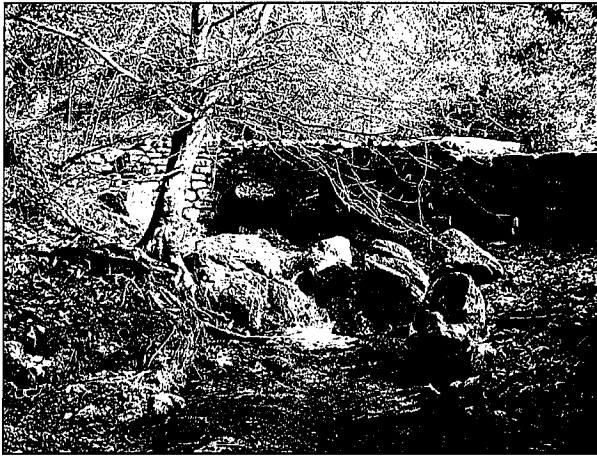
Two squashed 36" culverts at downstream camp road crossing are partial barriers. (PCRM 0.009)

- Site G..... Replace 2 existing Post Creek crossings with clear-span bridges. Revegetate corridor. (CP-7)
- Site H..... Remove 2 Post Creek streamside campsites [104, 106]. Revegetate and install temporary riparian exclusion fencing to limit access to informal trails. (CP-8)

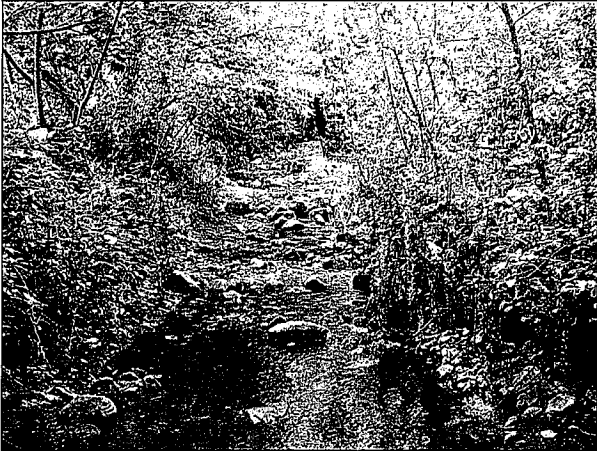
Post Creek riparian zone between camp roads. (PCRM 0.015-0.025)
