Garrapata Creek Watershed Assessment and Restoration Plan

July 2006

Prepared for
**The Garrapata Creek Watershed Community and
the California State Department of Fish and Game**

Prepared by
The Garrapata Creek Watershed Council

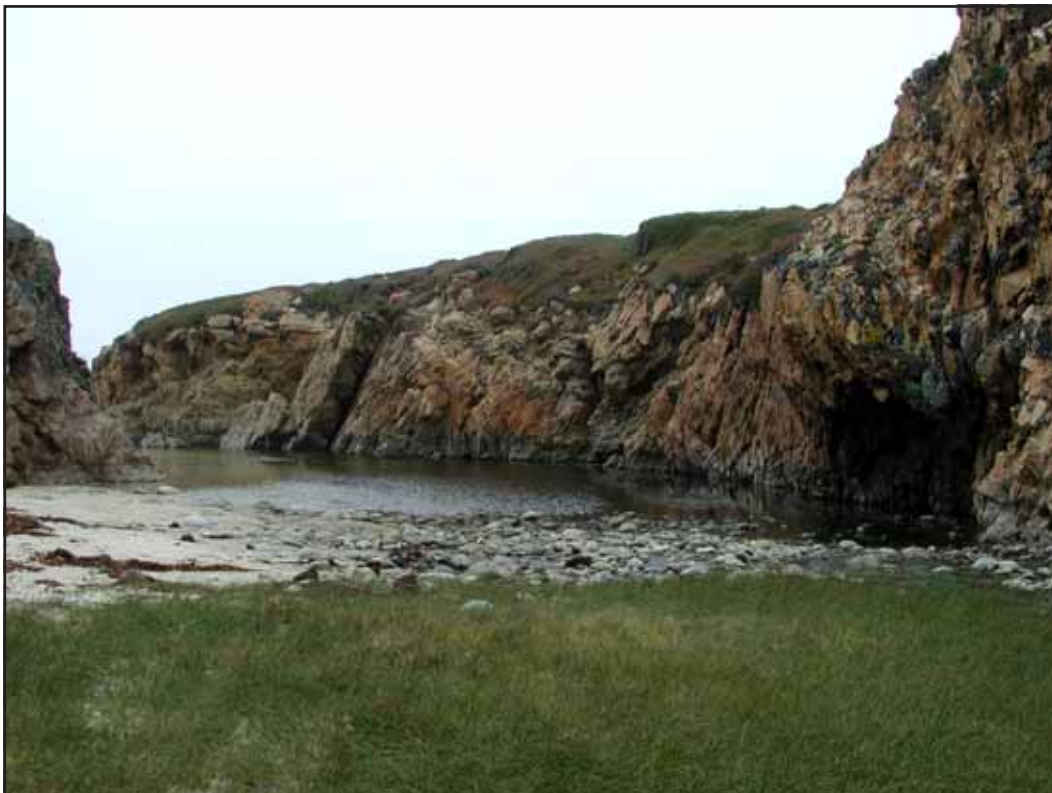
The mouth of Garrapata Creek is a dynamic environment where energy of the stream is balanced by the energy of the ocean waves (Figs. 32 and 33). The two forces tend to push sand in different directions. Usually by the middle of summer, when the ocean's energy and stream flow intensity have declined, sand replenishment along the beach is sufficient enough to form a partial sandbar across the mouth of Garrapata Creek. The result is a "coastal lagoon."

*Figure 32. Garrapata Creek Lagoon looking downstream.
The ocean is just out of view in the upper left corner. Photo: J. Casagrande 04 Aug 2005*

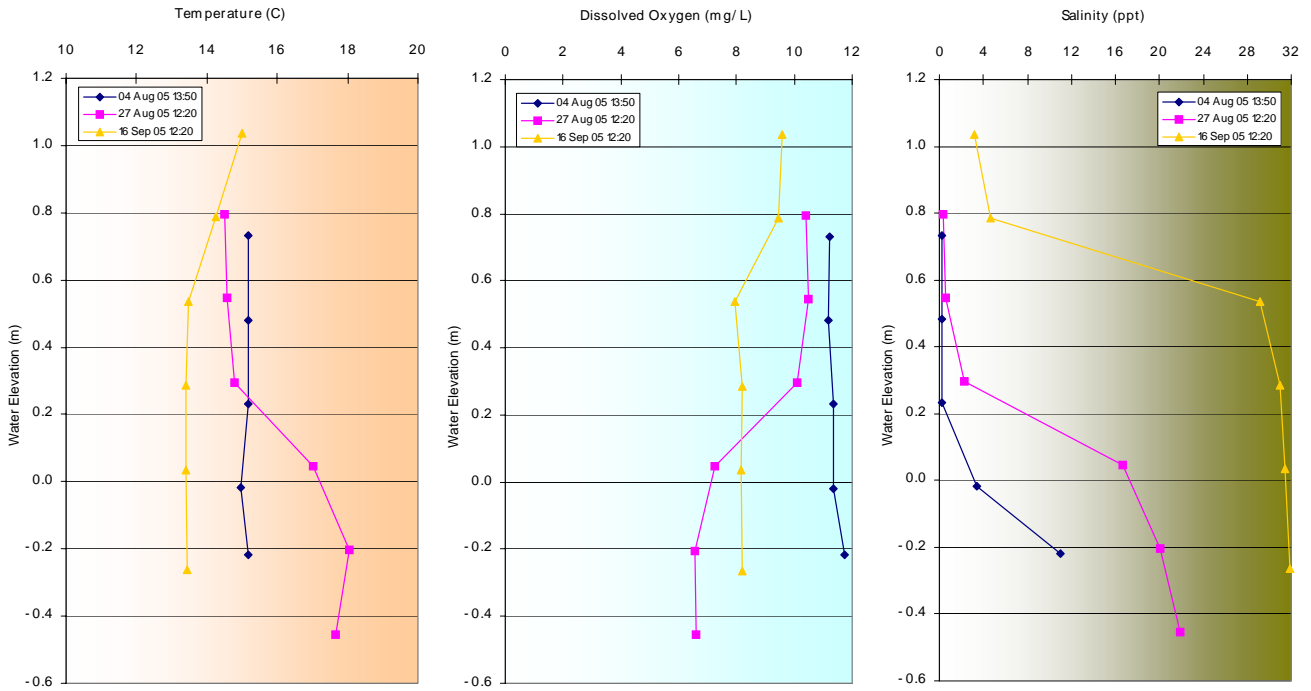
Density stratification of the water column, which is caused by the density differences between heavier saltwater and lighter freshwater, persisted throughout the year, especially in late summer and early fall. When a lagoon stratifies, it limits mixing of the water column. The bottom waters are unable to rise and cool during the evening and therefore retain their heat, causing the water column to become thermally stratified as well. Warmer temperatures increase decomposition rates of kelp and other organic debris; and as a result of the decomposition, dissolved oxygen concentrations are reduced, especially at the bottom of the lagoon.

In Garrapata Lagoon, thermal stratification was observed only in late August during a period of low wave energy and mild climate. At this time dissolved oxygen concentrations reached anoxic levels (i.e., no dissolved oxygen) on the bottom of the deeper portions of the lagoon. This was exacerbated by the decomposition of significant amounts of kelp that washed into the lagoon area in early summer prior to the formation of the lagoon embayment. Kelp continued to wash into the lagoon from wave overwash during high tide and wave events, especially in mid to late fall (Fig. 34).

Figure 35. Summer water quality surface to depth profiles (temperature, dissolved oxygen, and salinity) from Site 3 in the Garrapata Lagoon.

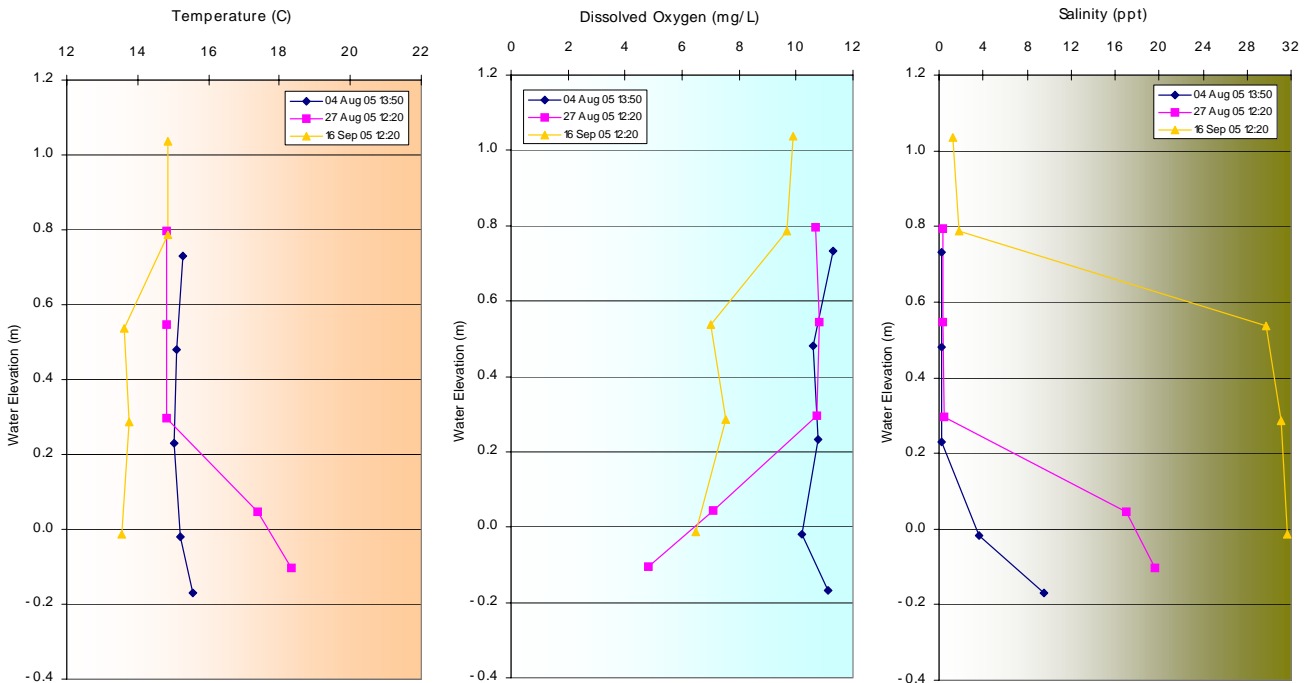
Figure 36. Summer water quality surface to depth profiles (temperature, dissolved oxygen, and salinity) from Site 4 in the Garrapata Lagoon.

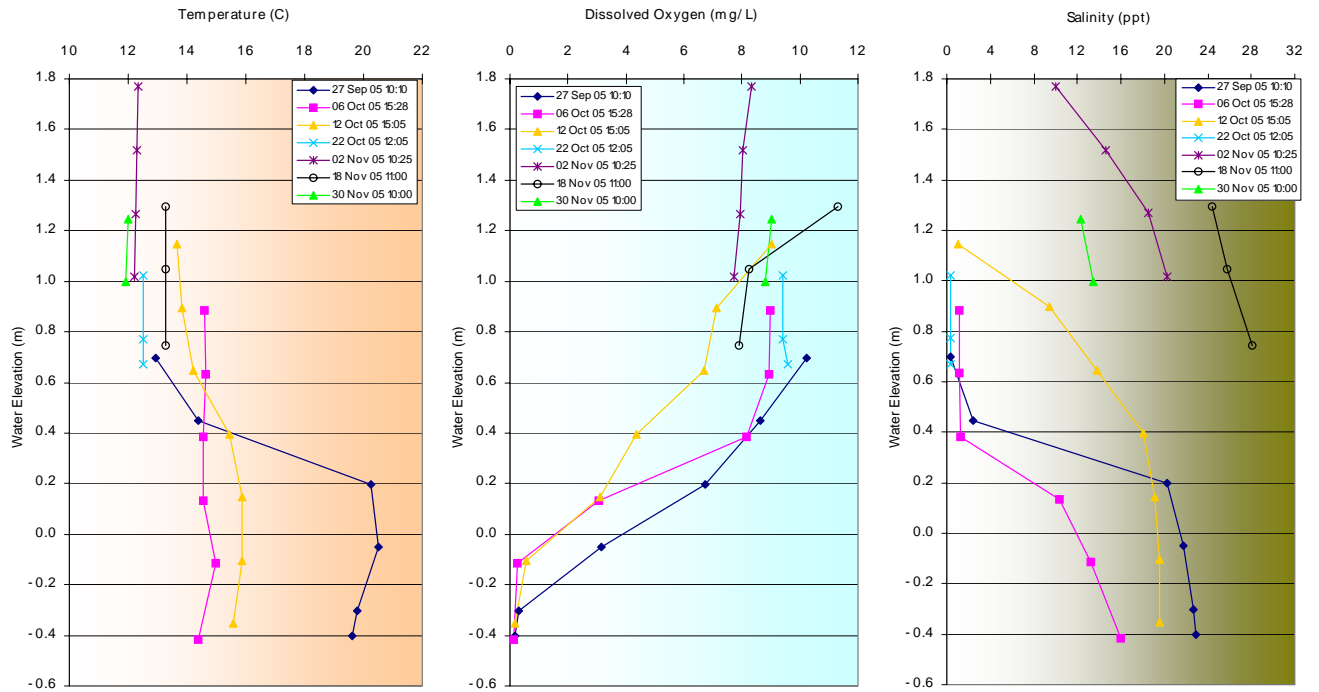
Figure 37. Fall water quality surface to depth profiles (temperature, dissolved oxygen, and salinity) from Site 3 in the Garrapata Lagoon.

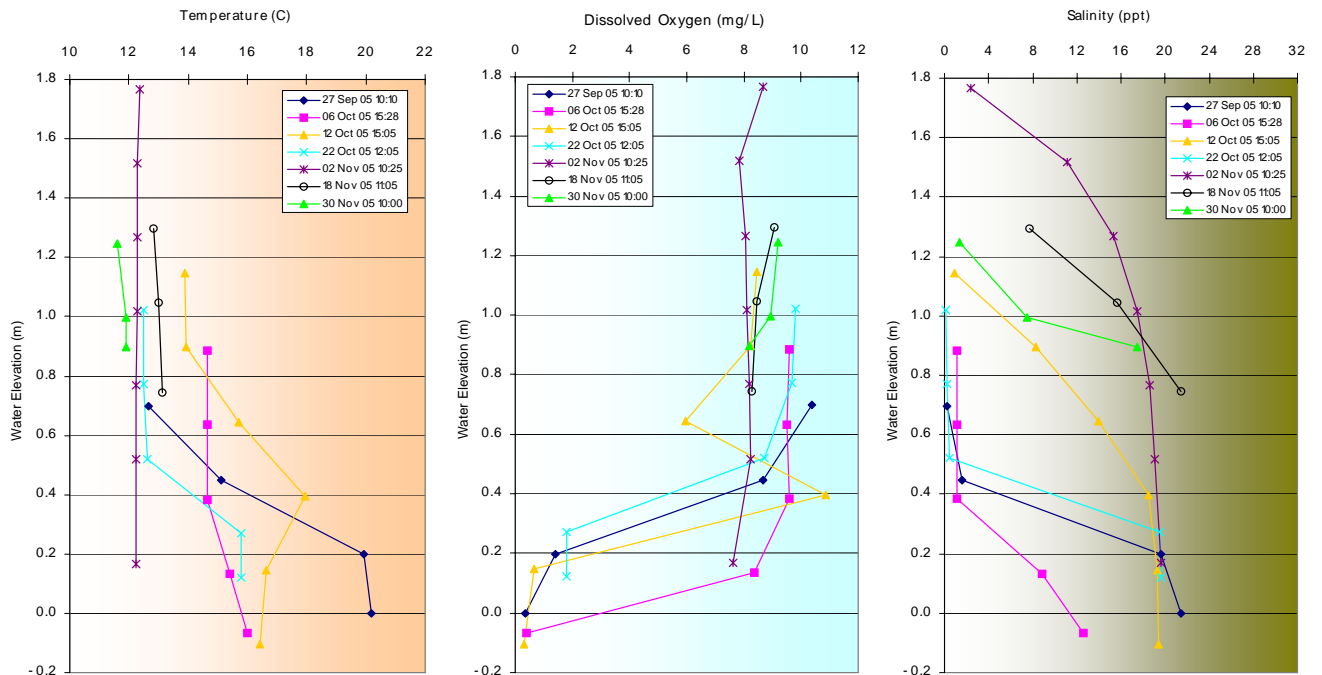
Figure 38. Fall water quality surface to depth profiles (temperature, dissolved oxygen, and salinity) from Site 4 in Garrapata Lagoon.

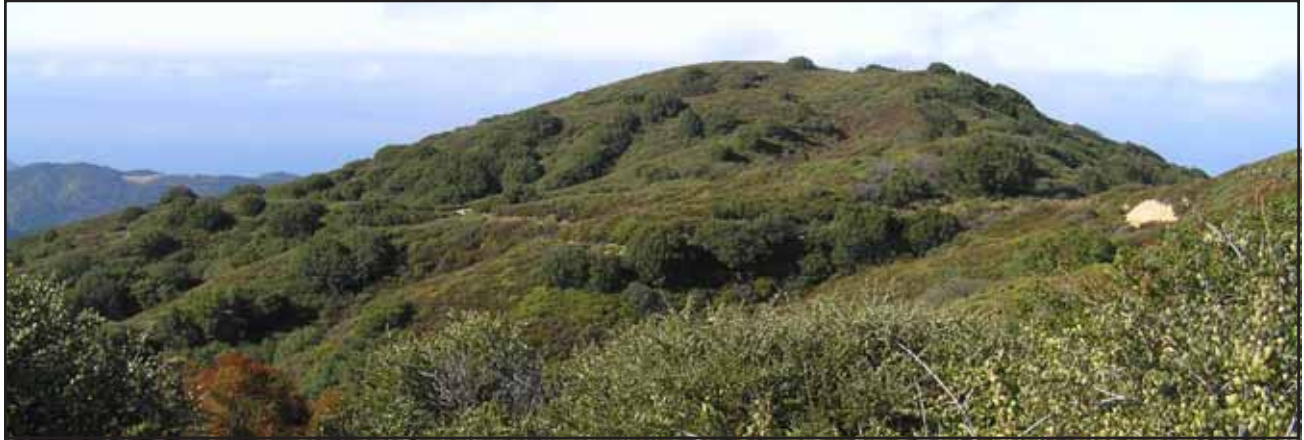
Figure 40: Upper portion of restored roadway traverses through dense mixed chaparral and small groves of coast live oak and canyon live oak woodland. The saddle on the right side of the photograph separates the Wildcat Canyon and Joshua Creek watershed basins. Photo: N. Nedeff October 2005.

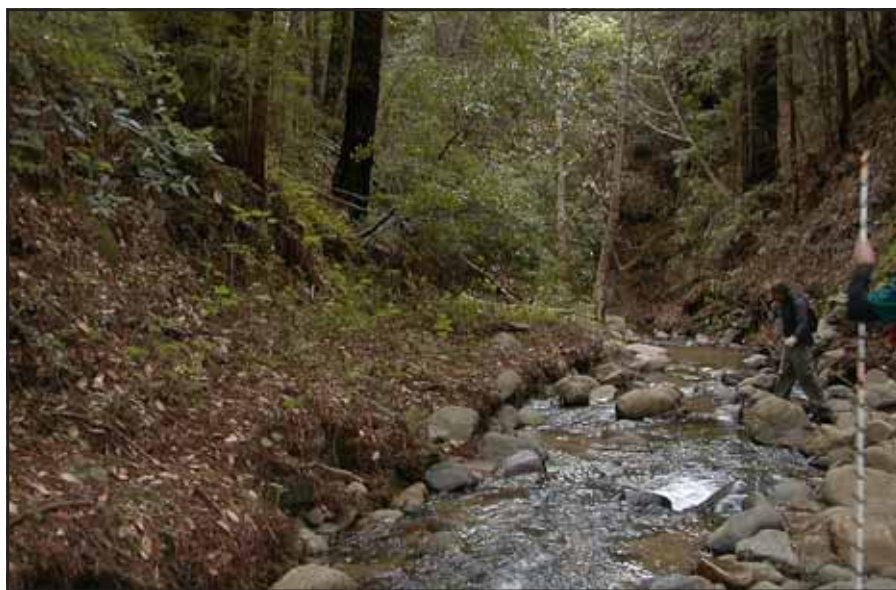
Figure 41: Redwood riparian habitat along middle reaches of Garrapata Creek. Note the relatively wide floodplain, which is unvegetated and covered with a thick layer of redwood duff. Photo: N. Nedeff March 2004.
